ARBORIST REPORT

December 9, 2021

8141 SE 44th St.

Mercer Island, WA

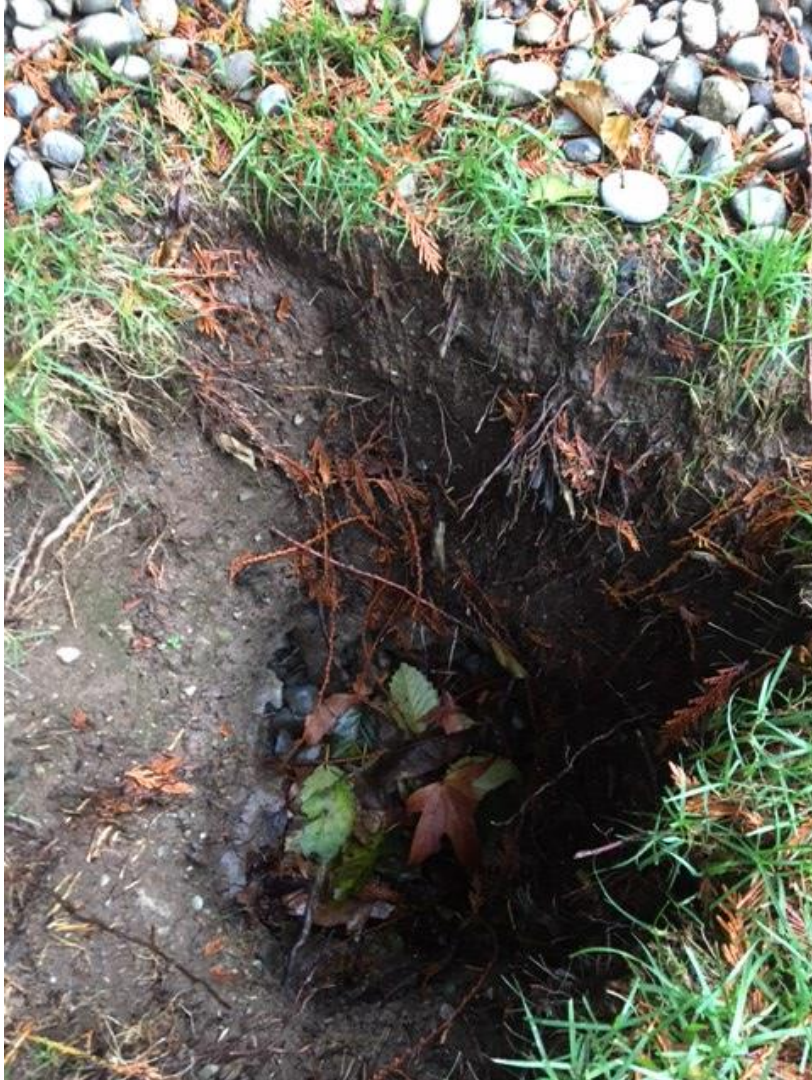
While no trees will need to be removed, Tree #4 will have excavation at its dripline on its western side, or about 15' from the center of the tree. The remainder of the dripline radius is undisturbed native soils and will not be impacted by proposed construction activity. While on-site I noted a small excavated pit near the dripline radius of this tree. The pit was apparently excavated for the purpose of soil sampling. The pit was approximately 24" deep and 15" wide. The sides of the pit revealed very small roots (1/4" diameter) that are most likely from the cedar tree. See Photo below. Further proposed excavation will probably impact similar roots. The tree appears vigorous and will likely generate new fine roots to compensate for those that might be severed.

15" wide by 24" deep pit reveals small cedar roots near surface.

- Tree protection shall be as detailed on the site plan.
- Arborist wood chips or the equivalent should be placed 3-4" deep on the bare soils near Tree #4 as soon as reasonable following excavation.
