October 20, 2021

Project: Pre-construction assessment for lot re-development at 7208 N Mercer Way, Mercer Island, WA. Parcel number 5315100025.

Objectives: Evaluate health of existing trees and establish criteria for the preservation of those to be retained.

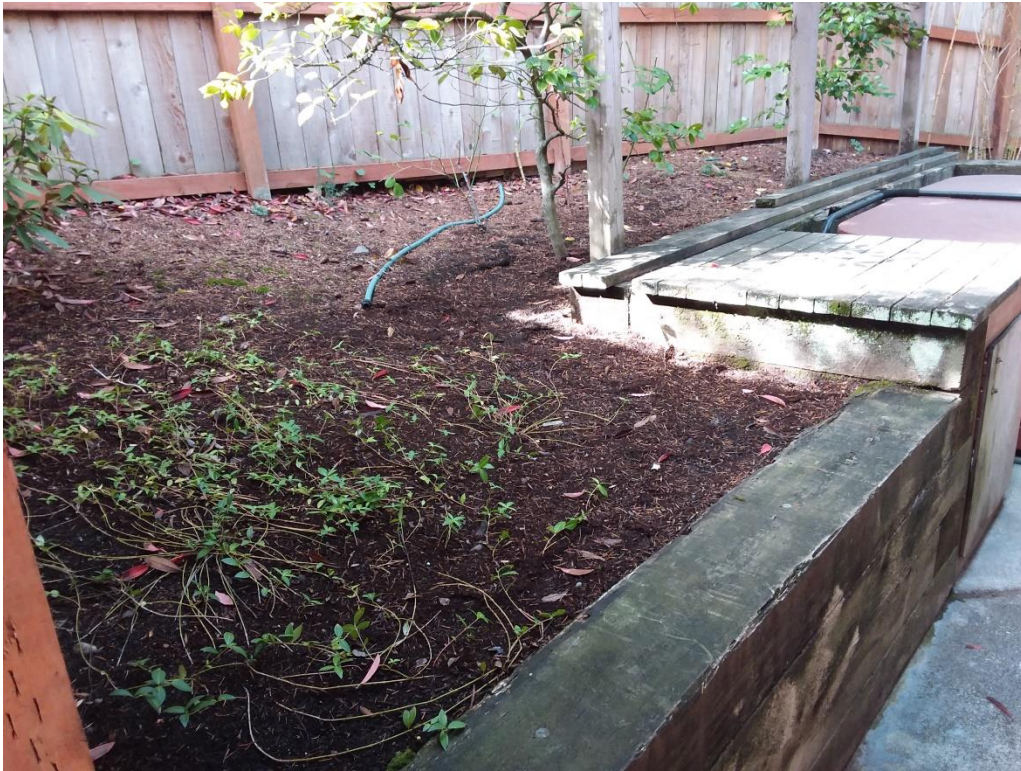
The other aspect to take into account is that the landscape timber retaining wall has been acting as a root barricade for this tree. The end of the turn-around point comes quite close if not exactly in line with where the retaining wall is currently. There should be no roots in the area of the driveway to disturb.

Figure 8. Looking at the landscape timber wall inside the fence.

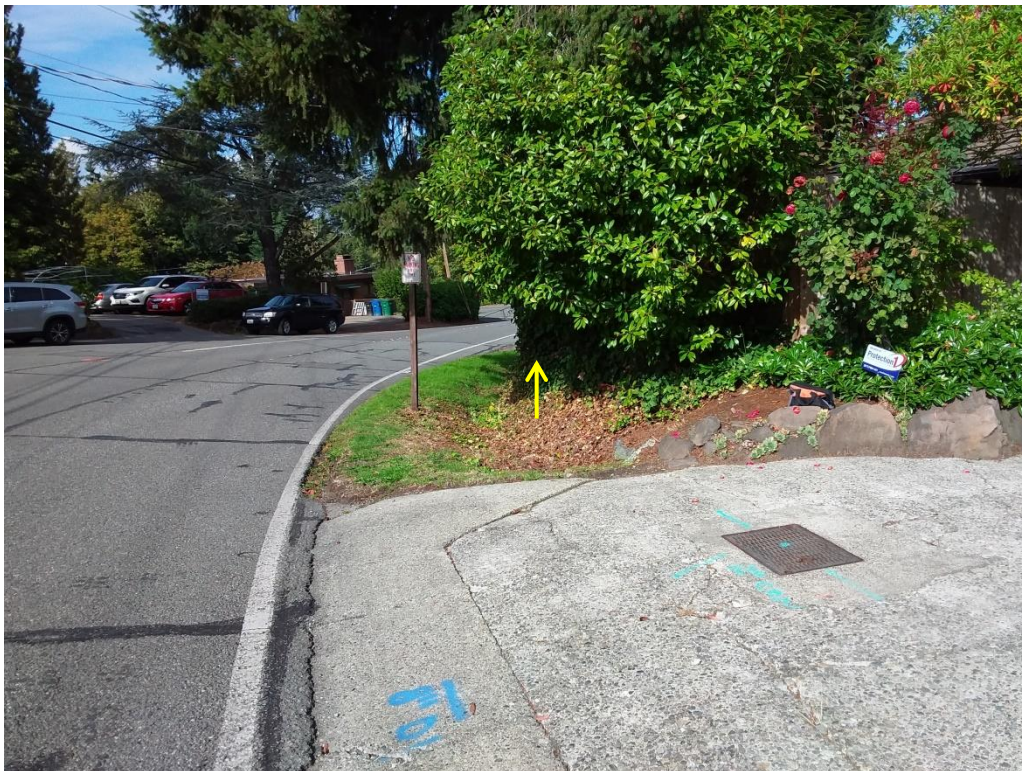
1. Douglas fir (*Pseudotsuga menziesii*) 20" DSH, 75' tall standing 12' NNW of the existing driveway, 12' NE of the white line of North Mercer, and 4.5' outside the existing wooden fence. Inside the fence there is a landscape timber retaining wall that is 7' from the fence at the closest point and 10' back at the furthest (Figure 8). A drainage ditch runs along North Mercer 3' below the base of the tree (Figure 9). The fir exhibits abundant new growth and good color. Its canopy comes down to within 10' of grade and is fairly balanced. Ivy is growing up the trunk. The tree was previously tagged as 50207.

Figure 9. Looking northwest along the ditch running below the #1 and #2 trees. The base of the #1 is just visible (arrow)

The ivy needs to be pulled off the bases of the #1-3 trees. They were clear of it a couple of times in the past so it should not be too difficult.

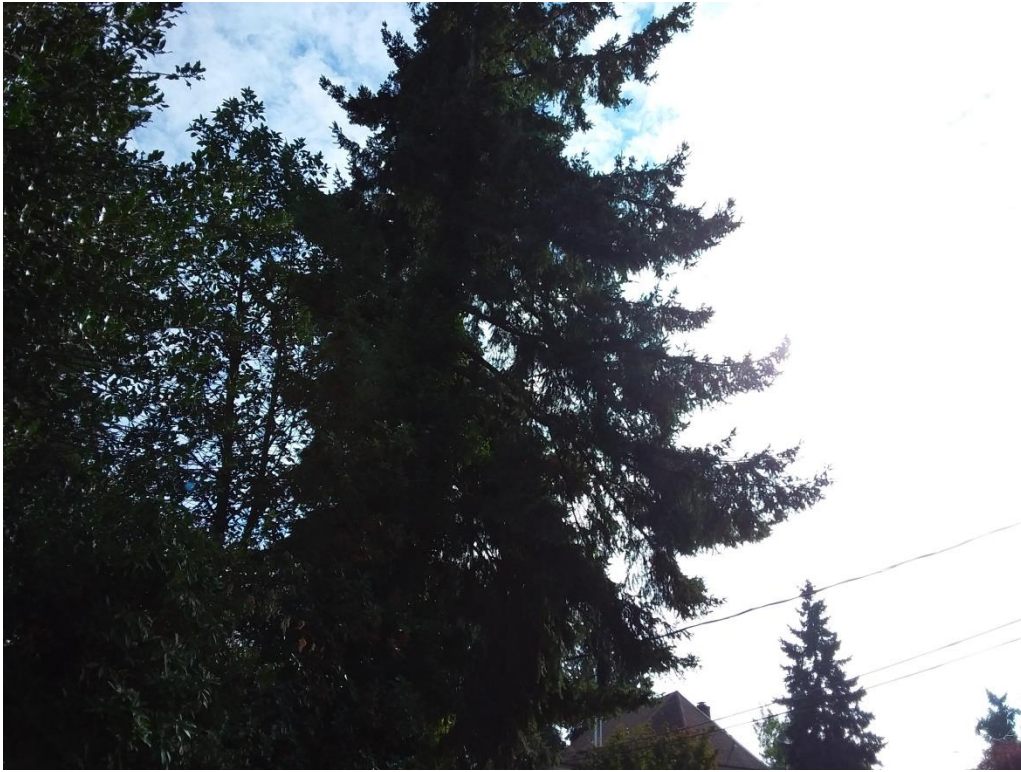
2. Douglas fir 16" DSH, 70' tall standing 11' NNW of #1, 11' off the white line, and 6' outside the fence. Tree is in good health with slightly less new growth than #1 and the majority of its canopy extends to the west. There are some overextended branches reaching past the white line (Figure 10). Ivy is climbing up this tree also. It was previously tagged as 50205.

Figure 10. Looking up into the canopy of the #2 fir showing the overextended branches.

The overextended branches on the #2 fir should be pruned back lightly to help prevent breakage.

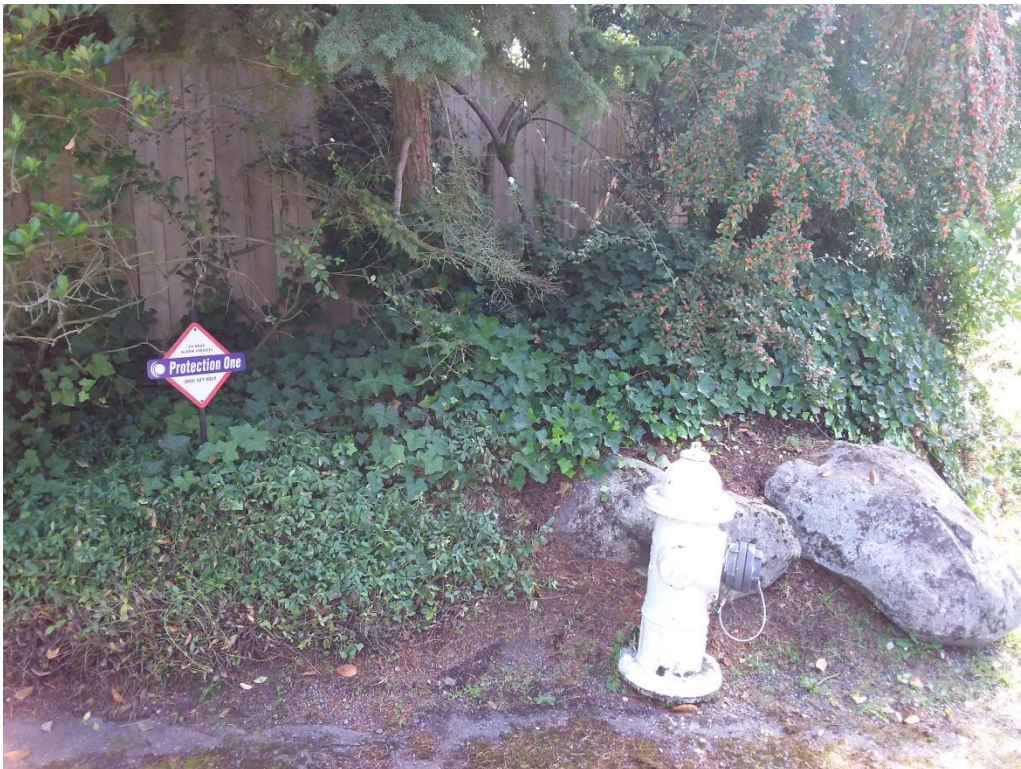
4. Mountain hemlock (*Tsuga mertensiana*) 7.5" DSH, 20' tall in good condition with ample new growth, rich color, and limited needle loss. The canopy is mostly in the NW quadrant due to pressure from the cotoneaster near its base and other trees in the yard proper. Tree stands 32" NNW of the corner post for the fence and 6' SE the fire hydrant at the corner. There are large landscape stones anchoring the landscape at this point. The two largest are 4' and 5' WNW of the tree (Figure 11).

Figure 11. Base of the #4 Mountain hemlock behind the hydrant. Note the large stones.

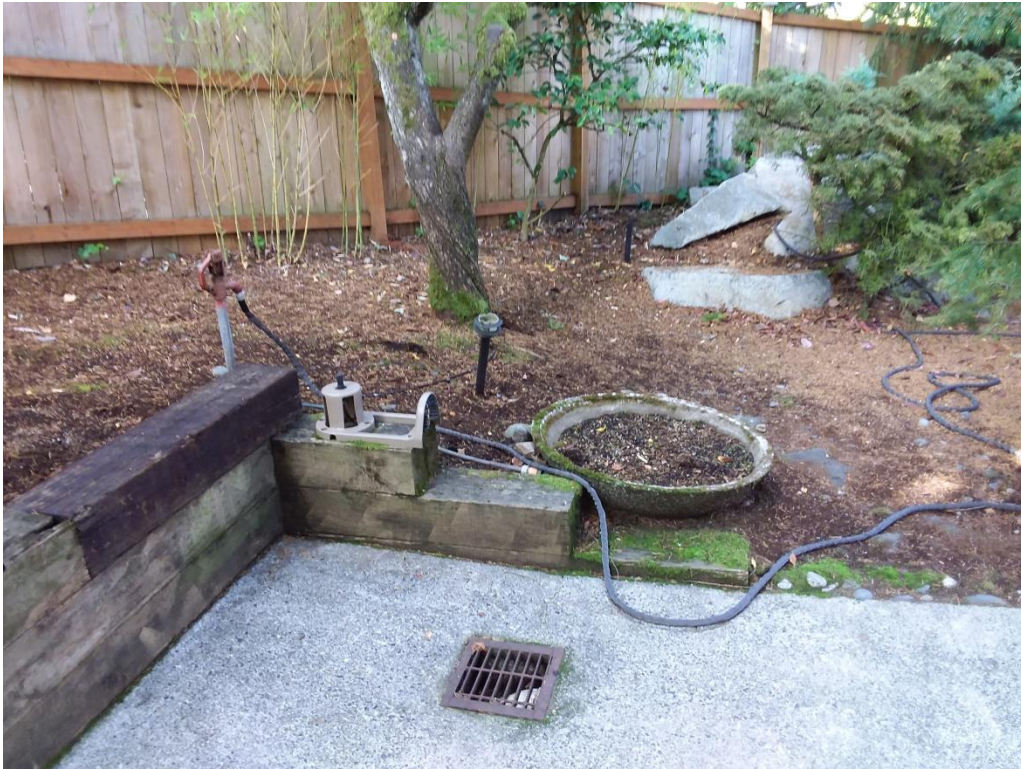
6. Italian Prune (*Prunus domestica*) 6" and 9.5" DSH, bifurcates at 36", it has been topped in the 14' range, spreads 8' on center and has been pruned to maintain these dimensions. Appears to be in below average condition. Tree stands 14' WNW of what is technically the west corner of existing house. The patio area is 54" SSE of the base of the tree. The stones for the water feature start at 6.5' N of the base of the tree (Figure 12).

Figure 12. Placement of the #6 plum between the retaining wall, fence and stones for the water feature. This is the area where the hammerhead will be placed.

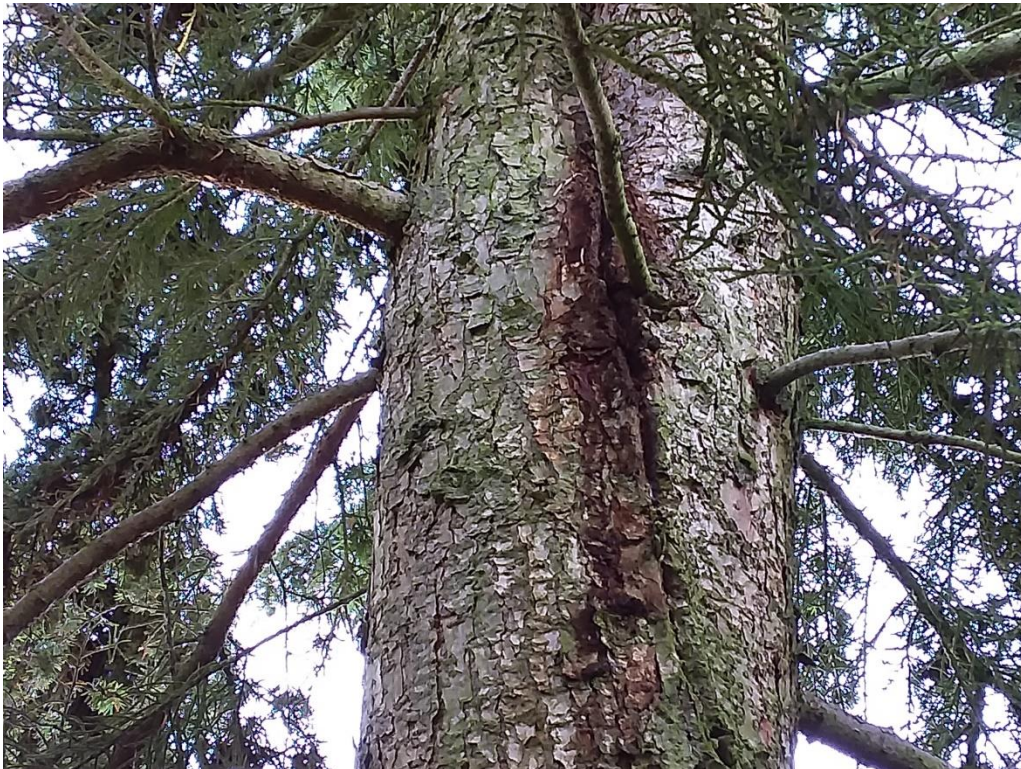
8. Mountain hemlock 10" DSH, 25' tall, standing 68" NNE of #7 and at the north end of the landscape stone. There are several other large stones around its base. It bifurcates at 9.5' and has an active fracture plane running up the SE face to where the stems fully separate two feet higher (Figure 13). The two stems spiral as they rise. Tree exhibits good health. The water feature starts 5' N of the tree, runs 10' SW of it, and extends more than 25' out to the northeast. Tree has a previous tag labeled 50614.

Figure 13. Looking up at the fracture plane in the #8 Mountain hemlock.

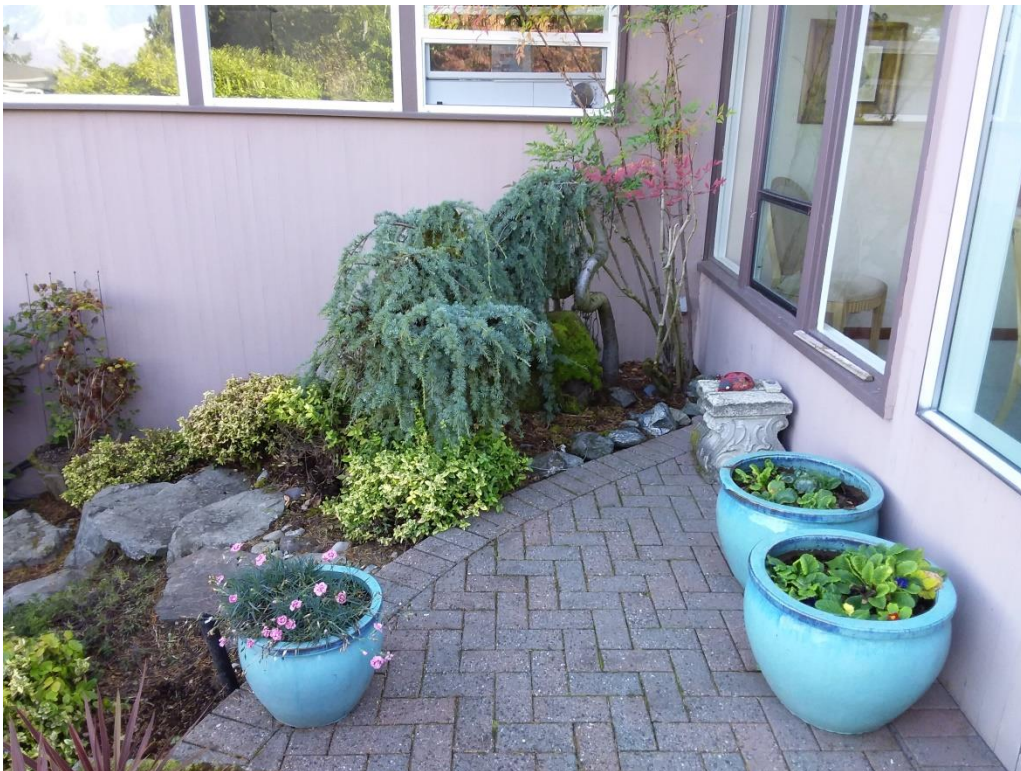
There is a Weeping Blue Atlas (*Cedrus atlantica glauca* 'Pendula') growing in the inside corner of one of the jogs on the north side of the house (Figure 15). There are a number of other ornamental shrubs in the yard like Weeping Spruce, viburnums, and small pines but nothing that reaches the size of significance.

Figure 15. The Weeping Blue Atlas cedar in the corner of the existing house. This tree is worth trying to salvage.

A number of the trees and plants at the site are worth salvaging, namely the Blue Atlas Cedar, the smaller Laceleaf maple, and some of the other small evergreens.

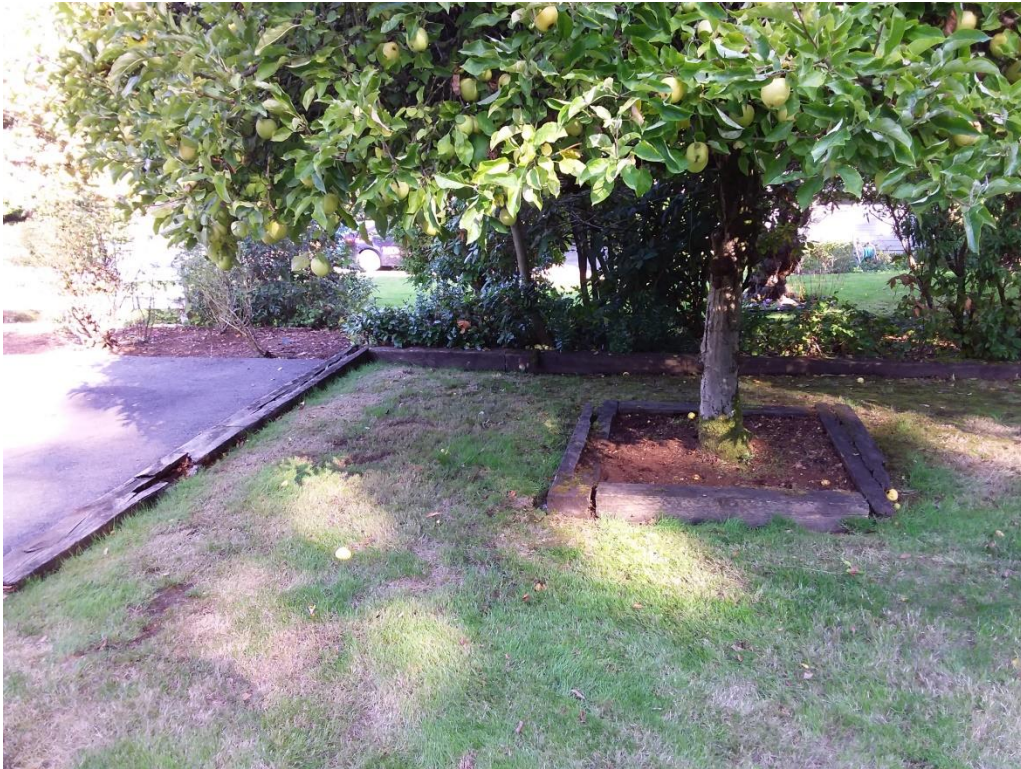
11. Apple tree (*Malus domestica spp*) standing inside of a rail road tie planting bed near the center of the northeast end of the parcel, 17' SW of the property line, and 9' SE of the end of the parking area (Figure 16). Tree is 5" and 7" DSH, bifurcates at 49", reaches 14' tall on epicormic shoots, and has a 9' radial spread. Fair health, cluttered canopy, does not appear to have been pruned regularly for anything save size.

Figure 16. Showing the location of the #11 apple. Note the landscape timbers framing the planter box. The tree has outgrown this space and the timbers should be removed and a larger area created for the tree.

The two fruit trees have been neglected and should be pruned annually to promote proper growth response and structure.

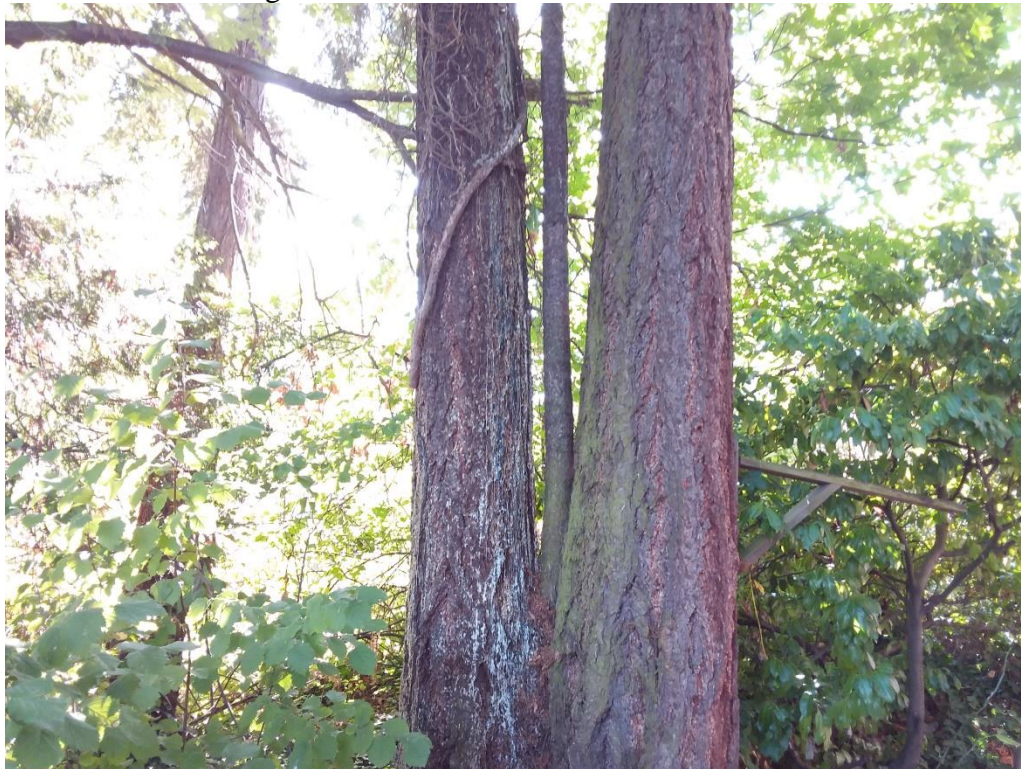
18. Dual stem fir with an atrophied subordinate spar sandwiched between the two primary trunks (Figure 17). The larger trunk measured 30.5" DSH, the smaller 25" DSH. The larger side reaches near 90' tall while the smaller tops out around 75' high. The large stem has a structural fault near the 50-foot level. A large caliper lateral arm grows off to the NW quadrant and extends over the existing home. It comes out flat and then turns vertical about four feet out from the column. The main stem above this point is offset to the SE comes back into vertical about 9' further up the column. Tree stands 14' on center southeast of the foundation existing house. It is 26' NE of SE corner of the existing house. There is a concrete walkway along the SE side of the house that is 8' back from the base of the tree.

Figure 17. Looking at the base of the #18 fir showing the atrophied spar squeezed between the larger two trunks.

Ideally, and with the neighbor's permission, the big spar on the #18 tree would be pruned back to reduce its likelihood of cracking off also. A climbing arborist will have to evaluate the spars strength of attachment and reduce the weight on the scaffold accordingly. At minimum 15% of the end weight should be pruned off the spar.
