RE: Stewart Residence 4600 Forest AVE SE St, Mercer Island

This is the follow-up to my site visit/inspection of the proposed construction plan and its possible effects on the Western Red Cedar in the backyard. The tree is located just off the middle of the deck. Project Arborist to be on site for installation of protection measures and in this case, the tree pruning and deck post installations to assure proper cutting of roots and limbs directly affected.

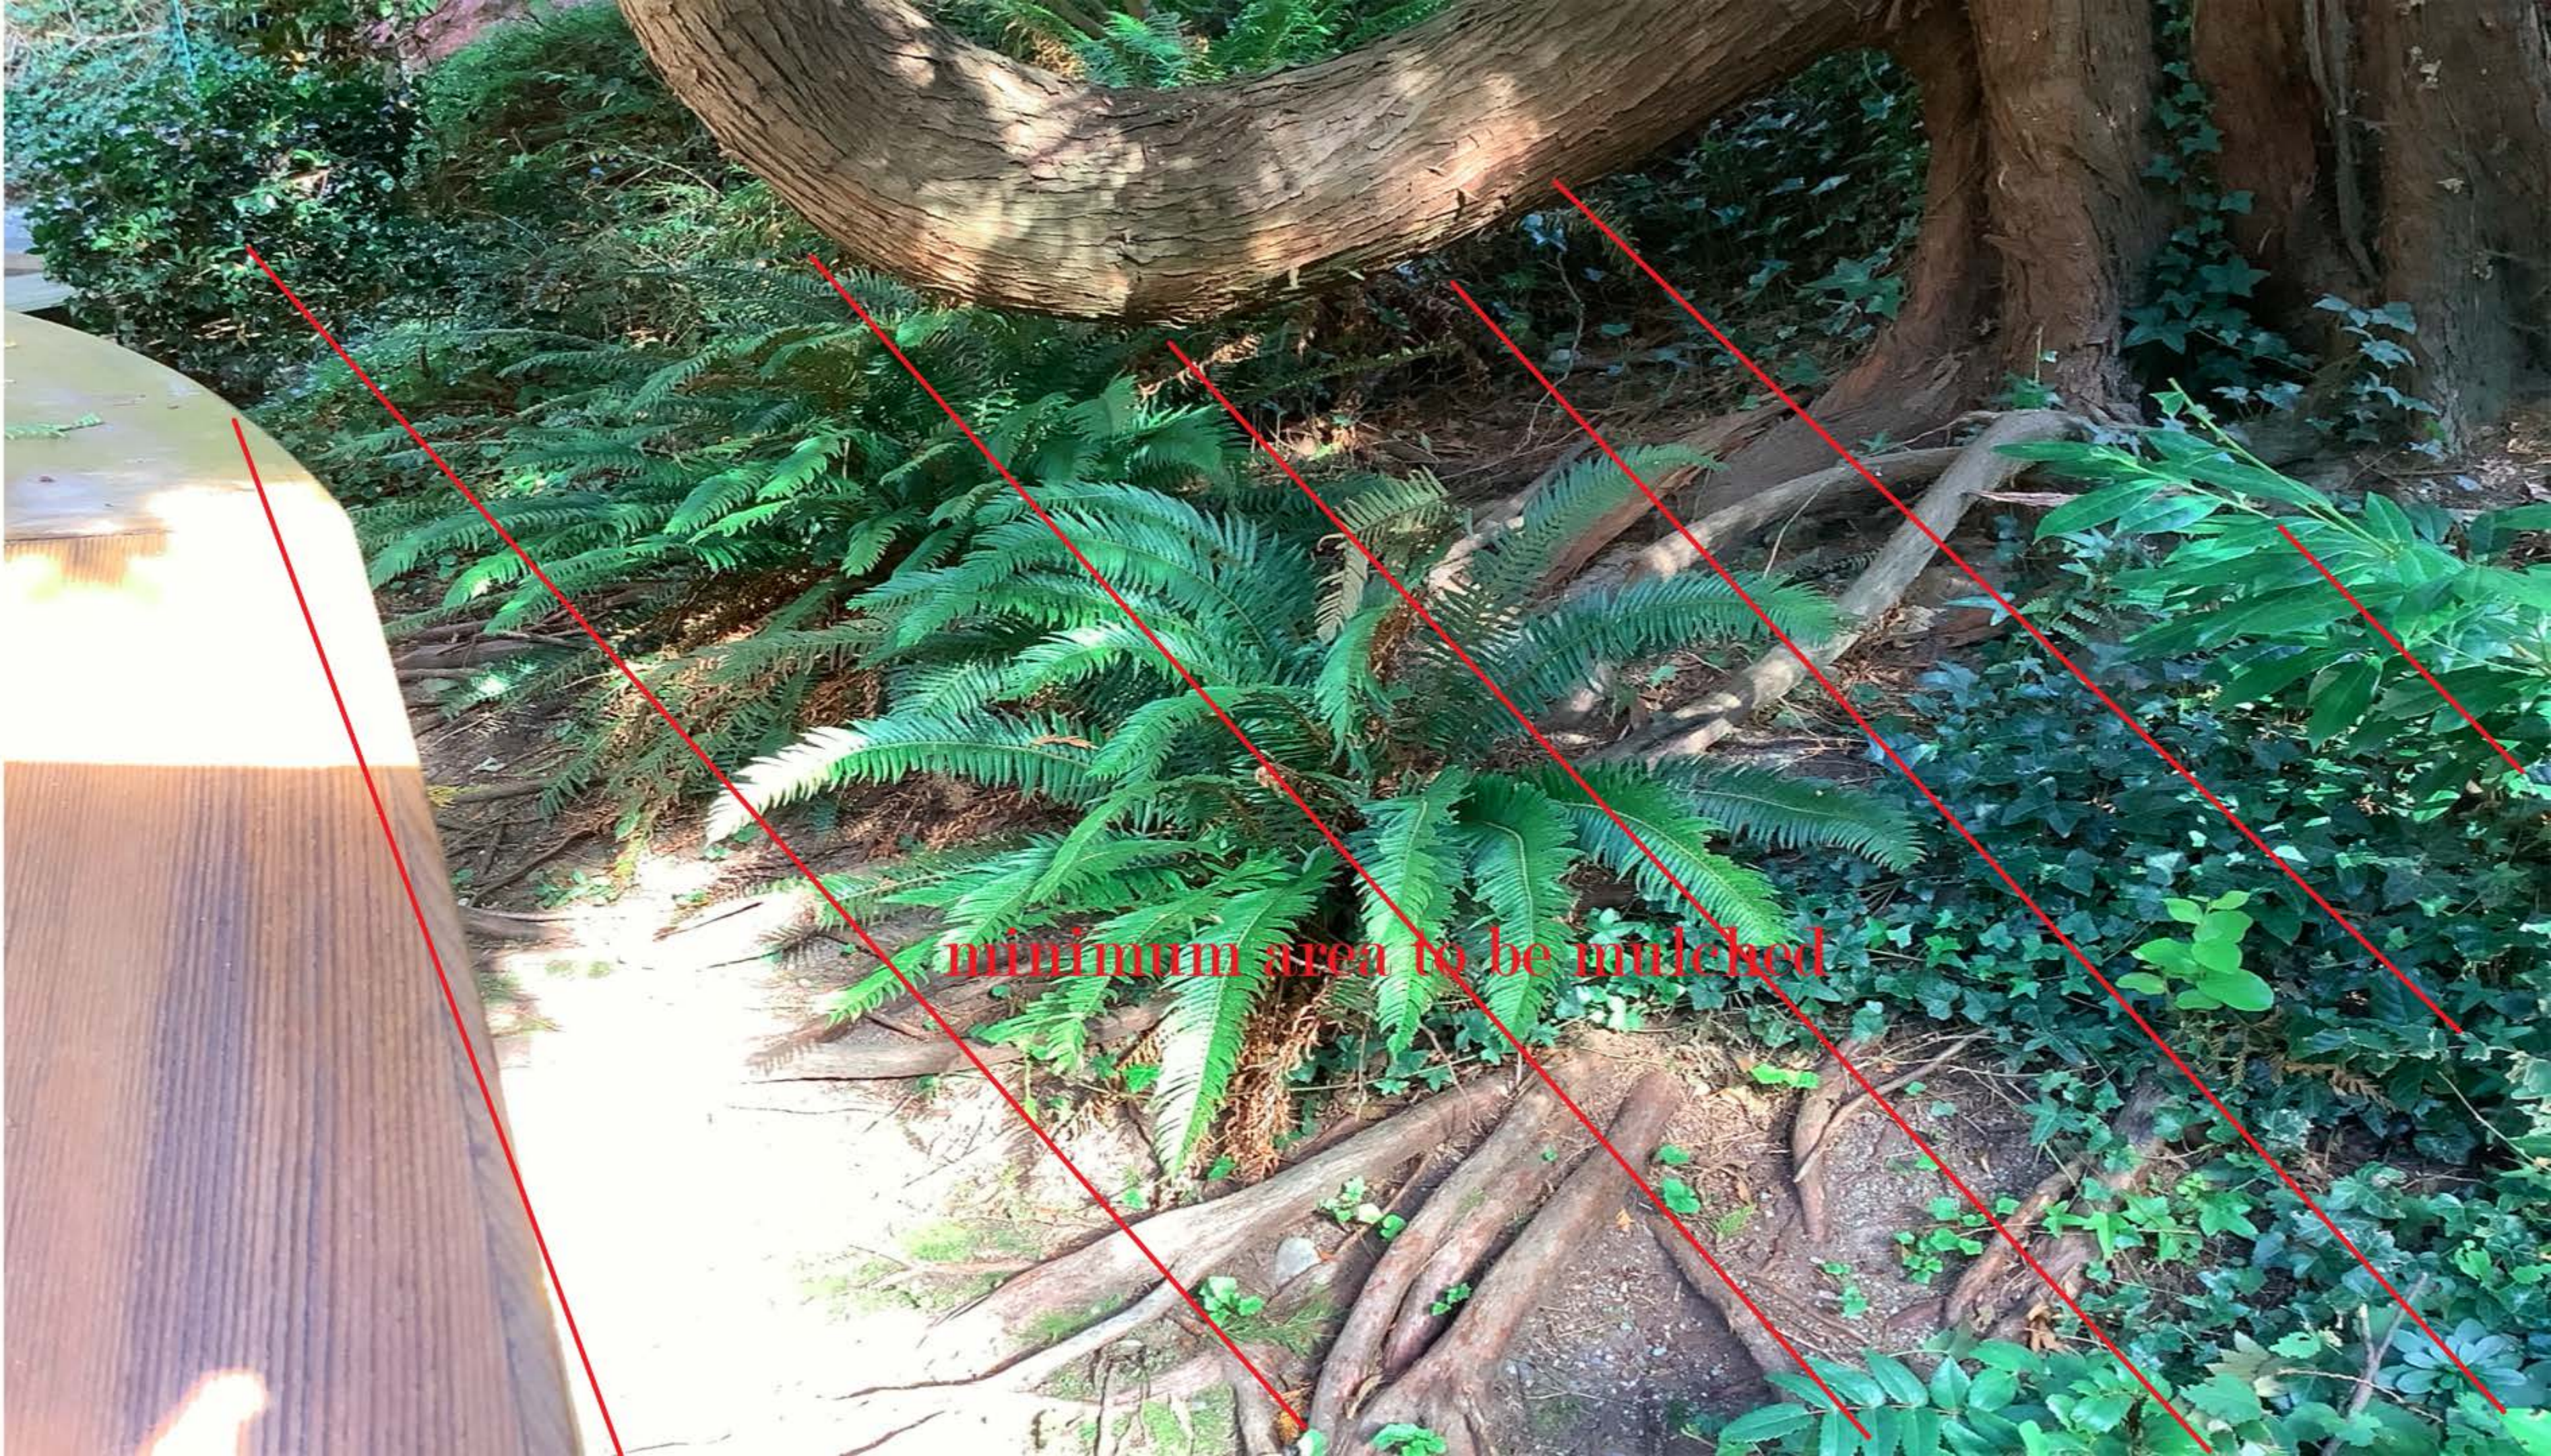
minimum area to be mulched

Crown to be raised 3-4' on this leader only

Re-inforcing posts locations

There are extensive surface roots from the tree. To protect this tree, mulch must be spread over the entire root system on the west side of the tree. If possible, extend this to the uphill side of the exposed roots. The mulch should be 5 inches but no more than 6 inches deep. As this is a sloping area, daily inspection and resupply/repositioning of mulch must be done to assure root protection. In addition, a lane of plywood sheeting be laid in place along the edge of the existing deck over the mulch at least 4' wide for added protection. A 4' tall tree protection fence is to be placed on the east side of this plywood walkway. No materials are to be stored outside of the plywood walkway.

I was shown the extent of trimming needed on the Cedar to make room for the proposed new deck cover. This trimming will be limited to 5-6 branches on the large sweeping limb growing off the main trunk of the tree. This will be well within the limits and pruning guidelines of the International Society of Arboriculture.

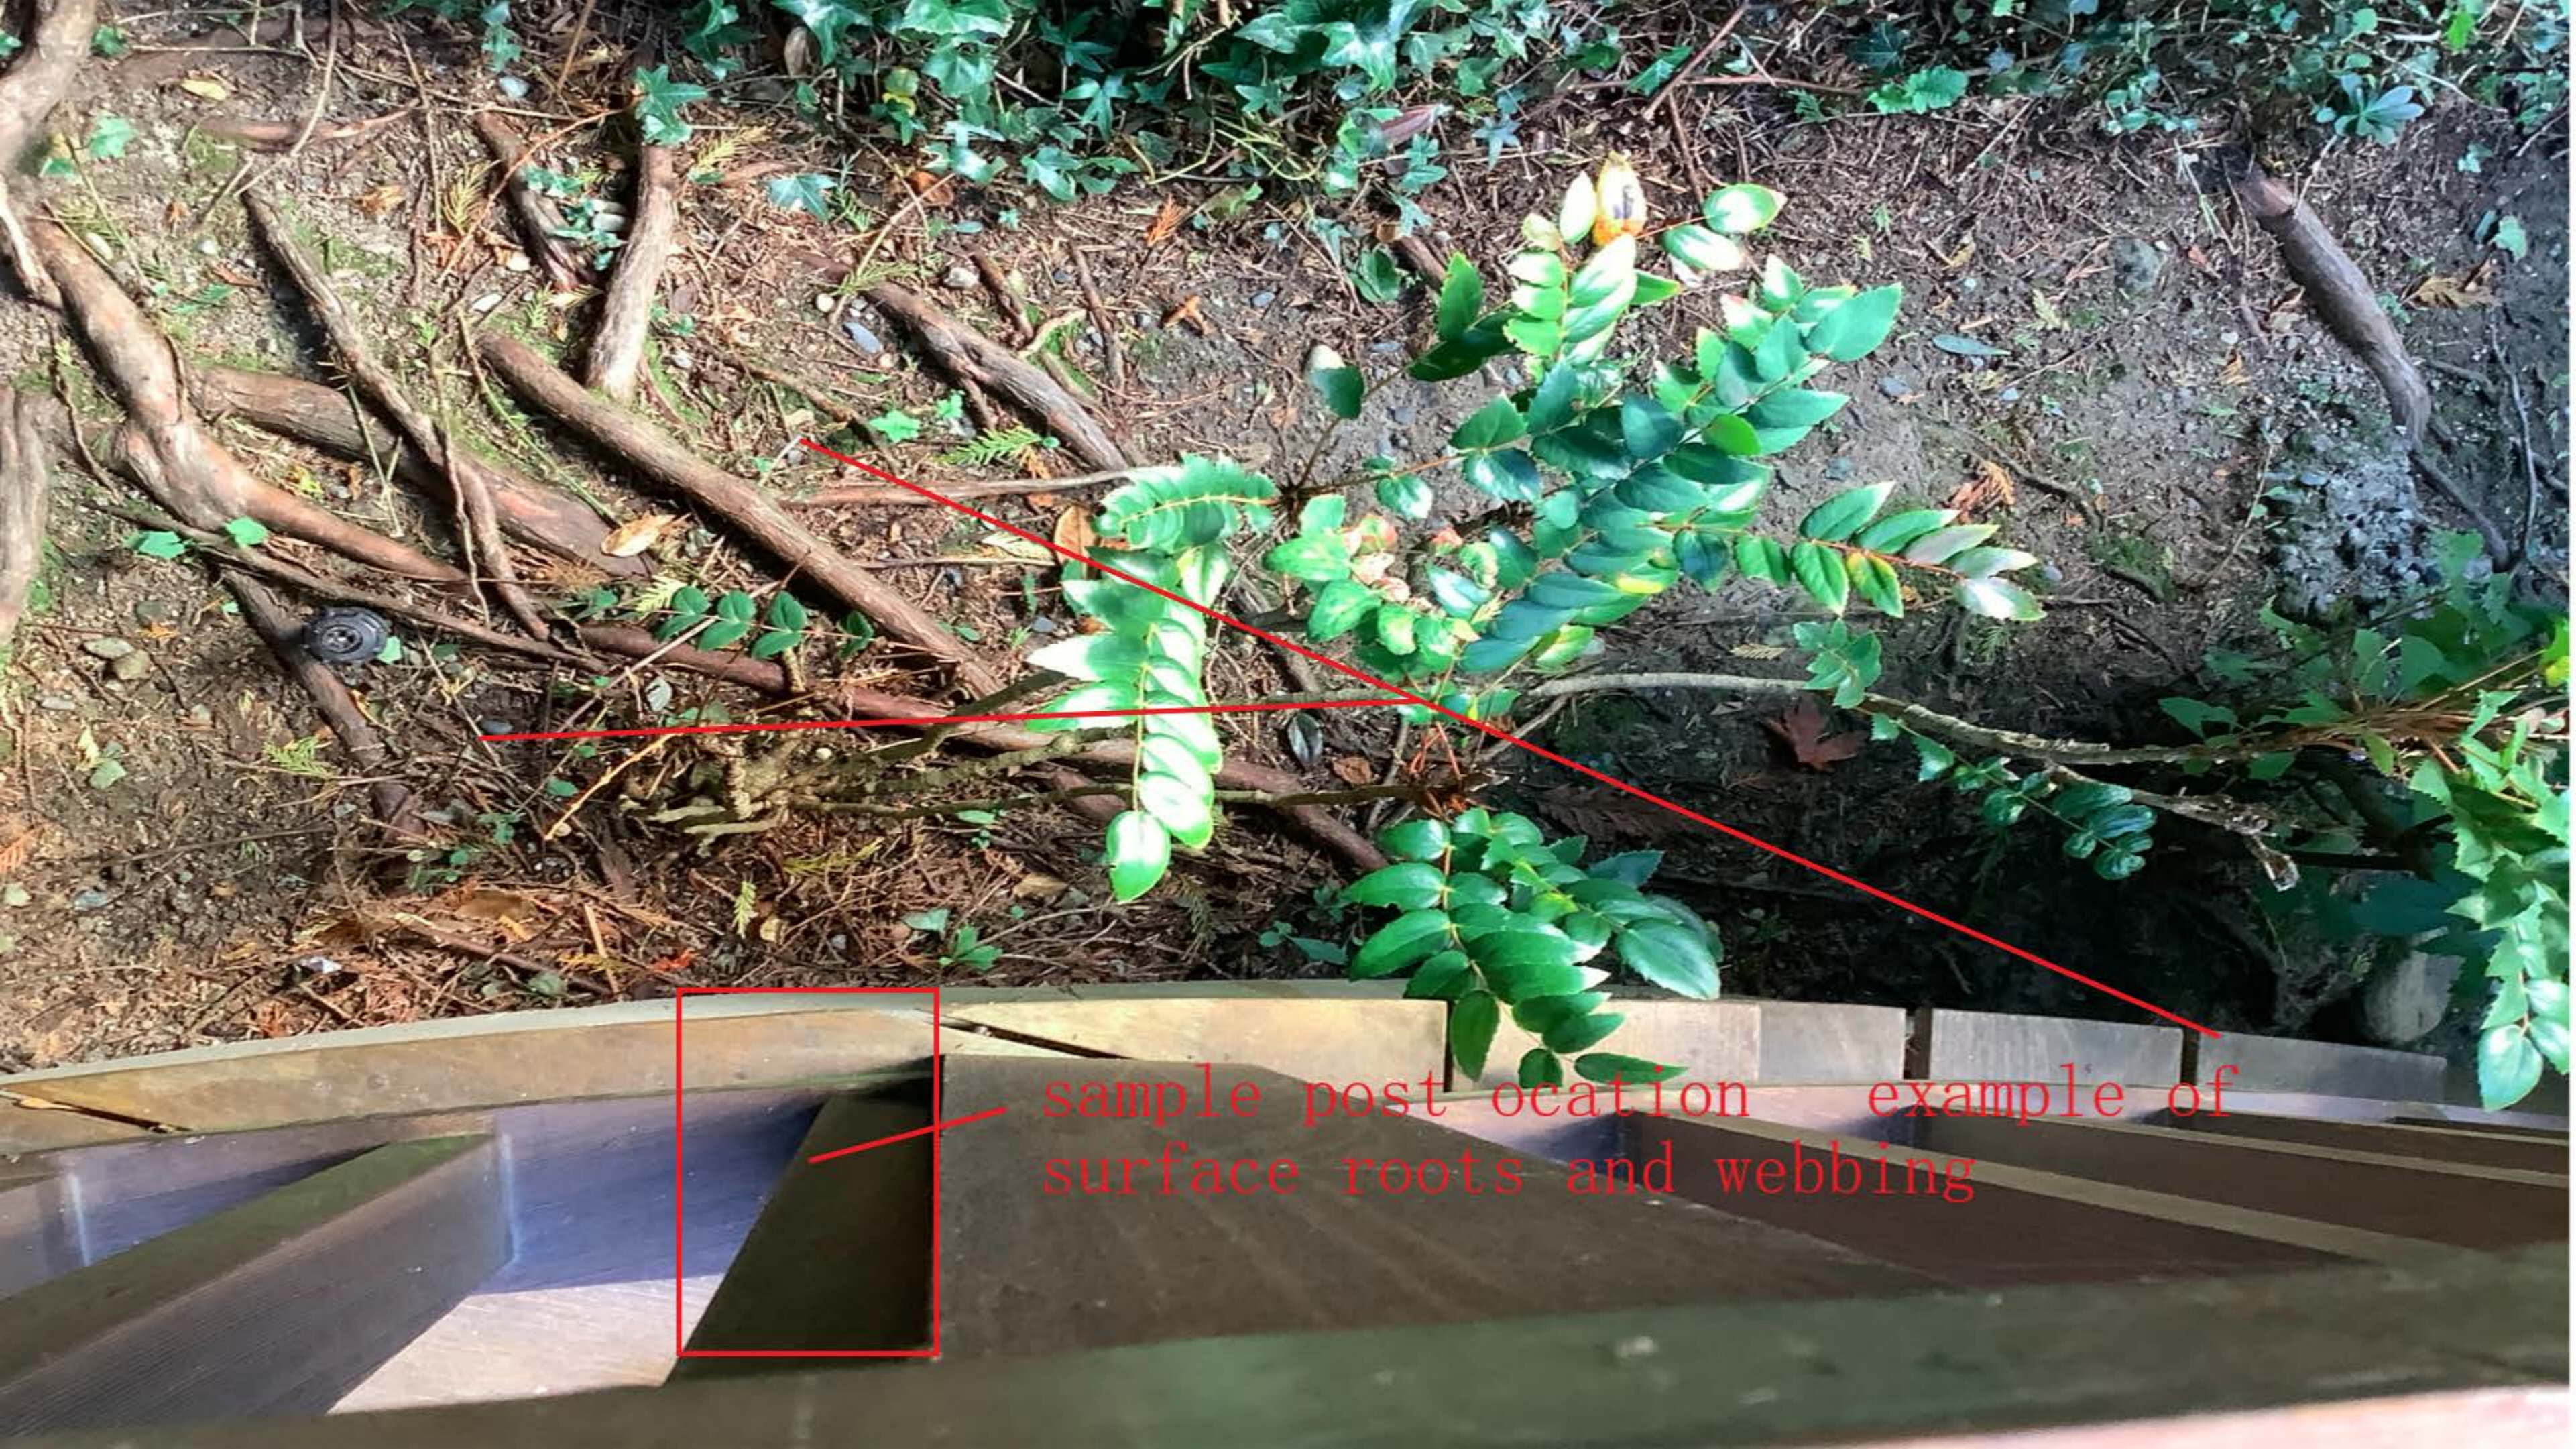
sample post ocation example of
surface roots and webbing

There are three new reinforcing posts to be installed and this directly next to the existing posts, which will remain. The new posts will not significantly encroach or damage the root system as the roots leading under the deck are in the 1-3" diameter range and crisscross, leaving wide spaces.
