ARBORIST Memo

May 16, 2022

9017 SE 60th St.

Mercer Island, WA

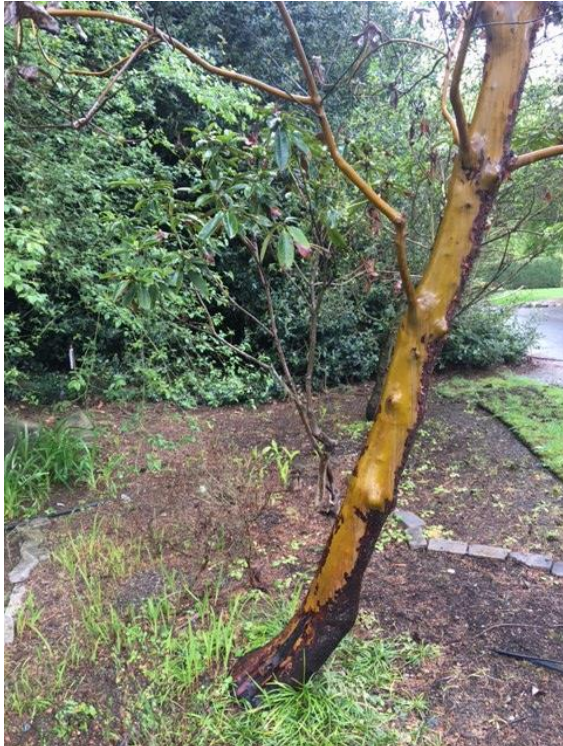
There is a Madrone Tree, *Arbutus menziesii*, that measured 4.97" DBH, rounded to 5.0" DBH. There are two (2) photos of the tree included below. The tree is leaning toward the street and the tree has a very advanced leaf fungal infection that has impacted 100% of the established foliage. There are new leaf buds beginning to open but they will be infected with the same fungal pathogen. The tree has landscape value and could possibly be nursed back to health by beginning a leaf fungal abatement program. It would not be unreasonable to remove the tree due to its current condition and to the fact that the lean cannot be corrected; the lean will become more problematic over time with regards to any risk of future failure with impact to the street, and pedestrian use. If you decide to remove the tree due to its structural lean and due to advanced defoliation, you will be required to plant one tree as near as possible to the current tree's location. If you retain it, the Tree Protection Fencing detailed for Tree #1 will also provide protection for this Madrone tree.

Madrone tree leans toward street. 5.0" DBH.

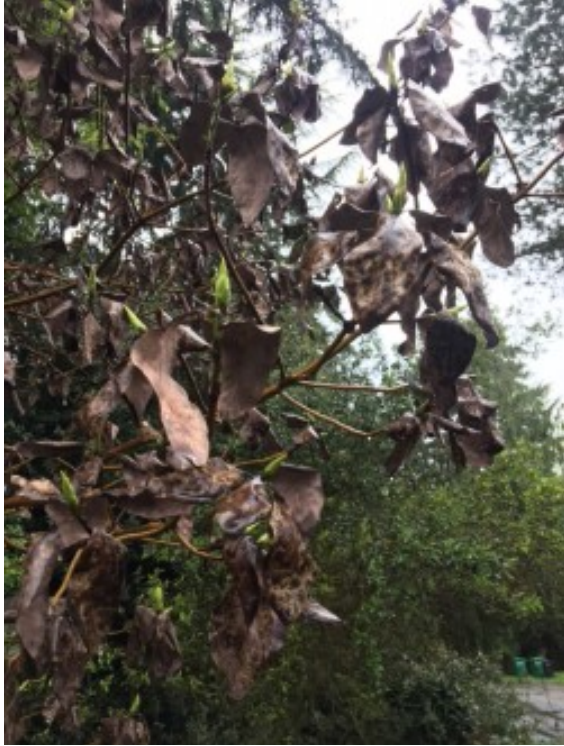
Madrone with 100% leaf fungal infection.
