Arborist Report

To: JayMarc Homes c/o Kenady Hague
Site: 4541 88th Ave SE, Mercer Island, WA, 98040
Re: Tree Inventory and Assessment
Date: April 26, 2022
Project Arborist: Connor McDermott,
ISA Certified Arborist #PN- 8704A
ISA Qualified Tree Risk Assessor
Reviewed By: Joseph Sutton-Holcomb
ISA Certified Arborist #PN-8397AM
Municipal Specialist, Qualified Tree Risk Assessor
Referenced Documents: Topographic and Boundary Survey (Terrane 06/11/2021)
Site Plan A2.1 (JayMarc Homes 04/11/2022)
Attached: Table of Trees
Tree Site Map
Planting Plan

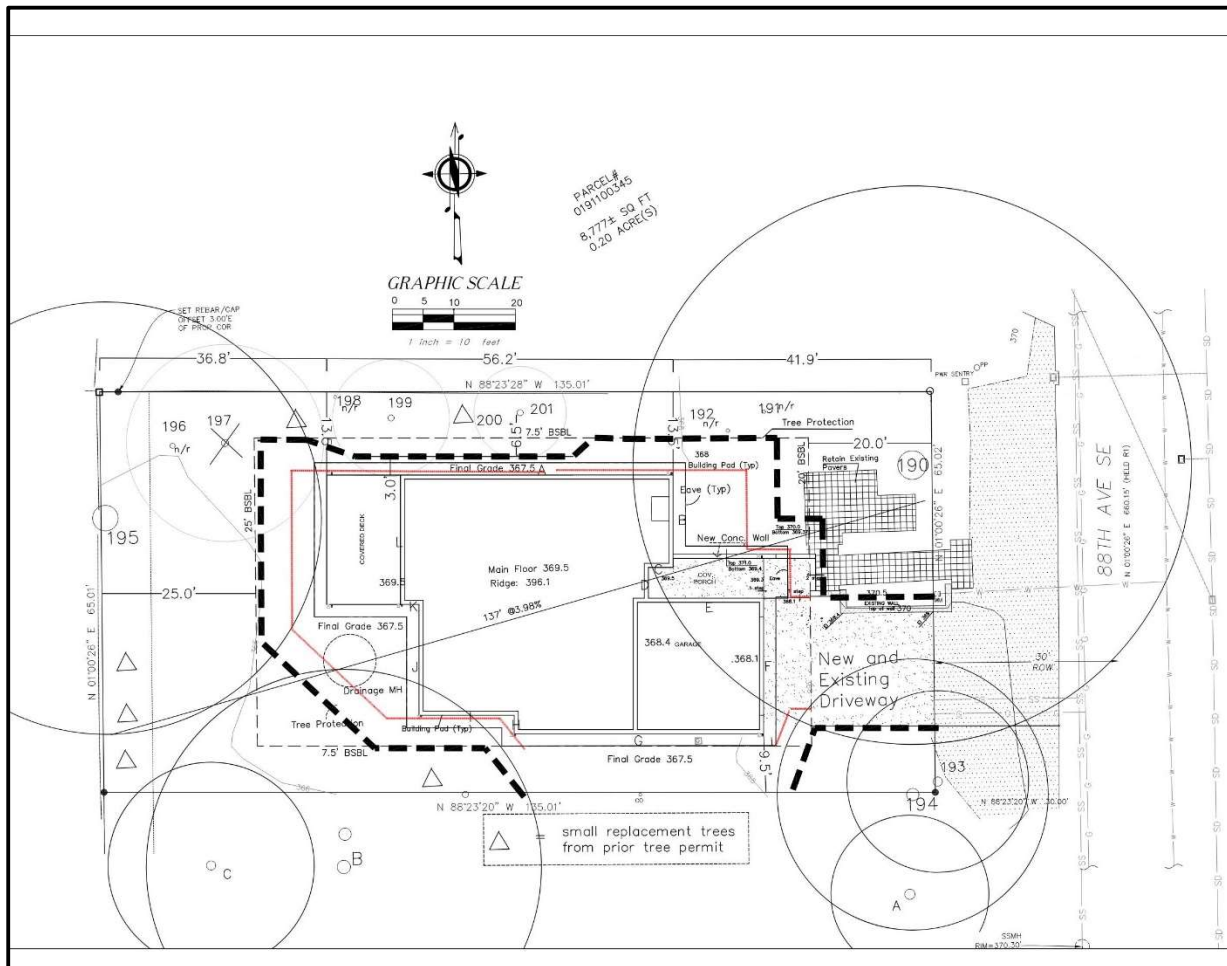
Figure 1. Site Plan A2.1 (Gary Upper, 04/11/2022). The plans show the footprint of the new house moving west, replacement of the existing driveway in place, and placement of the TPZ fencing in the dotted line.

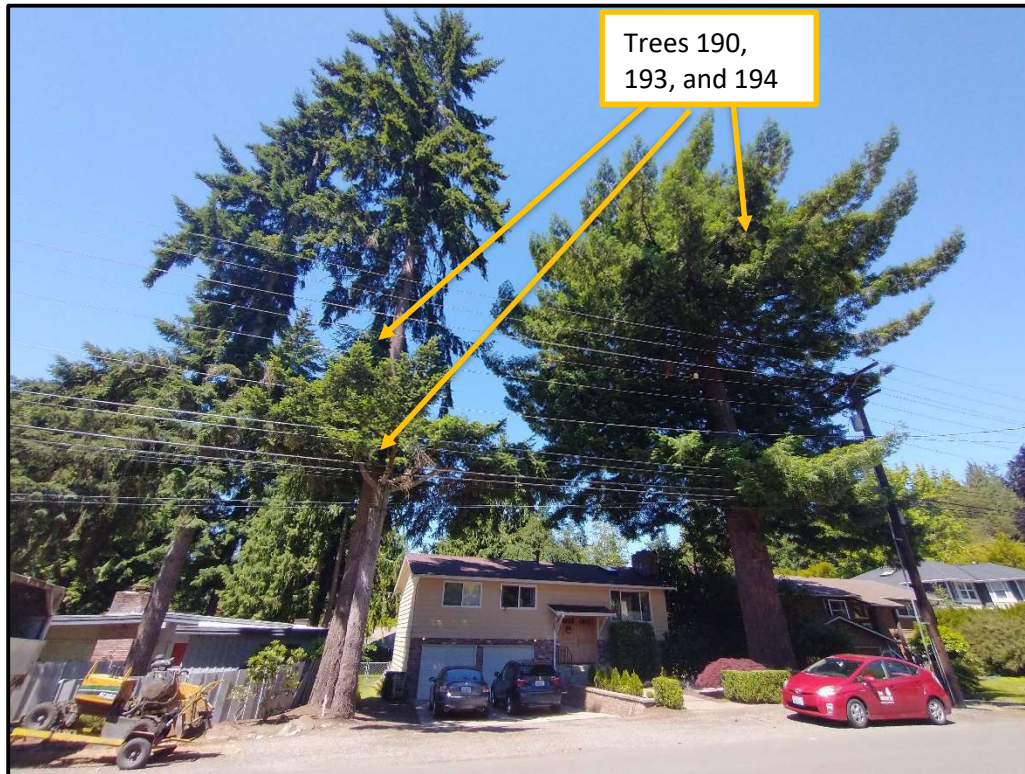
Per Mercer Island City Code (MICC) 19.10.060.A.2 30 percent of the trees of regulated size must be retained during construction and throughout a 5 year period. Exceptional trees, and trees over 24 inches are preferred to be retained by the City, this would Trees 190, 194, 195, and 201 are preferred for retention because they are either exceptional or a tree over 24 inches, per MICC19.10.060.A.2.b.ii.a (Photos 1 and 2).

Photo 1. The site viewed from the east. Trees 190, 194 are called out as priorities for retention as they are either regulated as exceptional or over 24 inches per MCC. Tree 193 should be retained with tree 194 as they are grown together and the root systems of the trees are likely linked.

- Obtain all necessary permits and approval from the City prior to commencement of site work.
- Exceptional and trees over 24 inches are preferred for retention. Trees 190, 194, 195, and 201 fit this criteria.

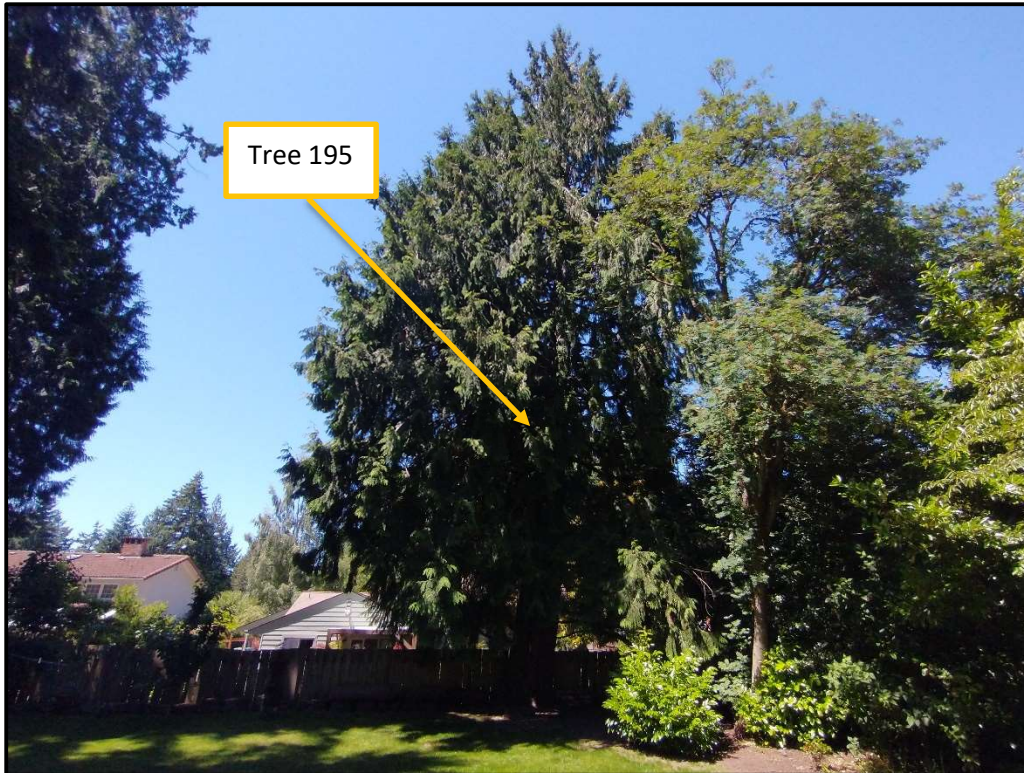
The design plan shows encroachment 36-feet east of tree 195 and 21-feet northeast of the base of tree B. The TPZ fence can be set to the furthest point of intrusion of trees 195 and B if the following measures are taken. To safely retain the trees, air excavation should be utilized to trench at the furthest extent of the encroachment and excavated to the depth of the subbase required so the exposed roots are able to be cut cleanly. An arborist should be present during excavation of the area to assess the root loss. If extensive structural roots over 2 inches are exposed during construction, the trees should be reassessed as extensive root cuts within a close proximity to the base can destabilize the trees.

Photo 2. Tree 195 is a mature western redcedar that is a priority for retention per MCC 19.10.060.A.2.b.ii.a as the tree is exceptional. If retained the soil conditions should be improved in the rooting area and watered during the dry months (April through September). Use air excavation at the furthest point of encroachment 36 feet east of the tree to assess the root impacts and set the TPZ.

Along this TPZ line I recommend installation of 6 inches of wood chips to protect the rooting areas of the trees. If any work or staging or access is required within TPZ then it requires soil protection with 3/4-inch plywood sheets.

If these measures are taken, we believe the TPZ of tree B can be set 36-feet east of tree 195 and 20-feet north of the tree and the retained throughout construction.

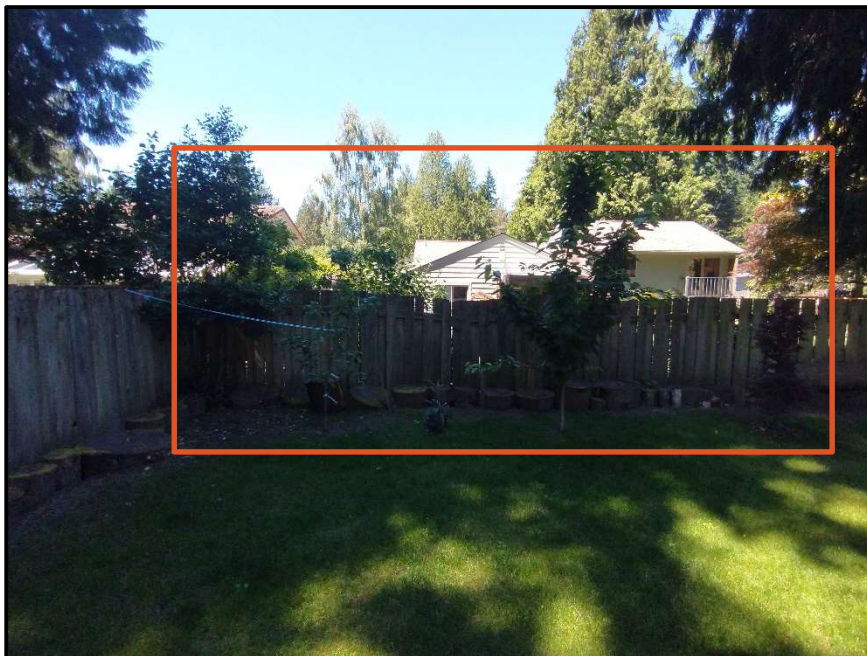
Two of the existing replacement trees fit the requirements of a replacement tree above and four additional replacement trees are required to fulfill the previous tree removal on site. I have attached a planting plan that should be implemented within the wet season (October through March) once construction is completed (MICC 19.10.070.B.5).

Photo 3. Replacement trees planted in the backyard outlined in red.

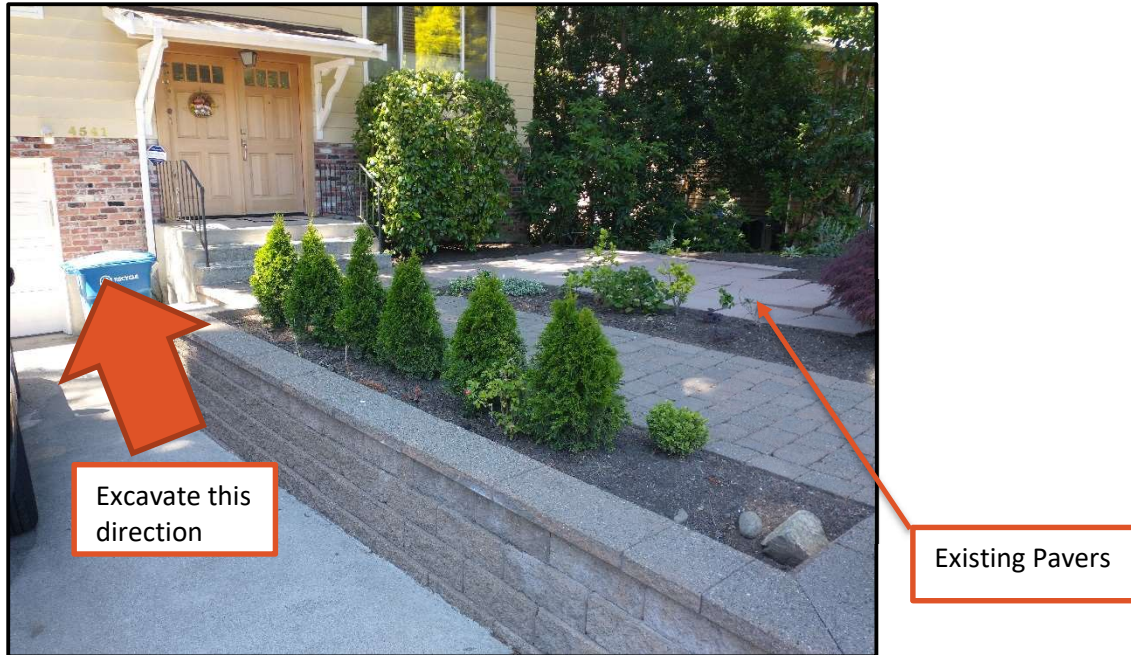
Removal of existing foundation and excavation for the water line- Tree 190

There are currently pavers at the base of tree 190. If they are to be removed, then I recommend that the pavers are removed by hand and the area to be landscaped.

Photo 4. Front entry of the home viewed from the east. I recommend that excavation begin from the existing structure to the new foundation area to protect the newly exposed soil. The existing pavers should be removed by hand and the TPZ fencing should be placed.

Excavation and demolition of the existing home foundation should be excavated from the existing structure to the new foundation or east to west to not compact the newly exposed soil and protect the existing rooting area.

- Excavate from the existing structure to the new foundation to protect the newly exposed soil for tree 190 and the existing rooting area.
- Use hydro-excavation to the furthest limits of excavation for the water line within the TPZ of tree 190.

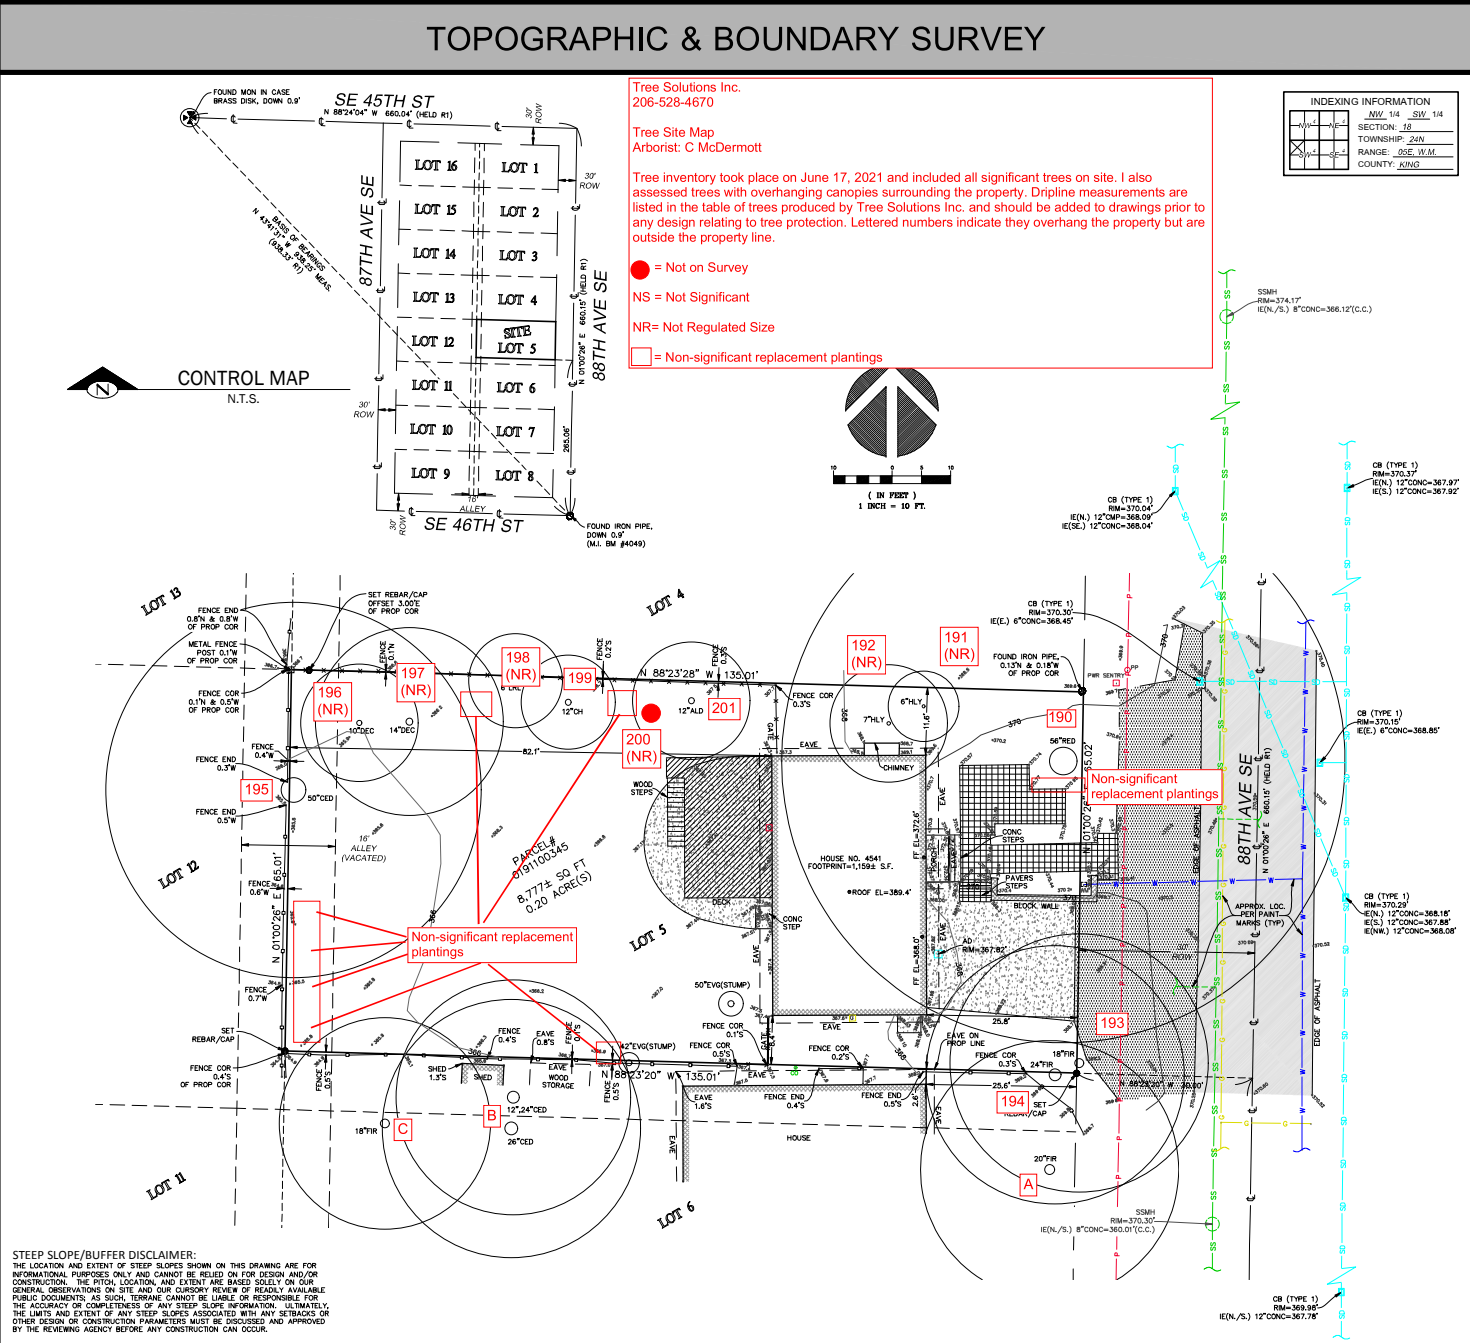
Tree Solutions Inc.
 206-528-4670
 Tree Site Map
 Arborist: C McDermott

Tree inventory took place on June 17, 2021 and included all significant trees on site. I also assessed trees with overhanging canopies surrounding the property. Dipline measurements are listed in the table of trees produced by Tree Solutions Inc. and should be added to drawings prior to any design relating to tree protection. Lettered numbers indicate they overhang the property but are outside the property line.

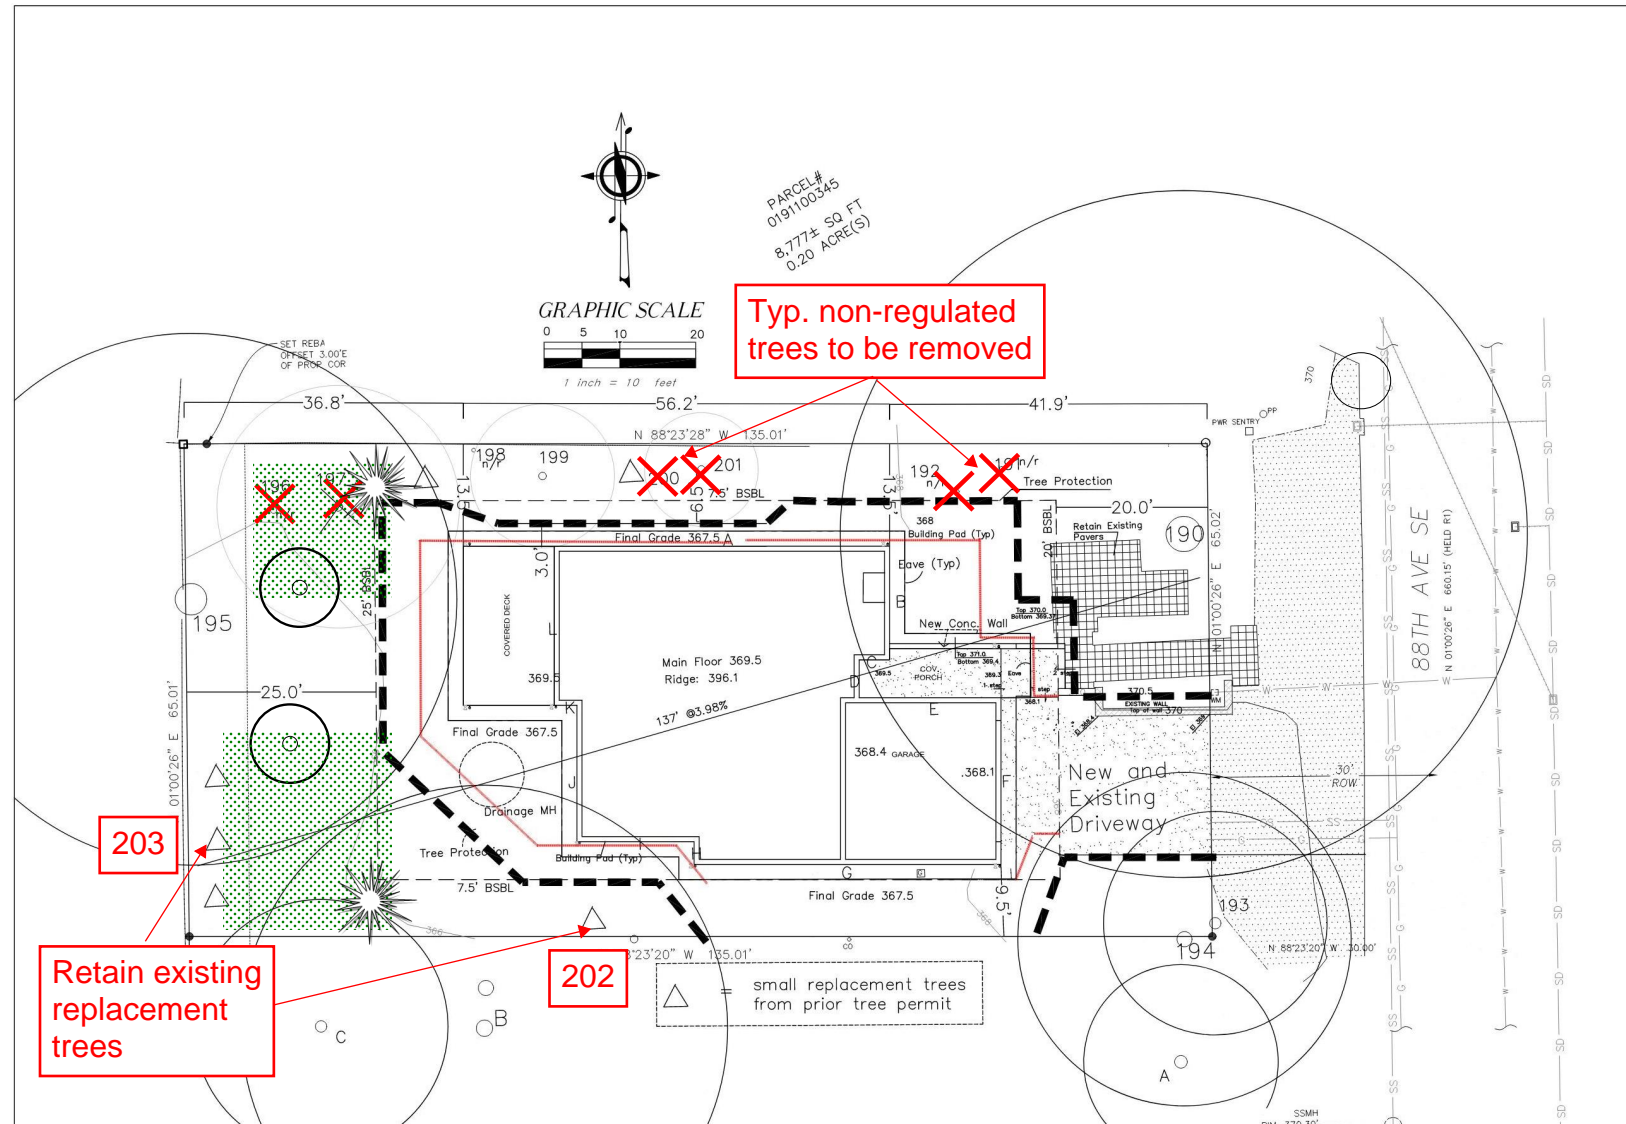
L-2

The City of Mercer Island requires that four trees to be planted on this property to fulfill the tree replacement requirements from a prior exceptional tree removal.

Prior to the development, one exceptional tree was removed and six replacement trees were required to be planted and retained during a five-year rolling period. Two of the existing replacement trees fit the requirements of a replacement tree. Four additional replacement trees are required to fulfill the previous tree removal on site.
