TECHNICAL MEMORANDUM

Date: August 19, 2021
To: Wes Giesbrecht, Cayson Fields LLC
From: Lexi Ochoa, ISA Certified Arborist®
Lucas Vannice, ISA Certified Arborist®
Project Name: Mercer Island Cayson Fields
Project Number: 190410

Subject: Mercer Island Cayson Fields Subdivision (1903-061) Air-Excavation Root Observation Memo: Tree #4591

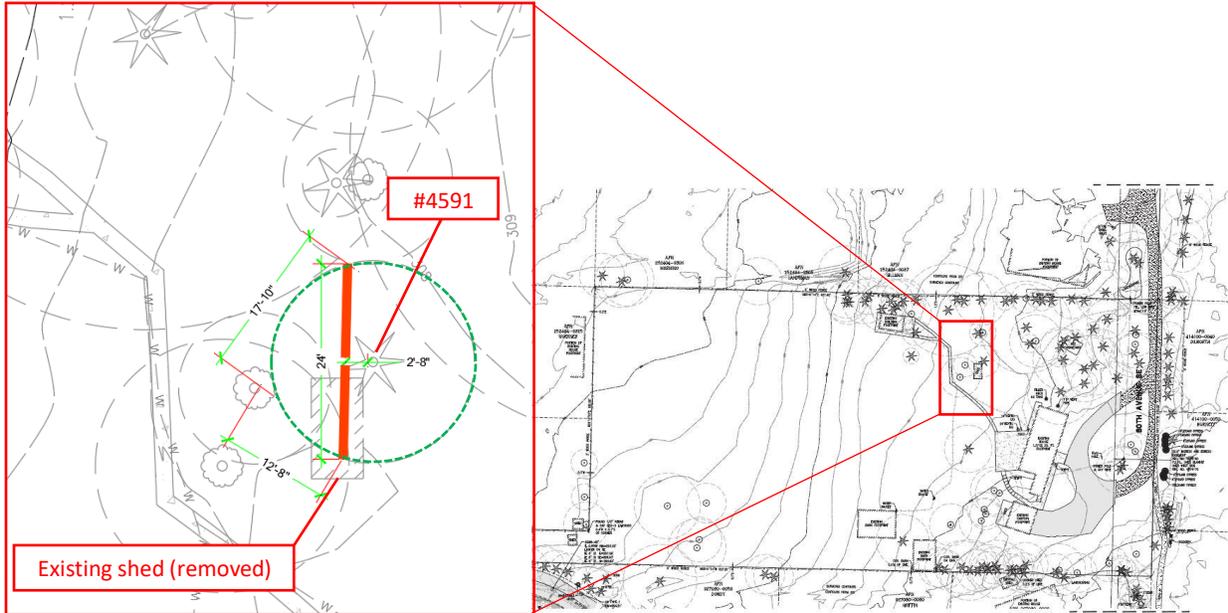
Bartlett was retained by Cayson Fields LLC (developer) to perform exploratory air excavation within the dripline of tree #4591 (Figure 1). The excavation area included approximately 24 linear feet of trench (about 12 inches wide and 24 inches deep), oriented north-south at the eastern limits of Lot 5 and adjacent to the Native Grown Protection Easement (NGPE). The NGPE boundary is about two feet eight inches west of the subject tree's trunk. Air excavation occurred along the limits of work for proposed development based upon site plans provided by the developer, titled Permit Revision 2 and dated August 15, 2019. The specific location of work for air-excavation was laid out in the field prior to the arrival of Bartlett by The Watershed Company (Watershed) ISA Certified Arborists®, Lucas Vannice and Lexi Ochoa, using the known location of surveyed existing site features to offset the proper location for the trench. The trench location was demarcated with white spray paint—Bartlett air-excavated within these boundaries. Watershed was on-call during this air-excavation work. On July 28, 2021, the trench was completely excavated, and Watershed evaluated the findings on-site. Watershed assessed the presence of structural roots (3 inches diameter or greater), transport roots (1 – 2 inches diameter), and fine feeder roots and small transport roots (<1 inch in diameter) revealed in the trench.

Figure 1. Air-excavated trench (vertical red line) with tree #4591 dripline noted with the green dashed circle.

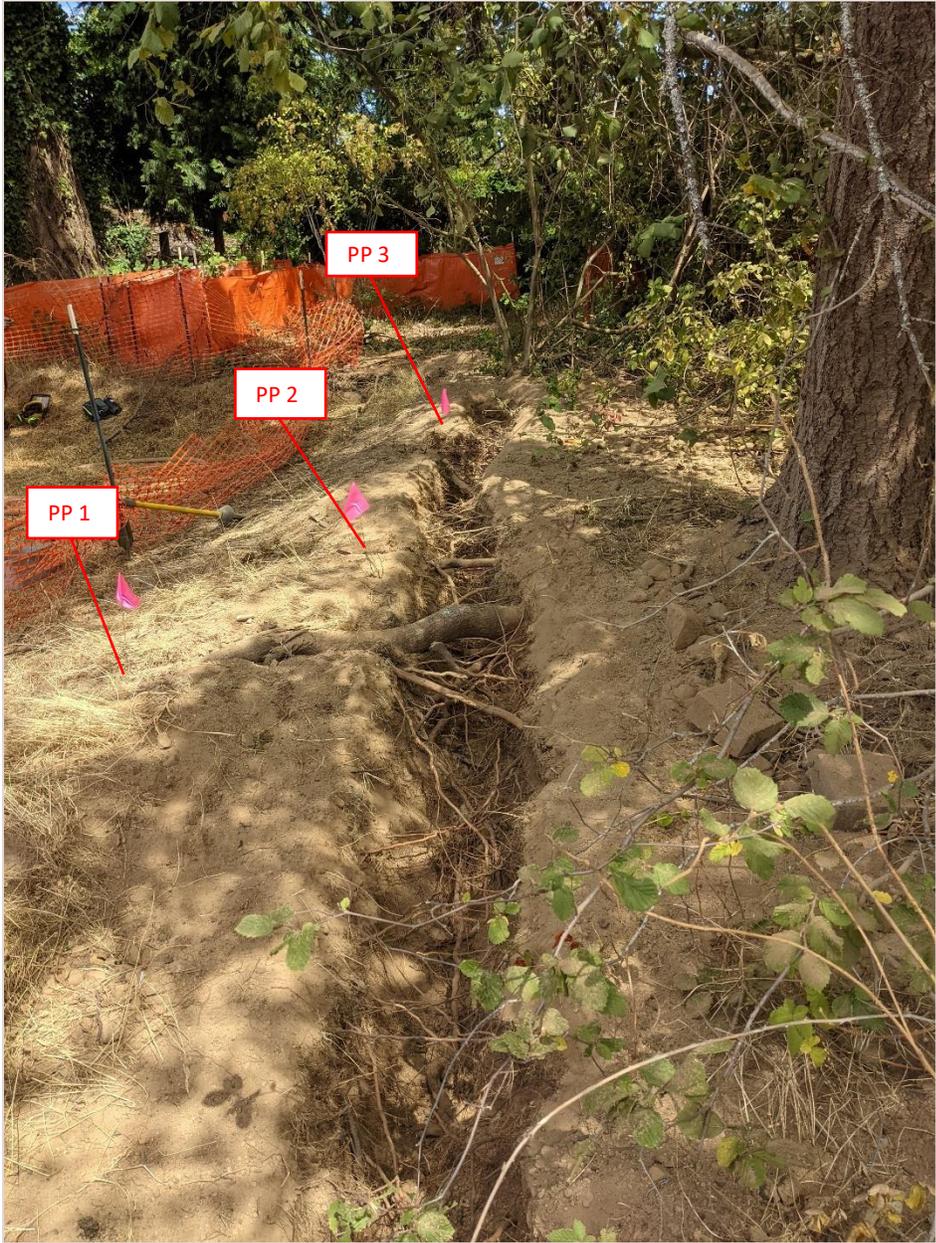
Bartlett's exploratory trench for tree #4591 revealed two structural roots, eight transport roots, and many fine feeder and small transport roots. The southernmost structural root, Photopoint 1 (Figure 2), was previously torn 90 inches from the trunk (Figure 3). The tear occurred within the limits of disturbance (the approved limits of disturbance were two feet eight inches from the trunk of tree #4591), presumably when the existing shed was removed. At this tear, the root measured four inches in diameter. Following best management practices, a clean-cut was made to facilitate proper wound closure above the tear damage 59 inches from the trunk. An additional root was torn along the same plane as the previously described root but was suspected of having belonged to adjacent vegetation, Photopoint 2 (Figures 2 and 5). A clean-cut was made, nonetheless.

Figure 2. Excavated trench (photo looking north) showing Photopoints (PP) 1, 2, and 3.

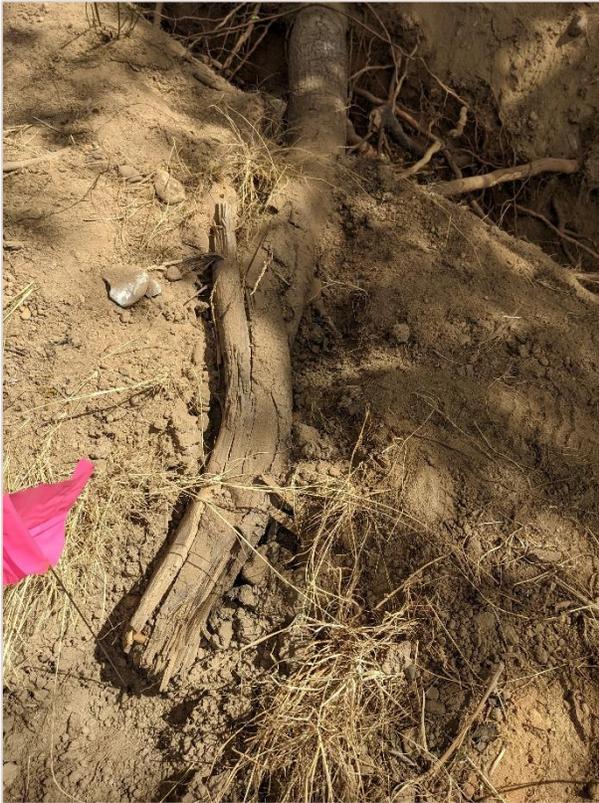
Figure 3. Photopoint #1, looking northeast, of the torn 4-inch structural root.

Based on the proposed location of the house, garage, and driveway, the location of tree #4591, its overall declining health, and the roots discovered during exaction, we do not recommend retaining tree #4591. The building pad and driveway located within the critical root zone will impact a significant percentage of the tree's critical root zone. While only two structural roots were discovered, the anticipated damage to the numerous transport roots from additional excavation, compaction, and added impervious surface is expected to lead to further decline in overall tree health.

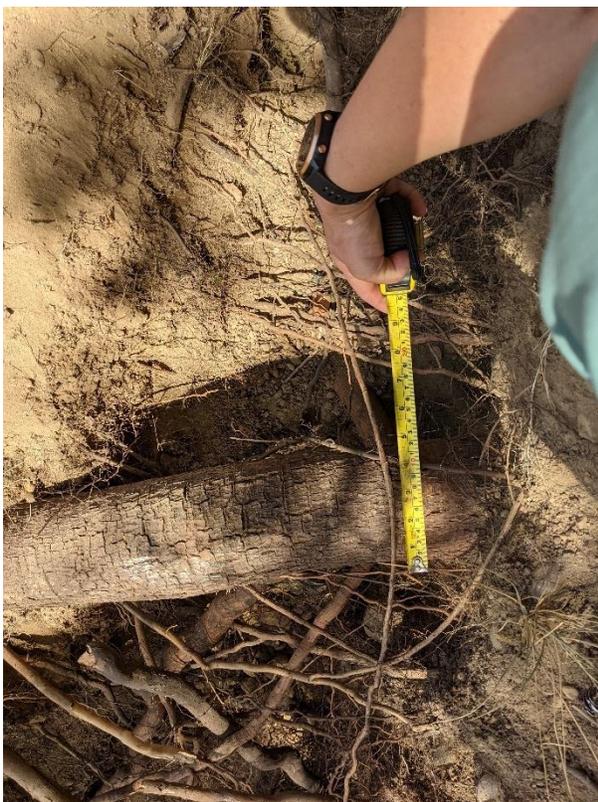
Numerous transport roots were visible within the trench, visible in three concentrated sections. The highest number of transport roots were found around Photopoint 1. The second-highest concentration of these roots was visible around Photopoint 3.

Figure 4. Photopoint #1, showing additional transport roots and feeder roots below the impacted structural root.

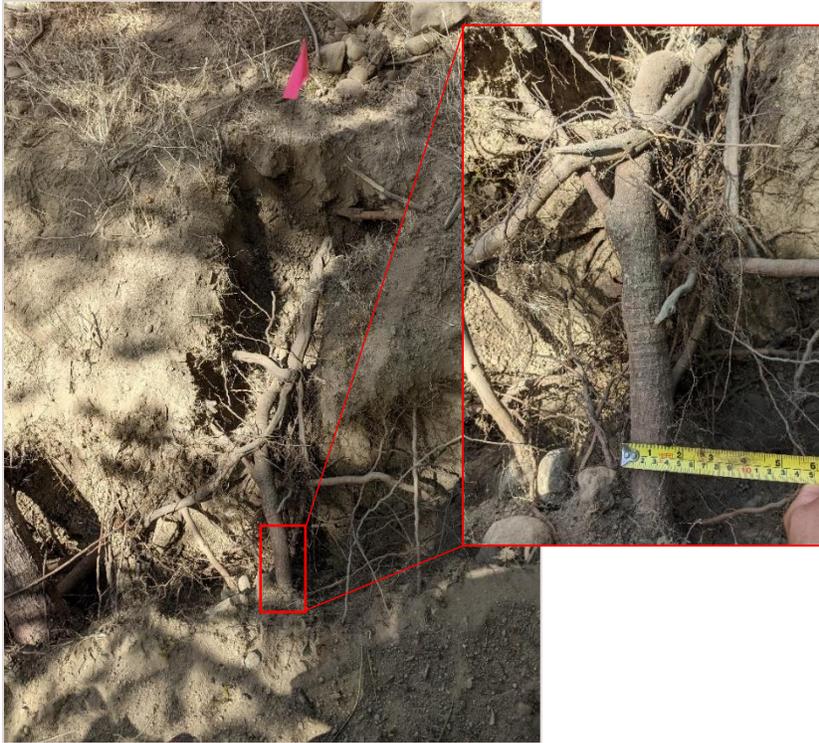
Figure 5. Photopoint #2, looking west, showing a 1.5-inch transport root.

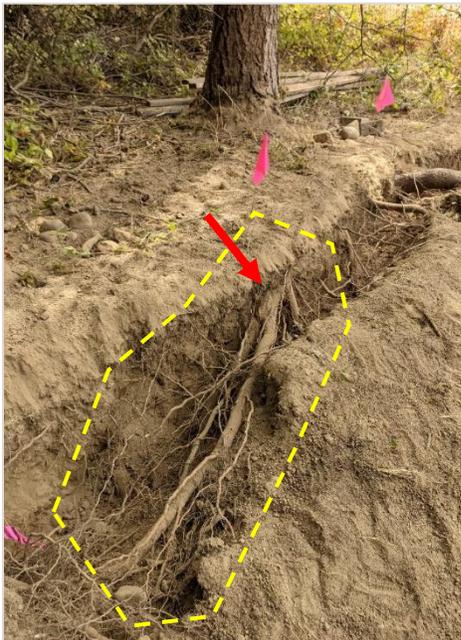
The second four-inch structural root was located on the northern portion of the trench, Photopoint 3 (Figures 2 and 6). It was visible six feet from the trunk and traveled parallel to the trench before dropping ten inches down into the soil, 10 feet from the trunk. At this point, the root measured one inch and indicated a north-northeast trajectory.

Figure 6. Photopoint #3, looking southeast, showing the second, 4-inch structural root (red arrow) and additional transport roots and feeder roots (within yellow dash).

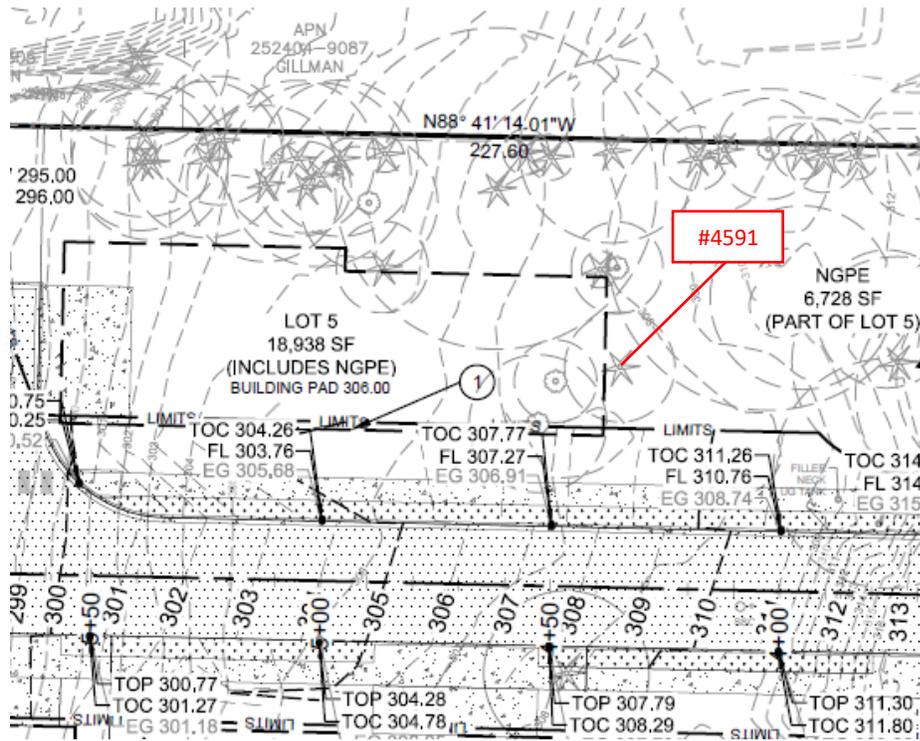
Figure 7. Preliminary approved plans showing Lot 5 in relation to tree #4591.
