NELSON GEOTECHNICAL ASSOCIATES, INC.

Critical Areas Study and Geotechnical Plan Review Moran Residence Development 5000 West Mercer Way Mercer Island, Washington NGA File No. 1211520

Photographic Documentation of Critical Areas

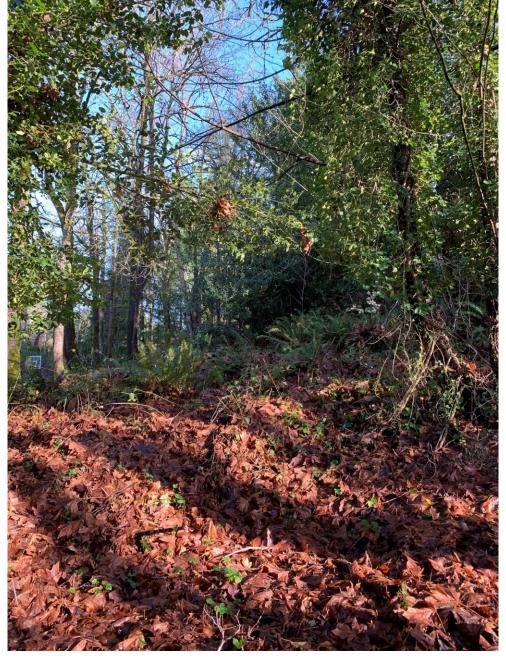
Figure 1. Typical slopes on property.

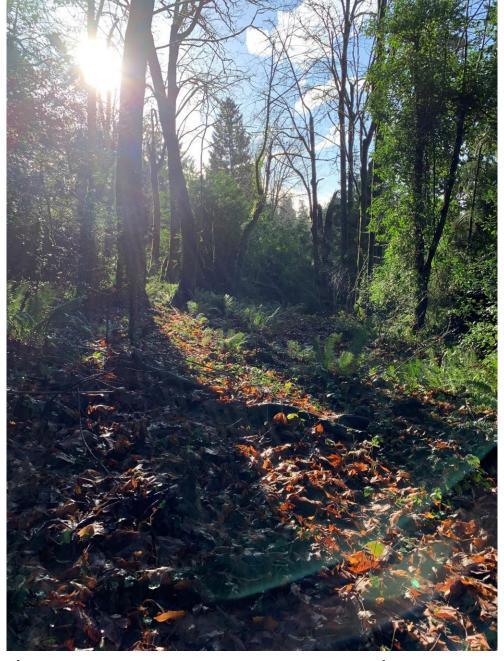
Figure 2. Typical Slopes on property; note moderate understory of ferns.

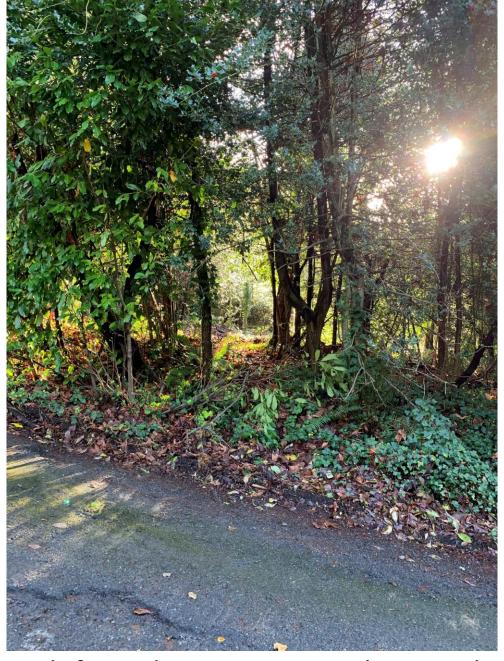
Figure 3. Looking south from driveway on north-central portion of property

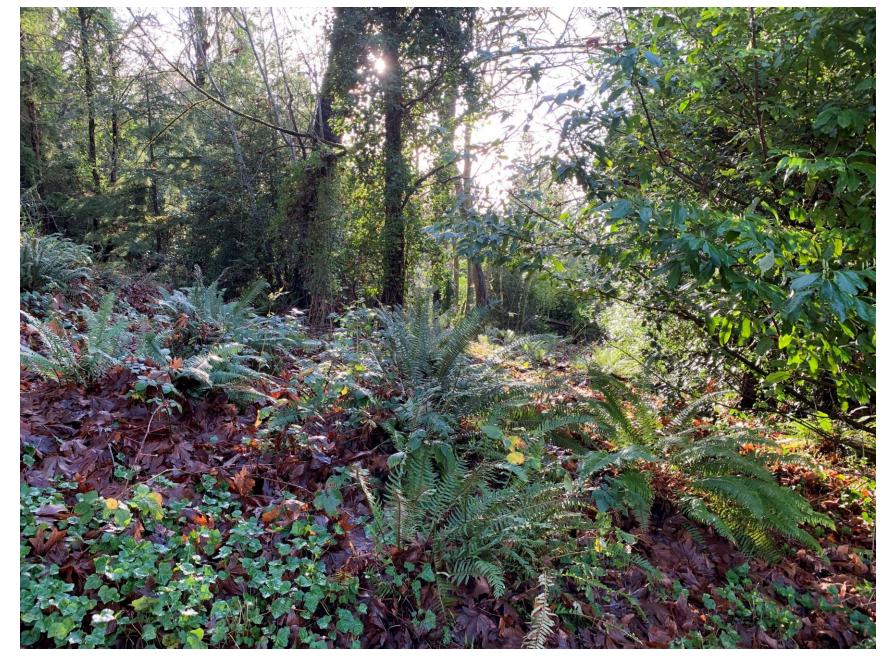
Figure 3. Typical slopes on property; note presence of laurel, ferns, and ivy groundcover.

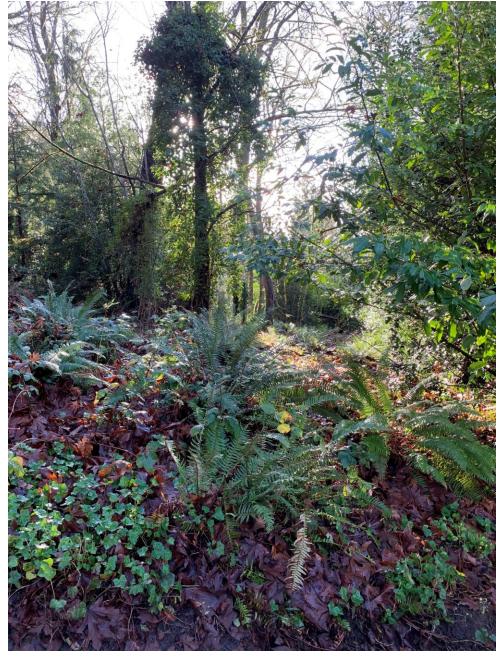
Figure 5. Looking southwest from north central portion of property.

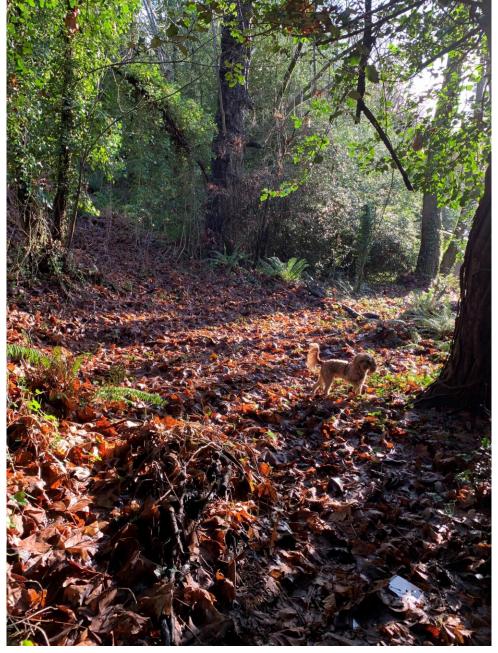
Figure 6. Midslope bench in central portion of site. Looking south.

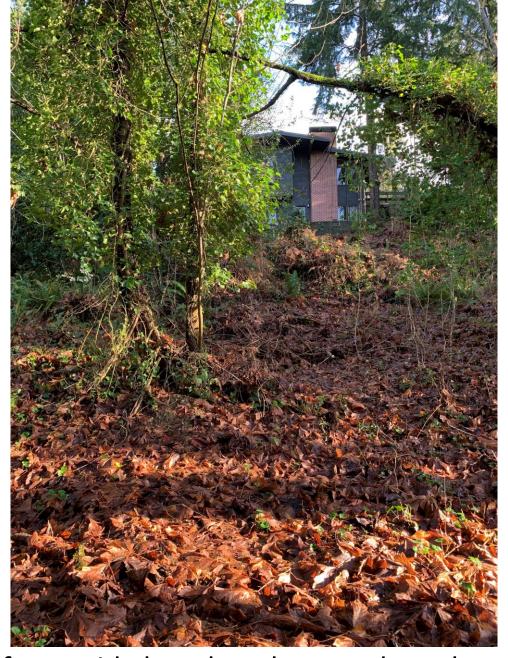
Figure 7. Looking southeast from mid-slope bench toward southeastern Landslide Hazard Area.

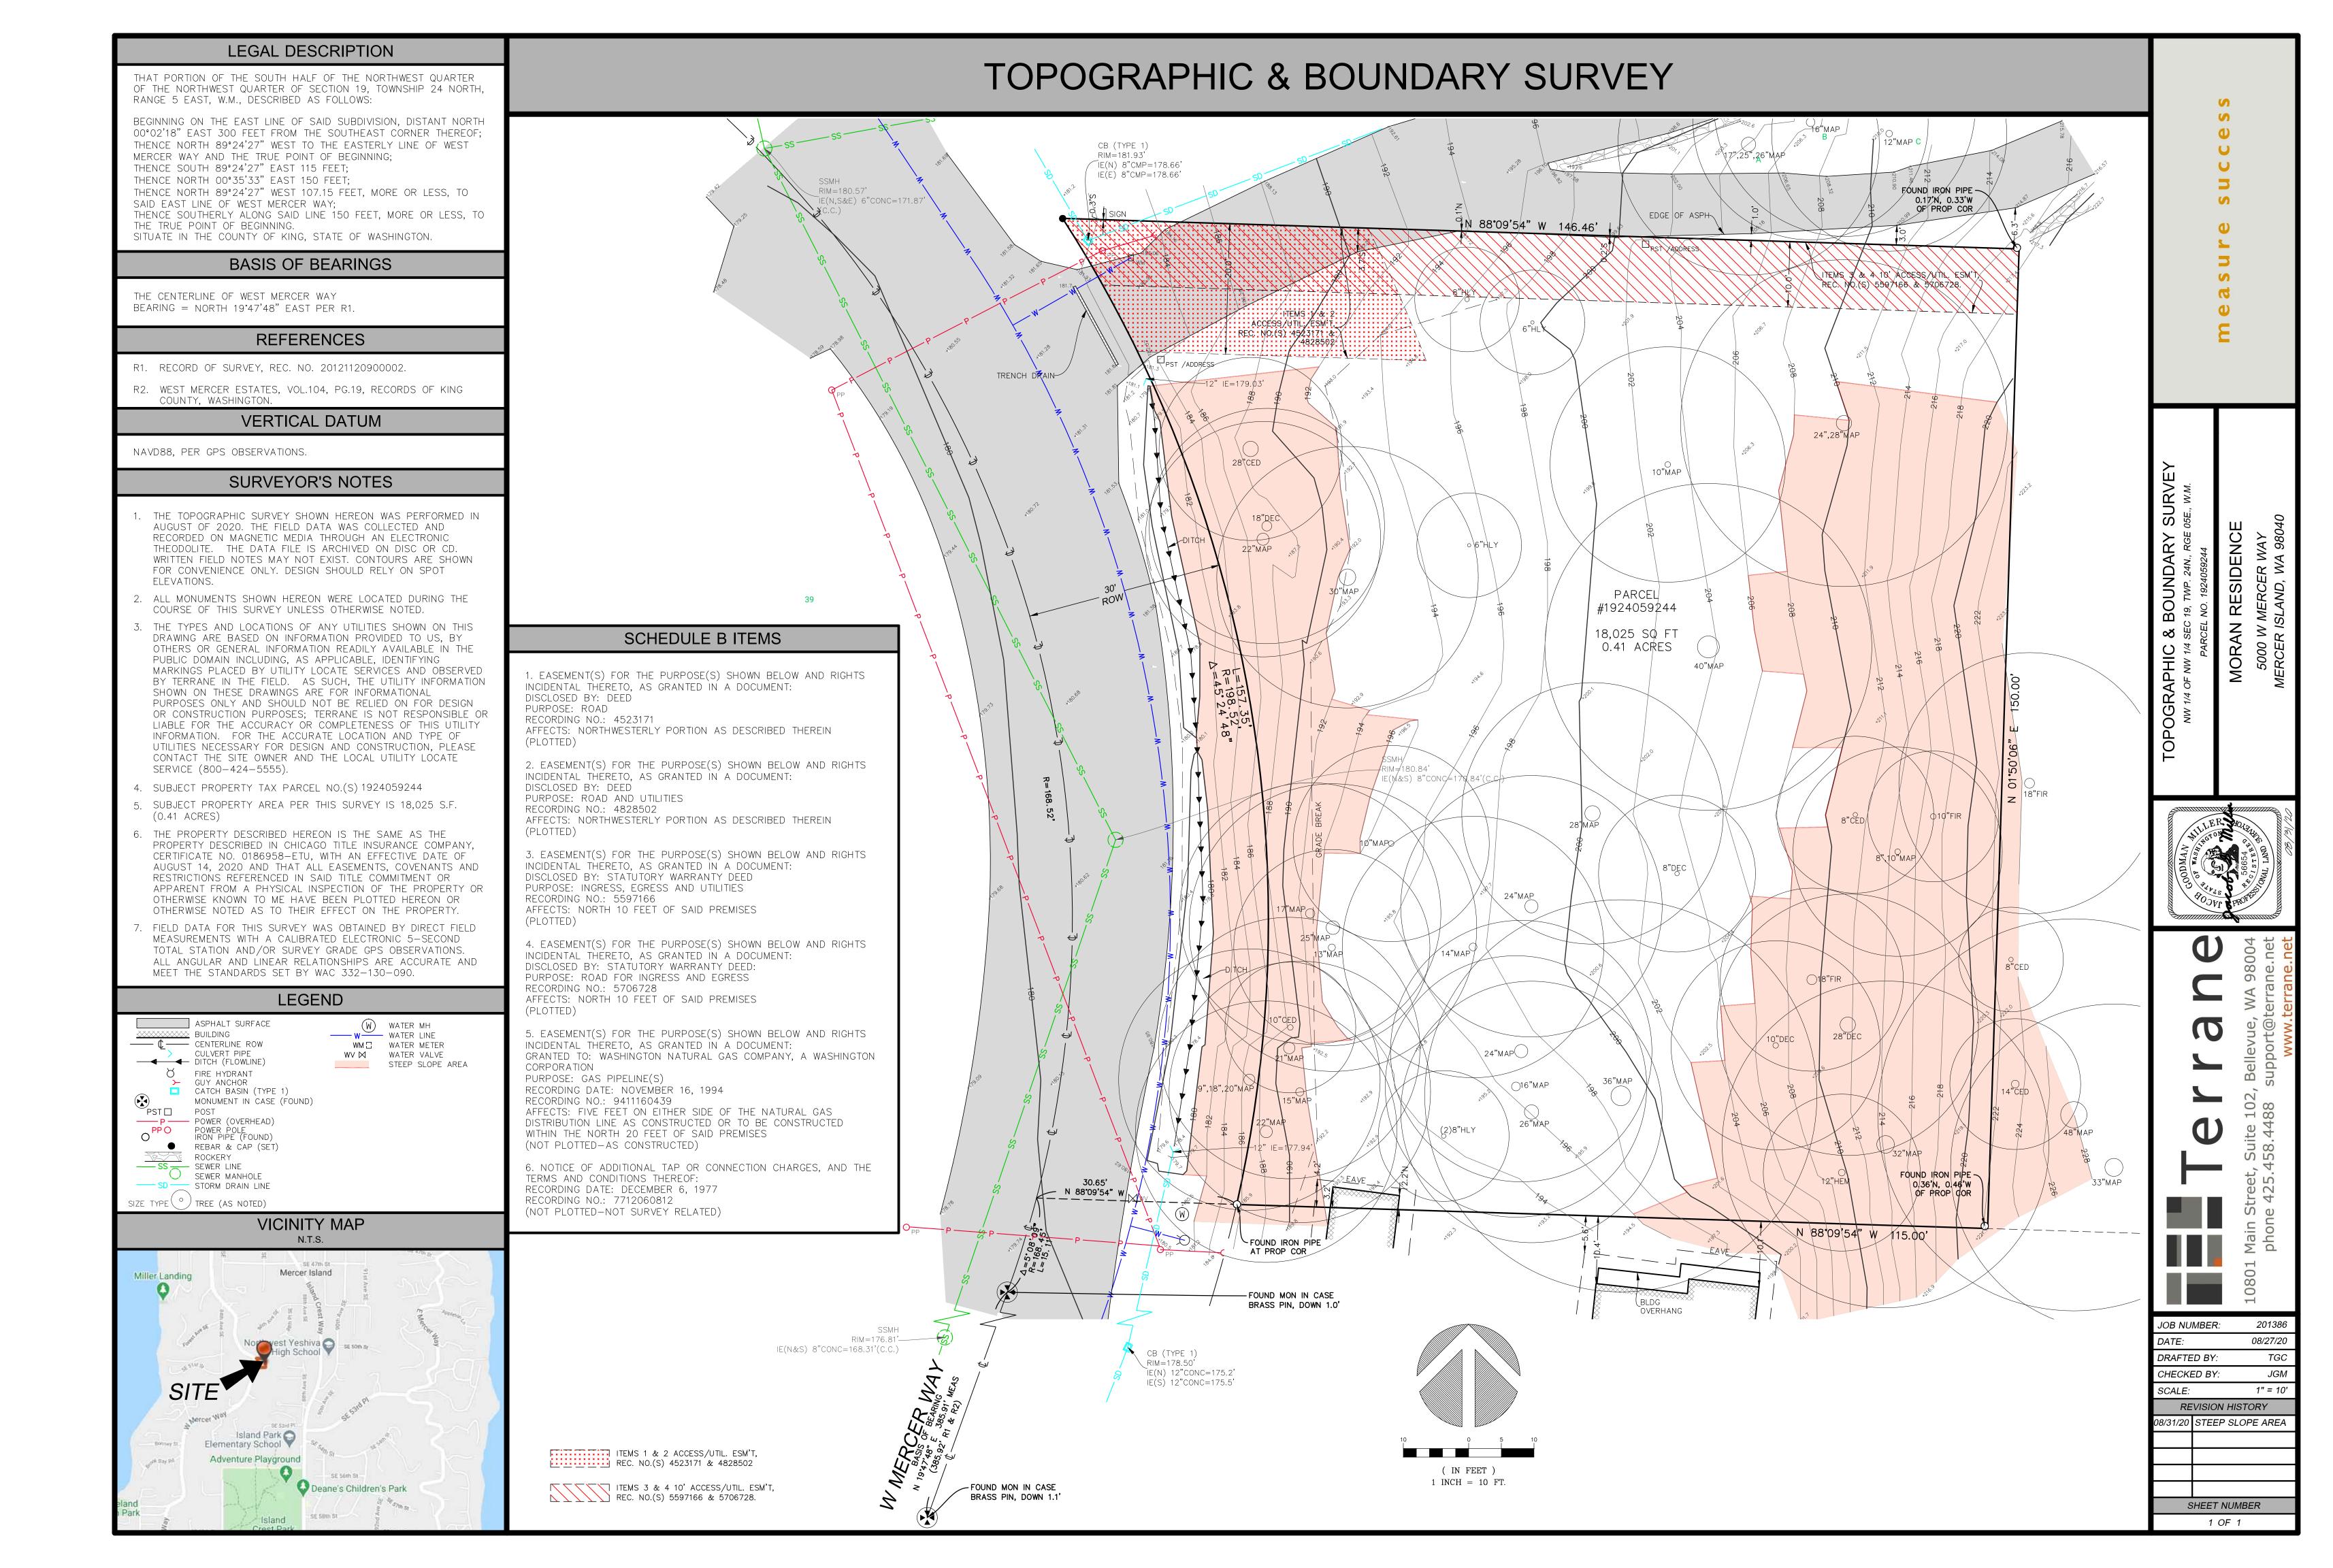
In accordance with MIMC 19.07.160(C)(2)(b), shallow landslide hazard areas include 25-foot buffers in all directions. The location of the designated Landslide Hazard Area in proximity to the site is shown on the Topographic and Boundary Survey attached in **Appendix B**. The proposed residence will be located as close as 13 feet from the toe and 6 feet from the top of Landslide Hazard Areas within the site and will therefore intersect and overlap the 25-foot Landslide Hazard Area buffers as shown on an excerpt from the Civil Engineering Plan Set in **Appendix C**, which also presents a scale map of the proposed project.

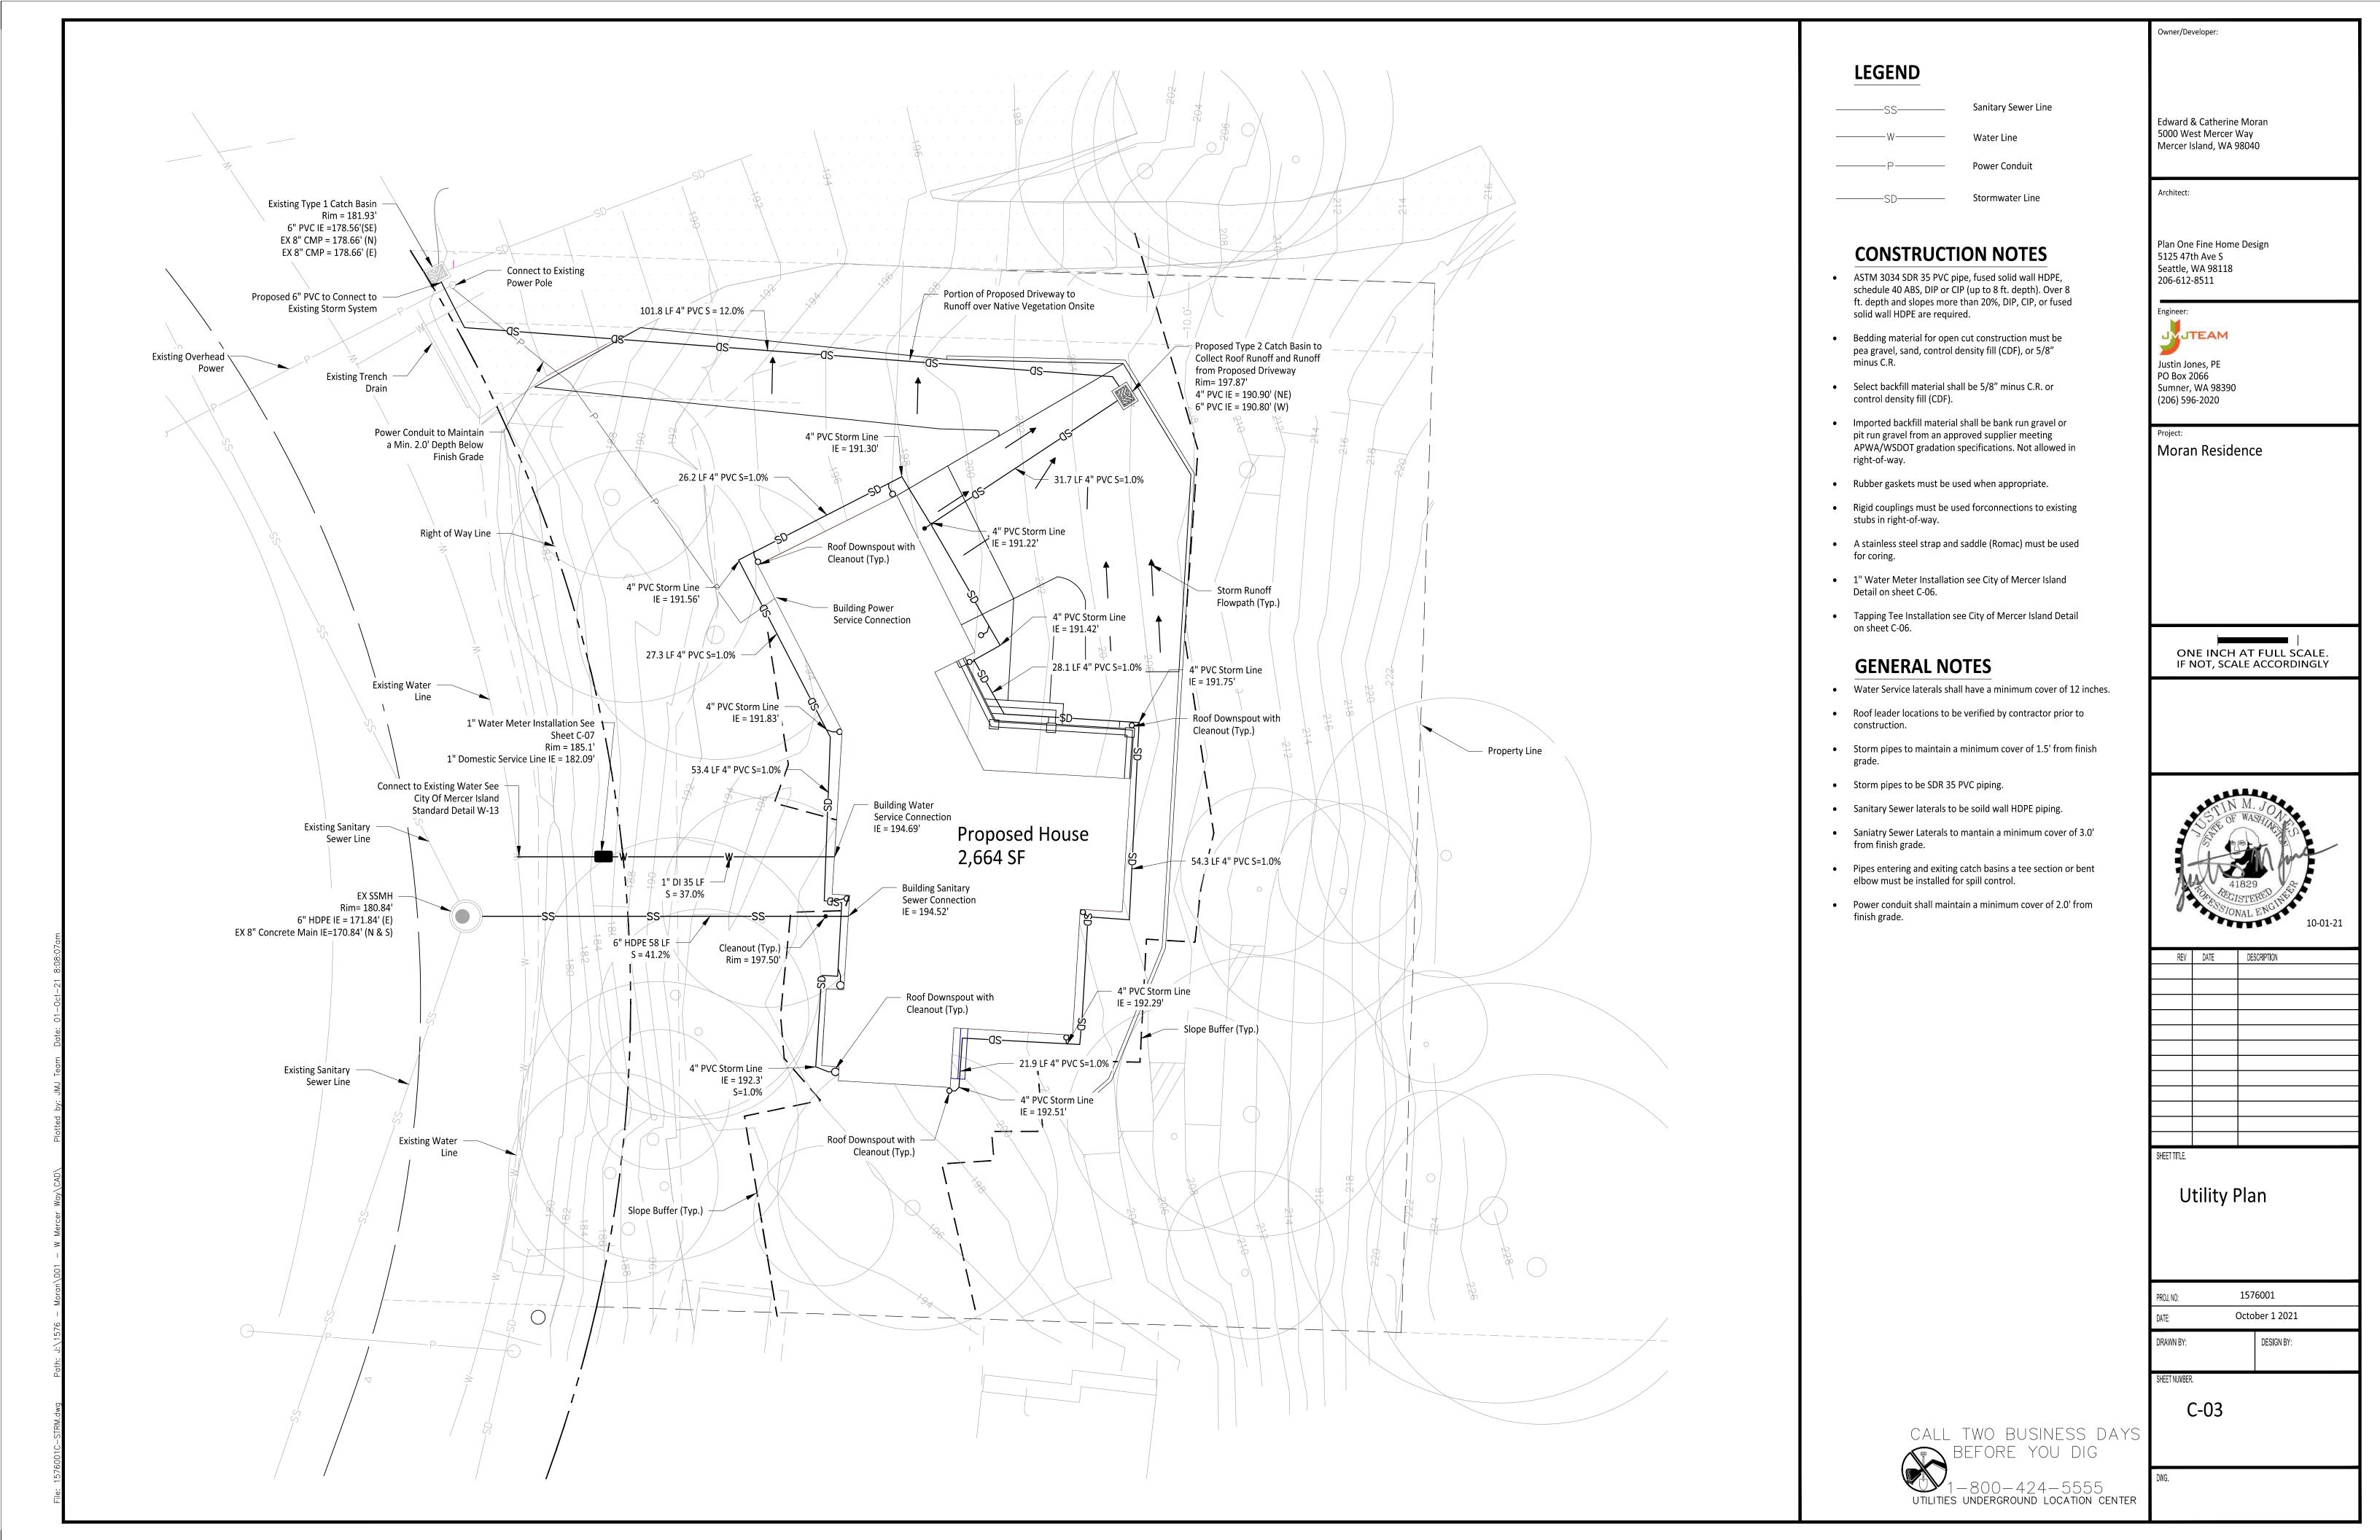
October 1, 2021 (Civil Engineering Plan Set Sheet C-03) – JMJ Team

Utility Installation: The Utility Plan on Sheet C-03 shows water and side sewer connections between the residence and West Mercer Way to the west. Resulting temporary excavations for utility connections over the steeply sloping areas should be temporarily shored as necessary. Temporary slopes on the site should be no steeper than 1.5H:1V. The contractor should develop plans to facilitate safe worker access and prevent instability during temporary utility excavations. We are able to provide consultation and review of utility excavation plans during construction, as warranted.

Backfill of utility trenches over steep slopes should be performed in level, benched lifts, and not be

completed in sloping lifts. Recommendations for trench backfill are outlined in the revised geotechnical

report and should be followed strictly.
