Arborist Report

To: Catherine Moran
Site: 5000 West Mercer Way, Mercer Island, WA 98040
Re: Tree Inventory
Date: Feb. 27, 2023
Project Arborist: Joseph Sutton-Holcomb
ISA Board Certified Master Arborist #PN- 8397BM
Municipal Specialist; Qualified Tree Risk Assessor
Attached: Table of Trees
Tree Retention Worksheet
Tree Protection Plan
Tree Replanting Plan
Tree Removal Exemption Plan
Memorandum: Tree Removal Exemption Justification

Summary

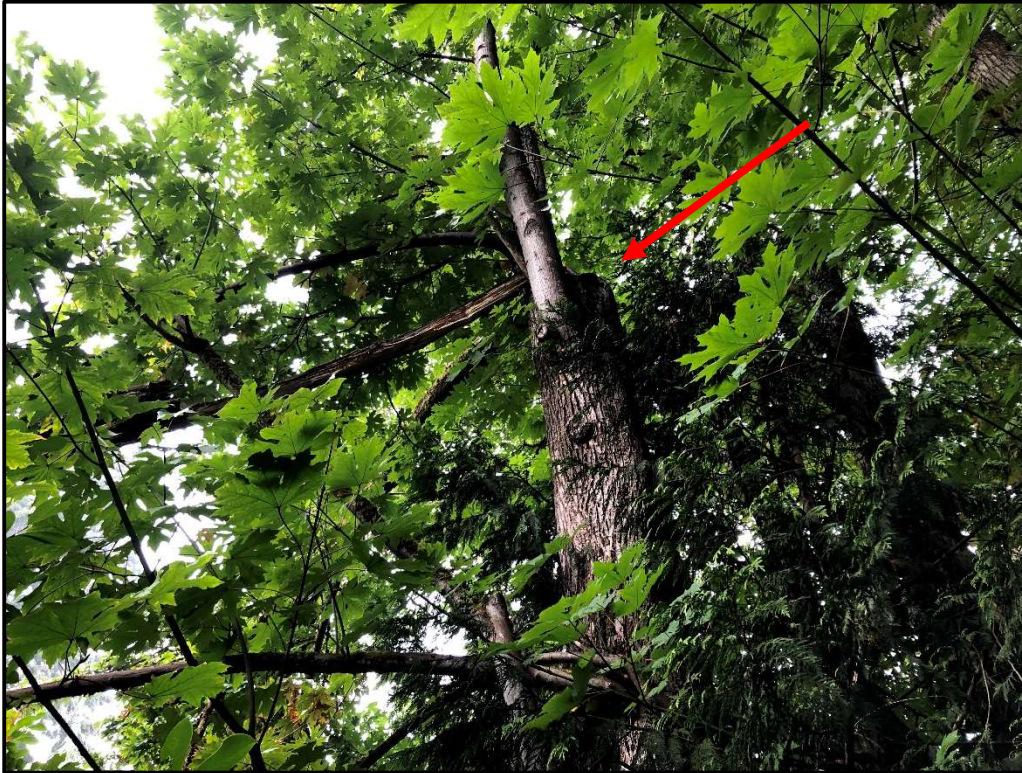
Photo 1. Looking up at the previously broken top (red arrow) of tree number 40. If retained, some reduction pruning should be done on the limb extending out over the road. Additionally, an aerial assessment should be conducted to determine the condition of the branch attachments.

40	<i>Acer macrophyllum</i>	Bigleaf Maple	25.9		Fair	Poor	1.1	1.1	39.1	31.1	30.0	Yes	Exceptional Grove	19.4	Retain	Broken top; branches starting to regrow trunk; branch over road originating from decayed area; should remove or reduce branch

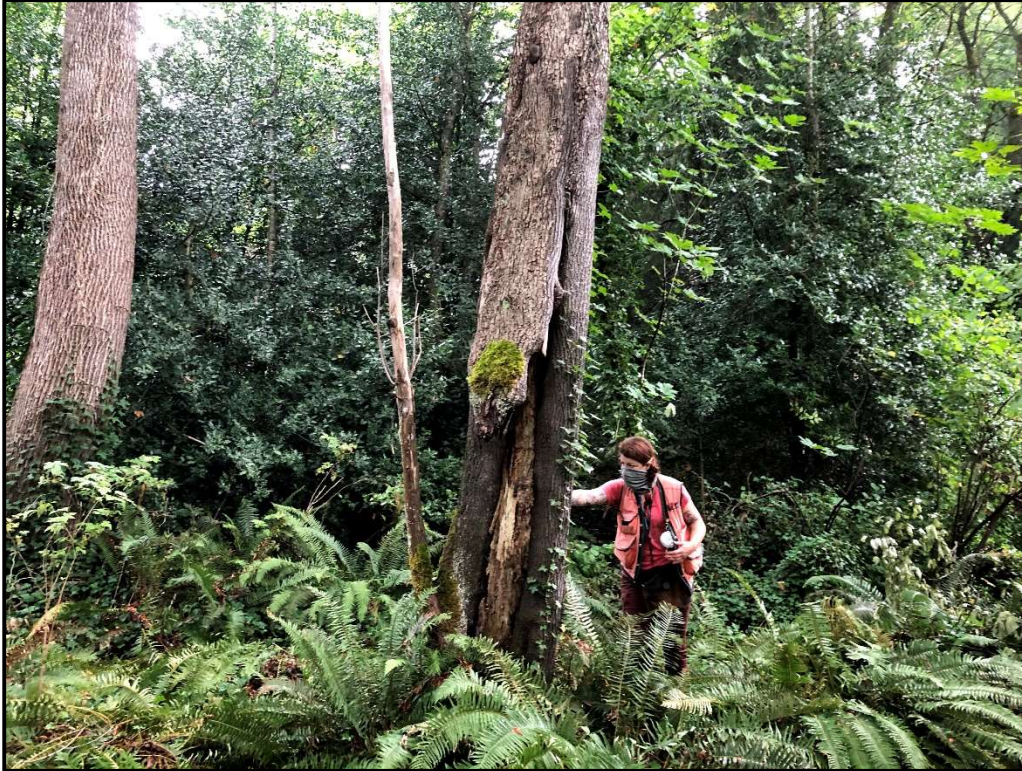
Photo 2. Tree 46 has a large wound that initiates at the base, this tree has a low retention value.

45	<i>Acer macrophyllum</i>	Bigleaf Maple	12.2		Fair	Poor	20.5	0.0	0.0	18.5	30.0	No	Exceptional Grove	9.2	Remove	Suppressed; previously broken top;wound to 12 feet
46	<i>Acer macrophyllum</i>	Bigleaf Maple	22.8		Fair	Poor	5.0	15.0	19.0	19.0	30.0	No	Exceptional Grove	17.1	Remove	Previous partial trunk failure; low retention value
47	<i>Tsuga heterophylla</i>	Western Hemlock	14.0		Fair	Fair	12.6	12.6	13.6	12.6	24.0	No	Exceptional Grove	10.5	Retain	Growing on large stump; diameter at standard height estimated
A	<i>Acer macrophyllum</i>	Bigleaf Maple	24.7	16,16,10	Good	Good	-	-	29.0	-	30.0	Yes	Exceptional Grove	18.6	Retain - offsite	Diameter at standard height estimated in direction canopy overhangs the site
B	<i>Acer macrophyllum</i>	Bigleaf Maple	23.0		Good	Good	-	-	26.0	-	30.0	No	Exceptional Grove	17.3	Retain - offsite	Diameter at standard height estimated in direction canopy overhangs the site
