Arborist Report

October 11th, 2021

Imani Homes
2405 74th Ave SE
Mercer Island, Wa

Arborist report for Imani homes. 7249 33rd Ave. SE., Mercer Island Washington. October 5, 2021. 1 PM. Address updated to: 2405 74th Ave SE. Mercer Island, Wa.

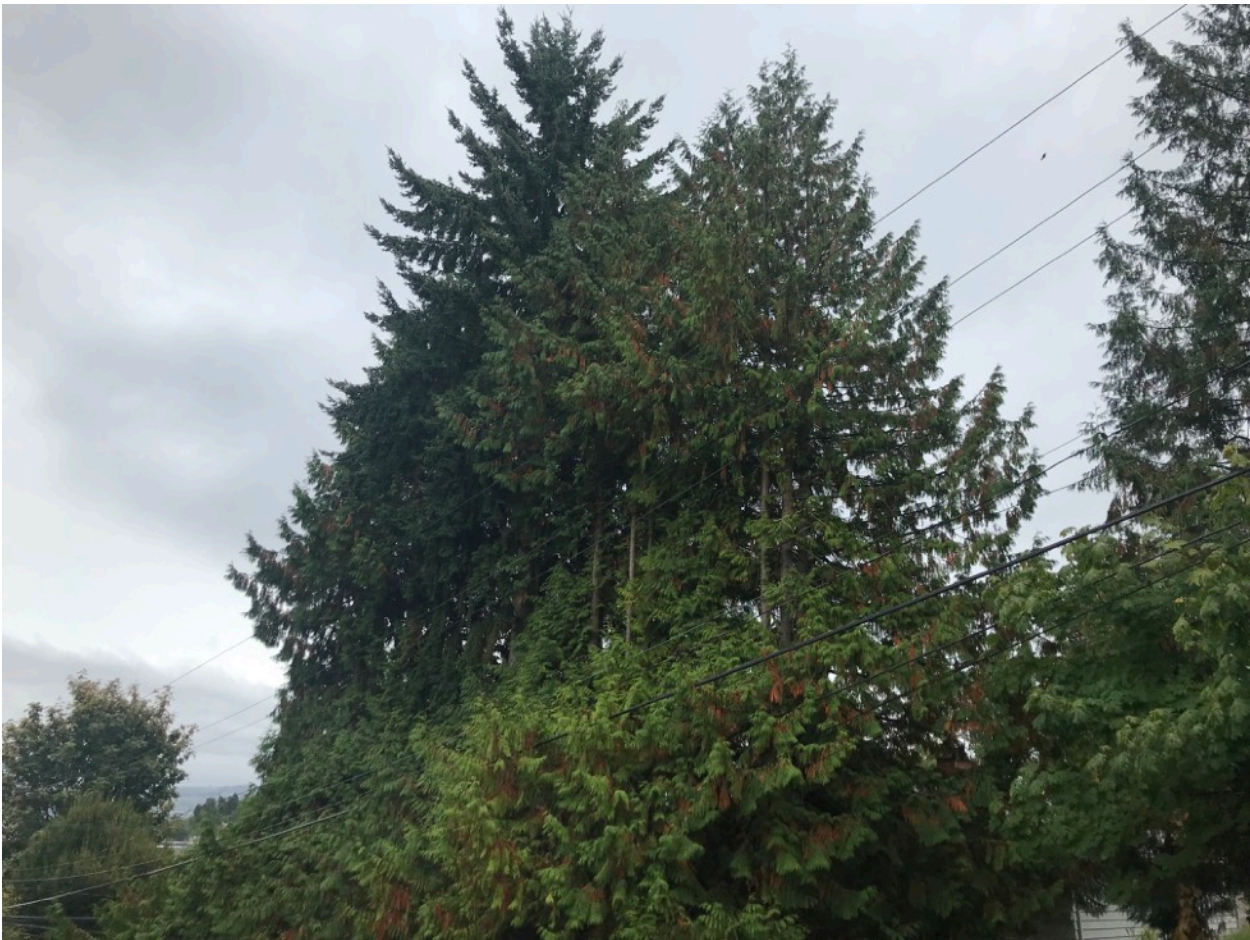
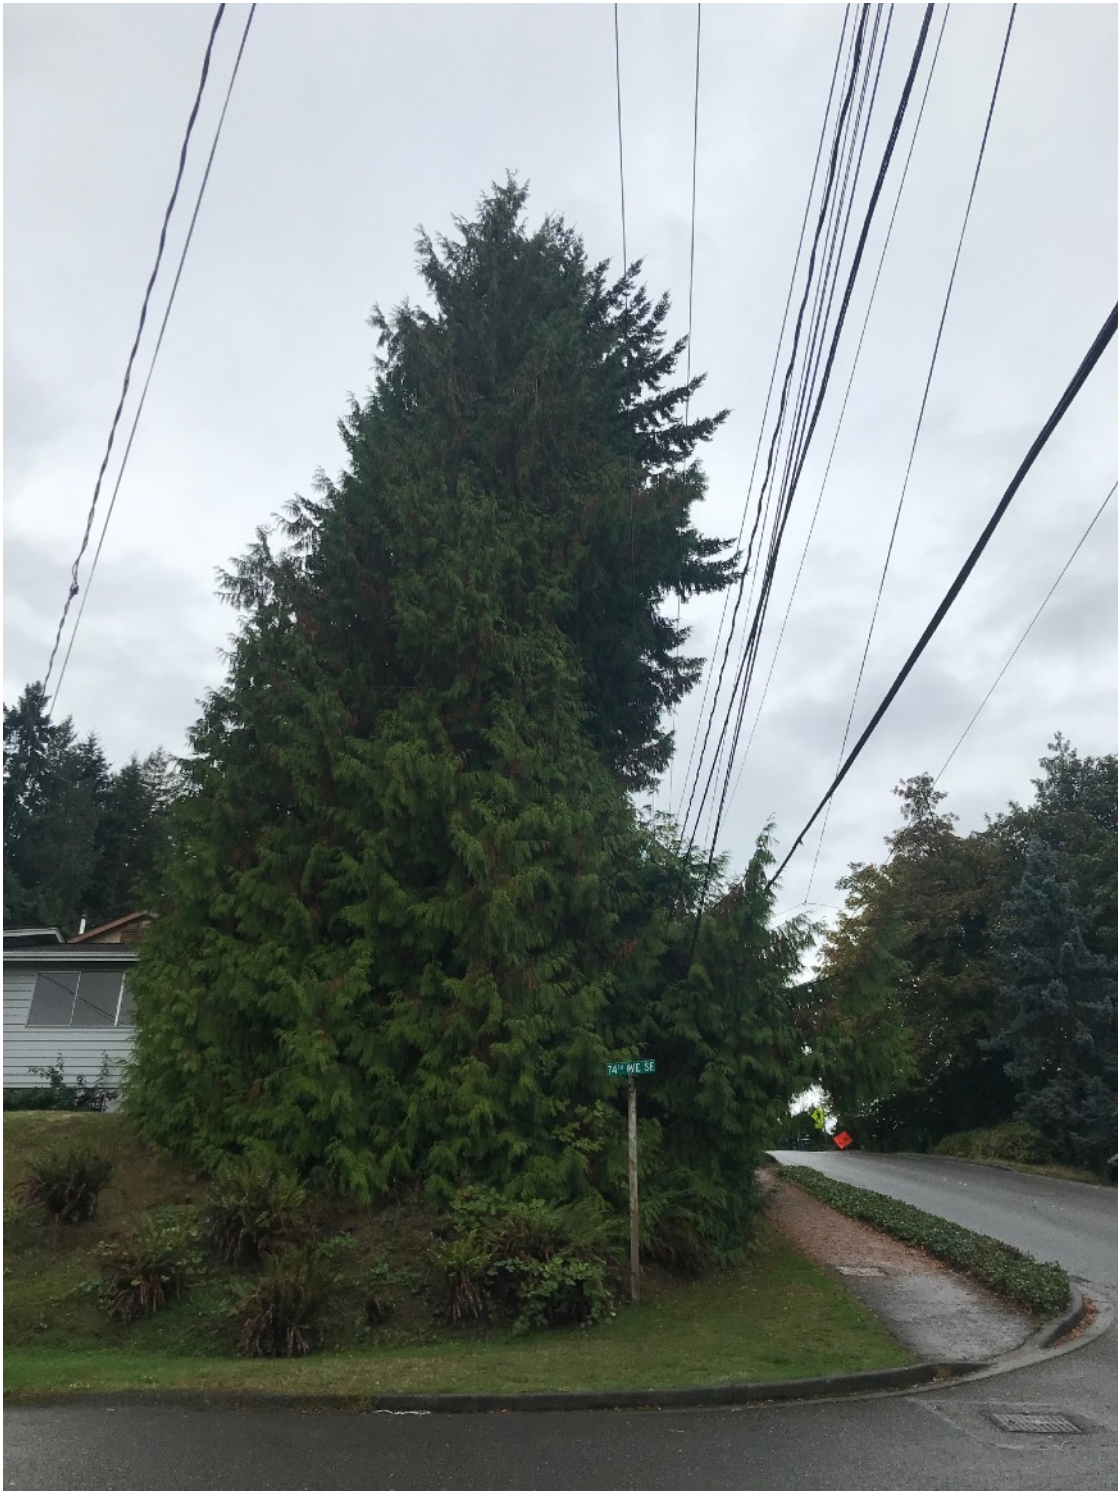
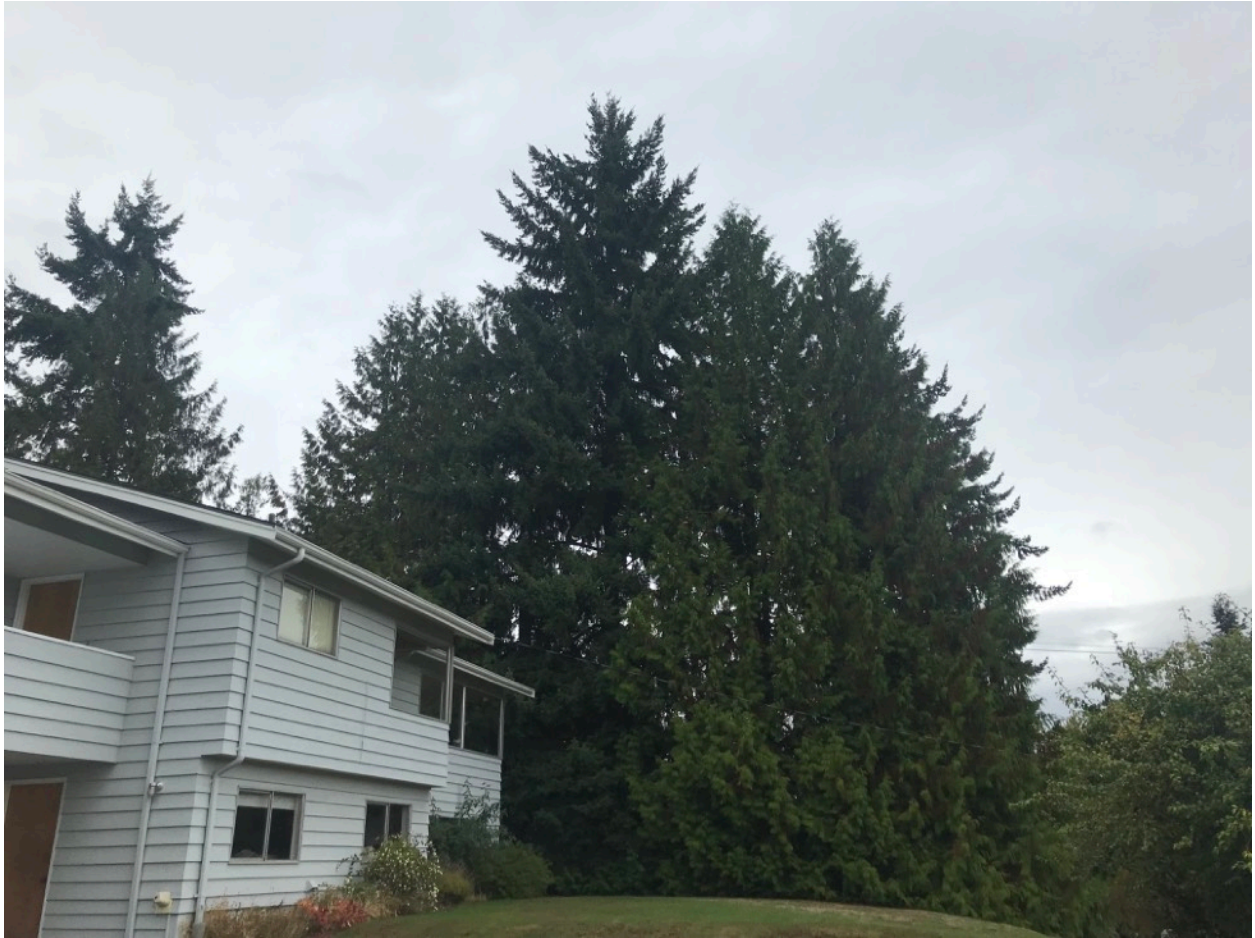
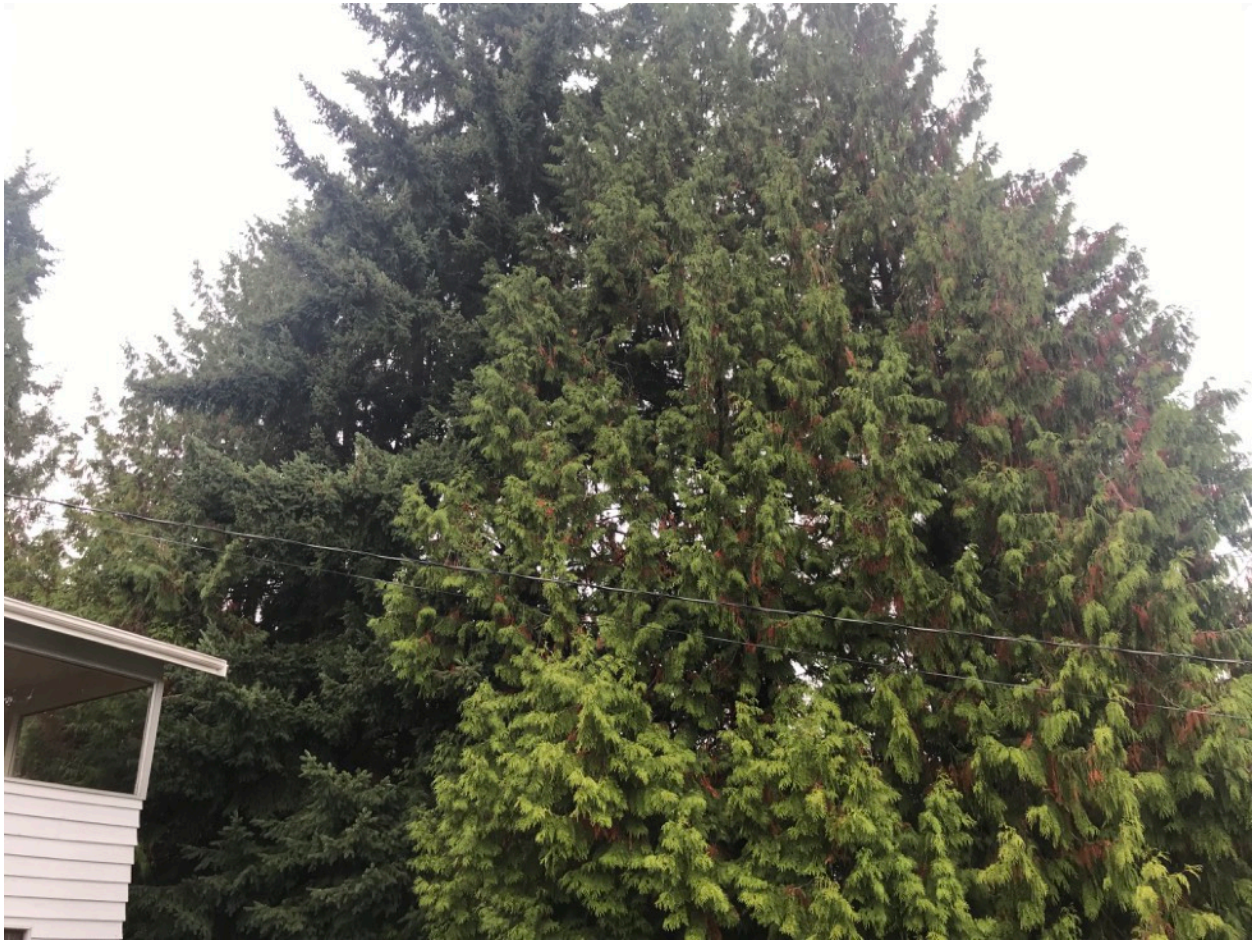
Photos of the Trees

Tree number 444 is in the northwest corner of the lot. It is a Western Red Cedar (*Thuja plicata*) with a diameter at standard height of 25 inches. This tree is condition one, despite the fact that it splits into multiple iterations approximately 12 foot above grade. This tree is not in need of any work, but some lifting of the low canopy on the southern side would create more usable space in the front yard and would not sacrifice privacy.

Moving toward the east, tree number 445 is a Western Red Cedar with a diameter at standard height of 15 inches. This tree is condition one despite also splitting into multiple iterations approximately 12 foot above grade.

Because of the multi-stemmed presentations that they have, it is likely that this entire row was topped. The canopies on these trees are dense but in a safe condition. These trees are likely doing a good job of buffering wind around their entire canopies. An ISA Certified Arborist would be able to lift the low southern canopies artfully, as well as alleviate some compression in the branch unions so that the trees could grow out with sustainable structure.

Tree number 446 is a Western Red Cedar with several main stems that originate approximately 3 foot above grade. The diameter at standard height reading of 23 inches was taken at the narrowest point below the branch union. This tree is condition one.

Tree number 447 is a Western Red Cedar that has a diameter at standard height reading of 21 inches. This tree is condition one and also a multi-stemmed specimen.

Tree number 448 is a Douglas Fir (*Pseudotsuga mensiezii*) with a diameter at standard height of 30 inches. This tree also appears to have been height reduced at approximately 20 foot above grade. This tree is condition two. There is quite a bit of deadwood in the low canopy and some of

the low scaffolds have gotten quite heavy because of the loss of apical dominance. A Certified Arborist could restructure this tree so that it grows out nicely.

Tree number 449 is a Western Red Cedar with a diameter at standard height reading of 27 inches. This tree is condition two. It splits into multiple stems approximately 8 foot above grade and this particular tree has quite a bit of compression between the main stems.

The easternmost tree is another Western Red Cedar. It is tree number 450 and it has a diameter at standard height reading of 24.5 inches. Like the other trees, this one splits into multiple iterations approximately 10 foot above grade. The tree is condition two.

All of the trees in this row appear to have been planted at the same time, most likely when the previous home was constructed. The entire stand has a drip line radius of 20 foot that starts in the center of each of the root flares. Despite some structural challenges, all of the trees are in healthy condition. There is some seasonal flagging on the Western Red Cedars, but there are no health concerns associated with these tree systems, nor are there any hazard issues that need to be addressed.

The clients informed me that ingress and egress for the construction project, as well as the new residence on the site, will come from the east instead of from the north. Wrapping Tree Protection fencing around the entire drip lines of these systems prior to demolition activities commencing will be a simple matter and the tree systems will not be in the way of construction or demolition. At the time of the site visit, I had not yet seen plans for proposed developments to the lot. Doing clearance pruning on the southern canopies of the conifers will not have an adverse effect on the health of the systems. In general, conifers can be limbed up by one third of their total height without having an adverse effect on the health of the systems. At the time of the site visit, the live crown ratio of all of the trees in the row was 100%. Plenty of foliage is in ground contact.

So long as tree protection fencing is installed at this site prior to activities commencing, all of the trees should endure the construction process without adverse effects to their health. Line clearance pruning is being conducted on the east side of the systems along 74th Ave SE.
