DOWNSTREAM ANALYSIS REPORT

Proposed Residence
2526 70th Avenue SE
Mercer Island, WA 98040

Tax Map #217450-3730
January 12, 2022

CES #2013

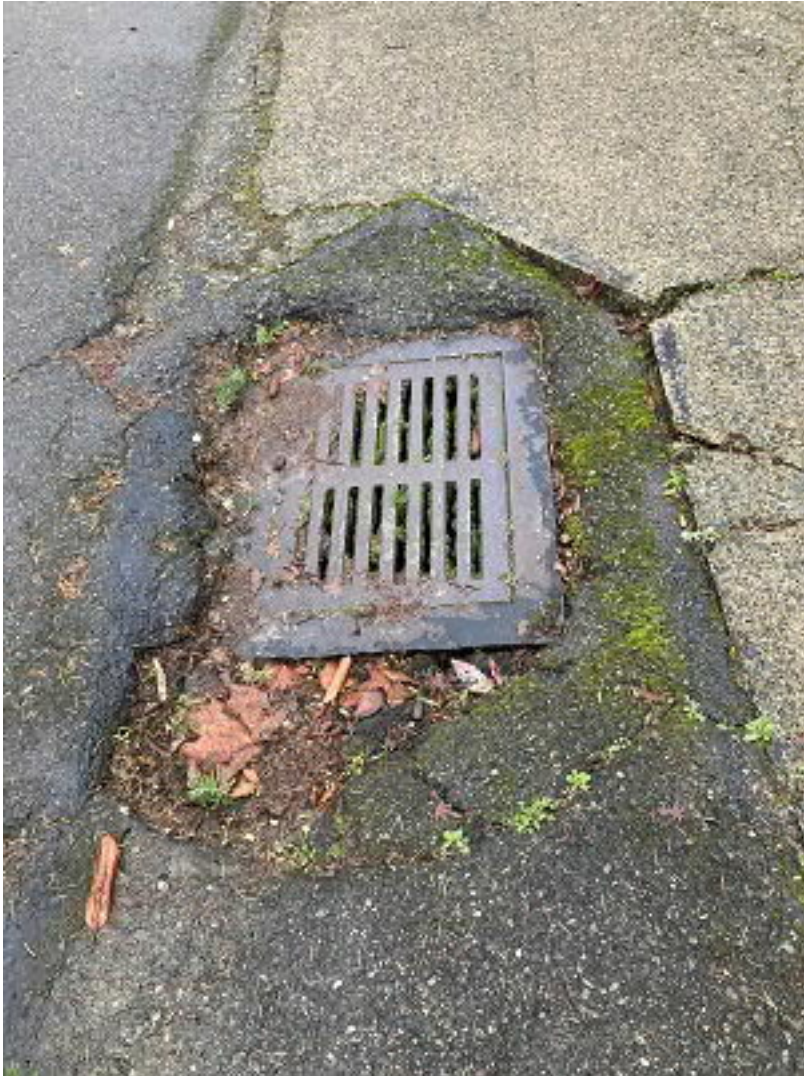
Picture 2: ROW between 2526 and 2520 70th Avenue SE
This is connection point for new house.
Existing storm drain runs north under eastern ROW.

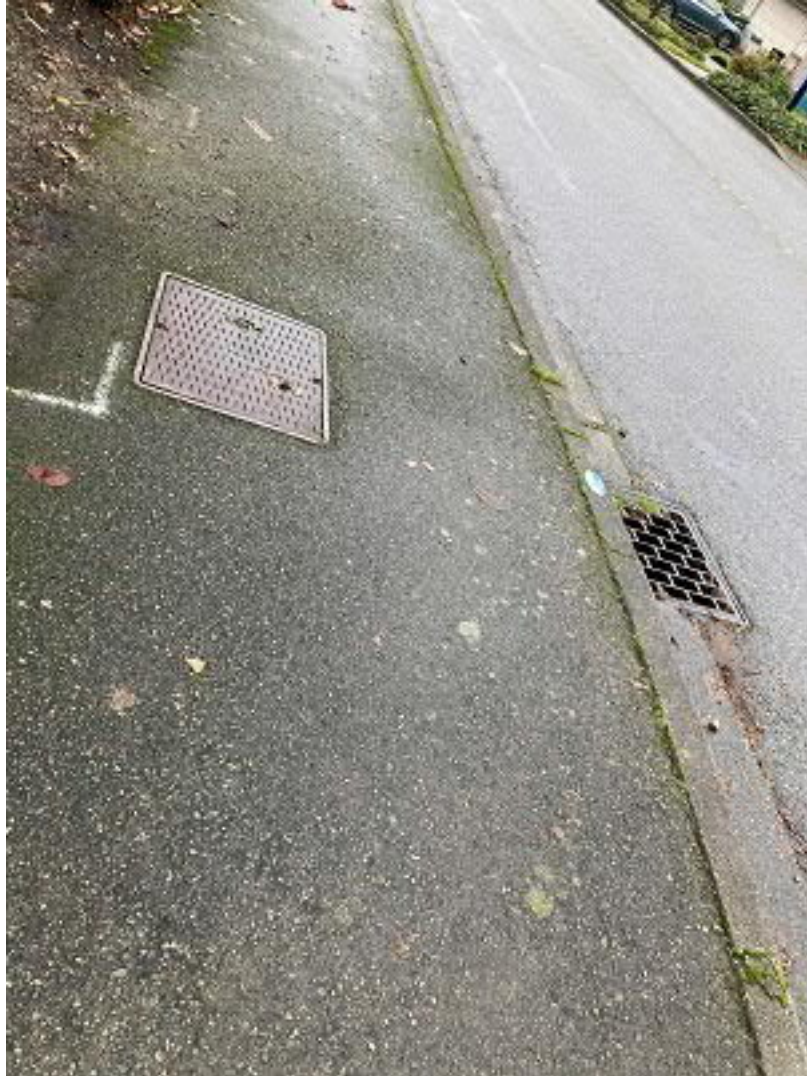
Picture 5: southwest corner of 70th Avenue SE and SE 24th Street
Existing storm drain has just made a 90-degree turn to the west. The main is under the solid lid.

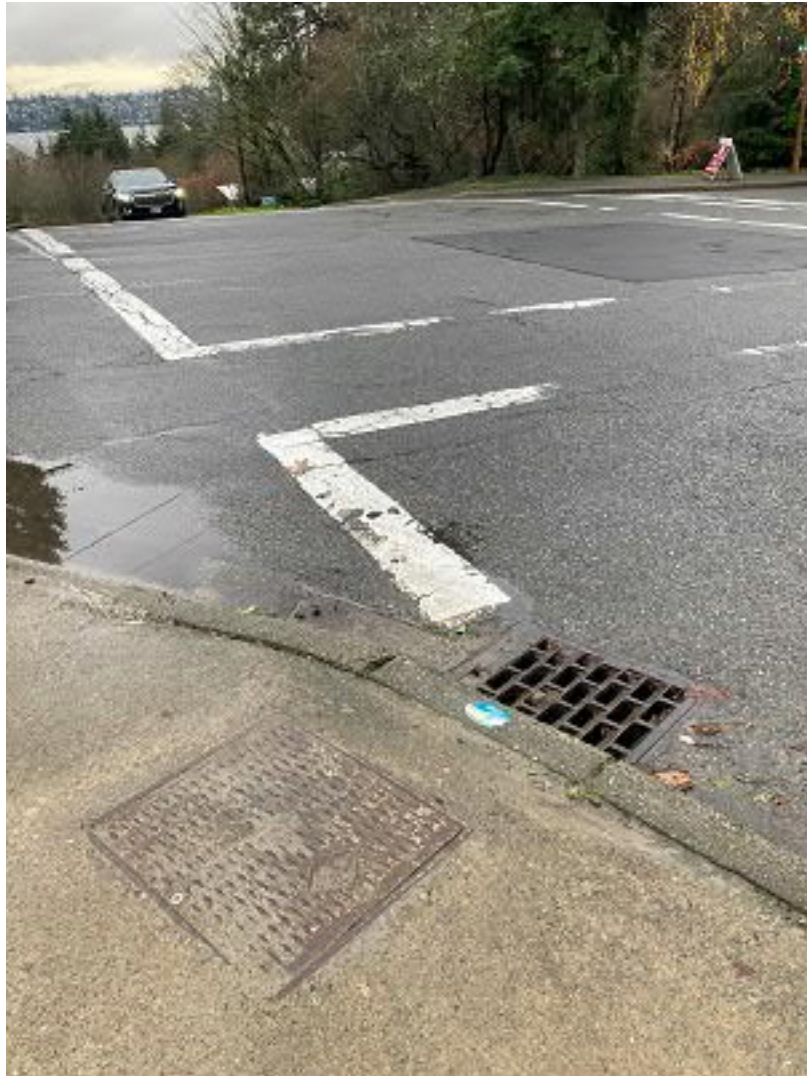
Picture 8: ROW at SE corner of SE 24th Street and W. Mercer Way
From here (solid lid), water crosses diagonally across the intersection.

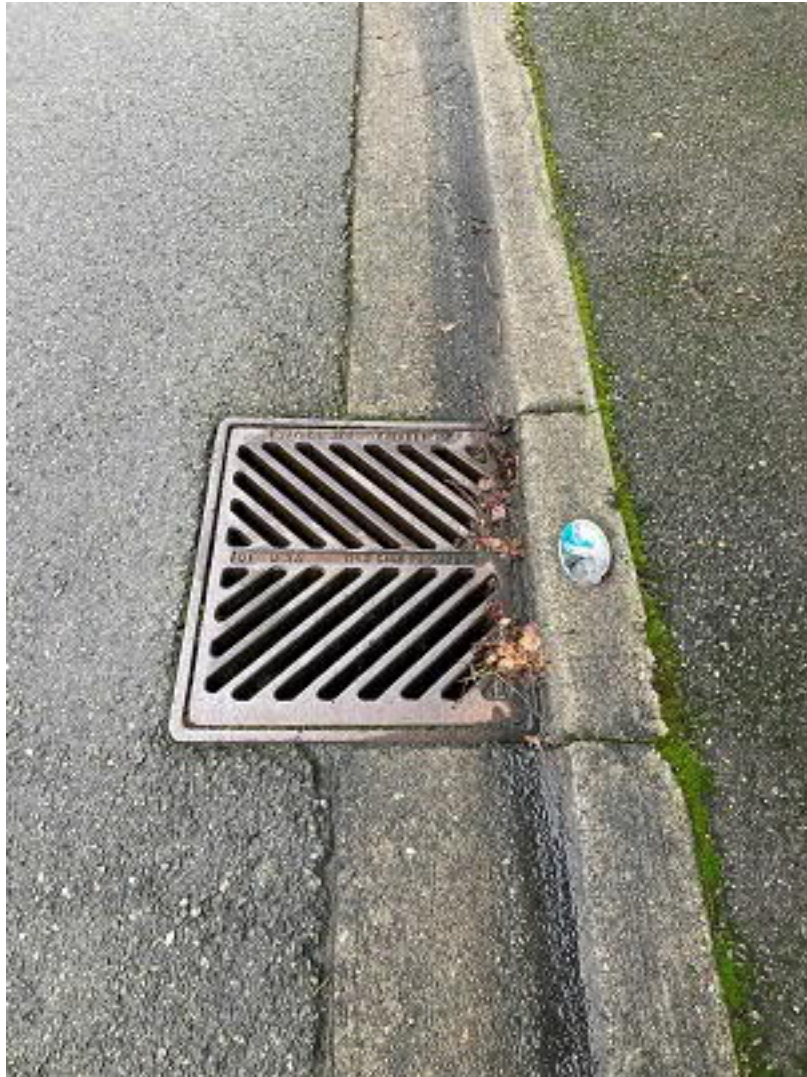
Picture 9: just west of NW corner of SE 24th Street and W. Mercer Way
Heading west under north side of SE 24th Street

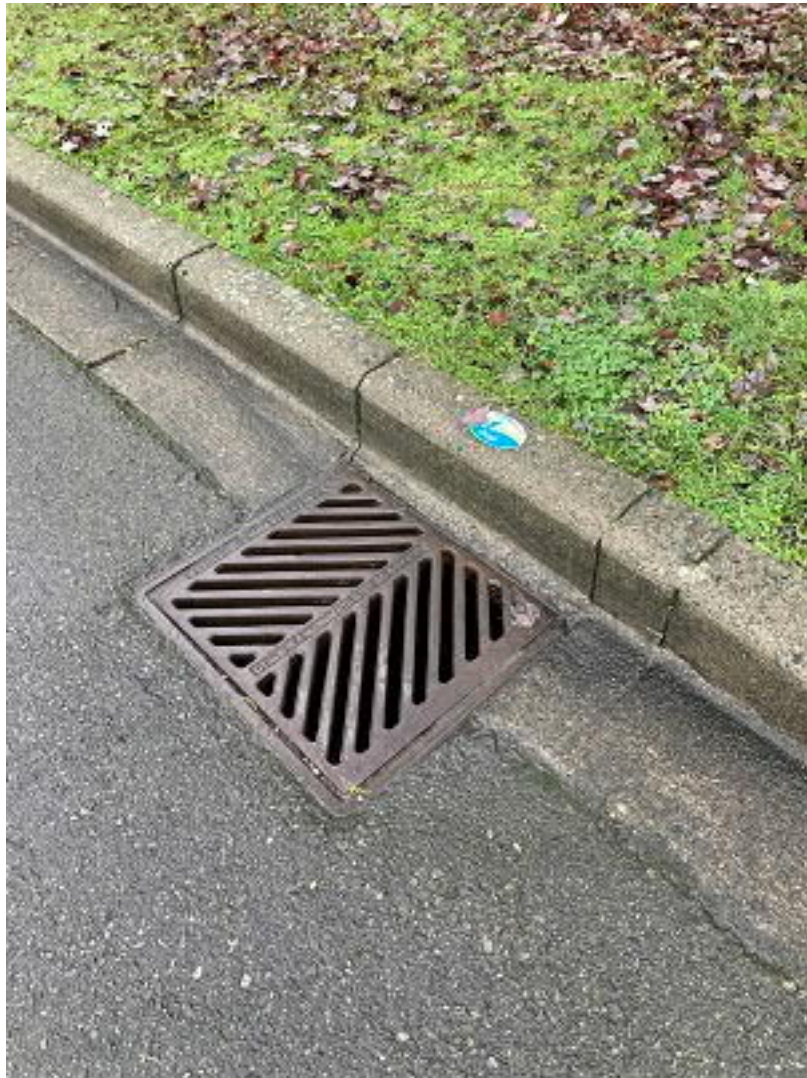
Picture 11: north side of intersection: SE 24th Street and 63rd Avenue SE
This is a Type 2 catch basin, very big inside.
From here water turns to the northwest and heads into Aubrey Davis Park.
