August 18, 2021

**Project:** Pre-construction assessment for lot re-development at 7845 SE 62<sup>nd</sup> Street, Mercer Island, WA. Parcel number 4094800130.

**Objectives:** Evaluate health of existing trees and establish criteria for the preservation of those to be retained.

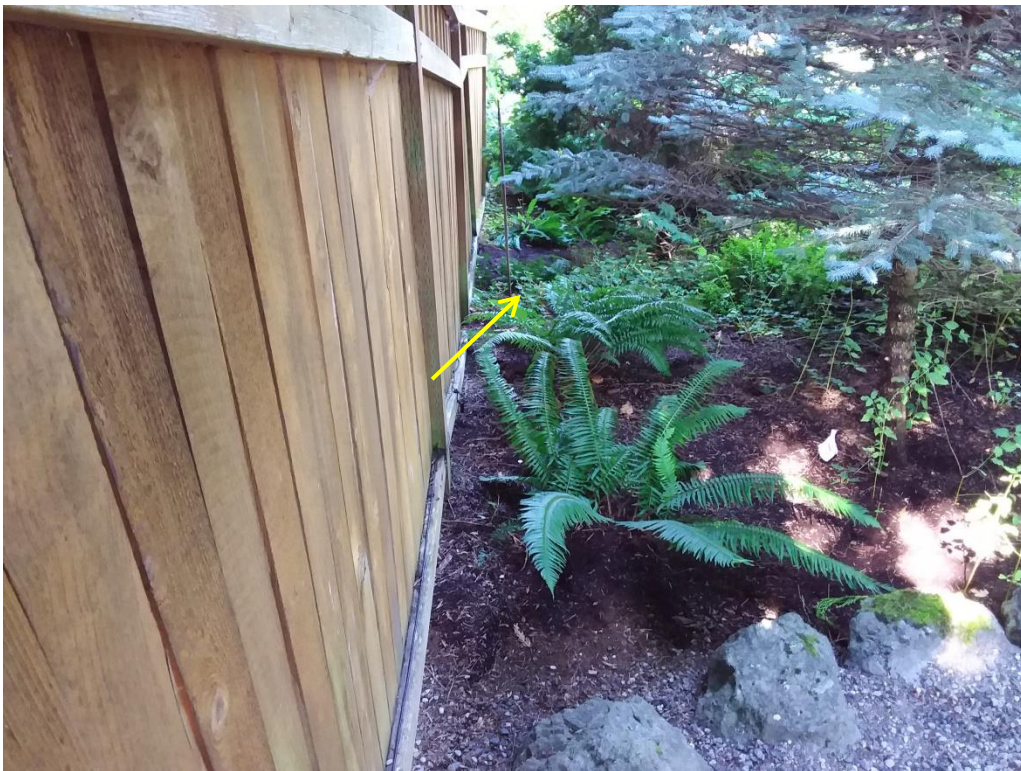
Small stone retaining walls were laid down north to south by a previous owner in order to create planting beds. The western (lower) wall starts at the south fence where it is 16” high, runs at least 25’ getting taller as it moves north, and ends at 30” high where it intersects with the timber frame staircase leading to the upper garden area. The second (upper) stone wall is 11-12’ E of the first, starts out a single stone high at the fence (Figure 4), increases in height as it moves north to about 24” tall, and then wraps to the southeast of the existing garden shed where it is 26 in tall as shown in Figure 5.

Figure 4. Looking west down the south fenceline. The stones at the south end of the upper retaining wall are shown at the bottom of the image. The lower wall starts where the yellow arrow points.

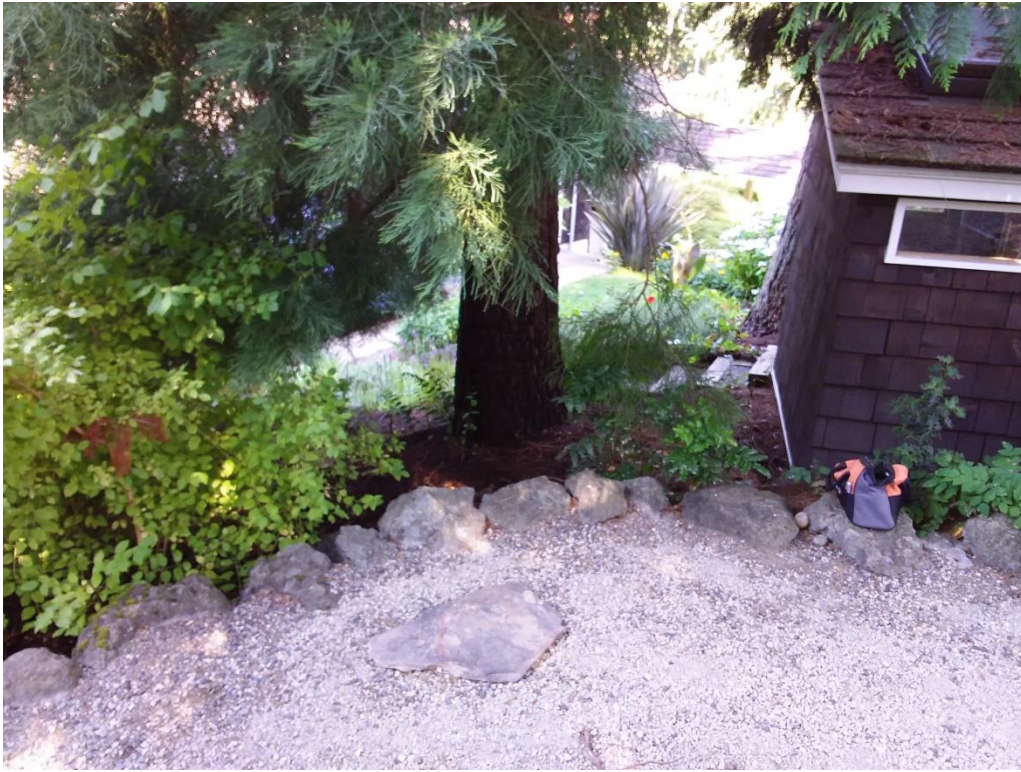
Figure 5. Looking NW at where the upper stone retaining wall curves to the south of the garden shed. The #3 sequoia is in the center of the frame.

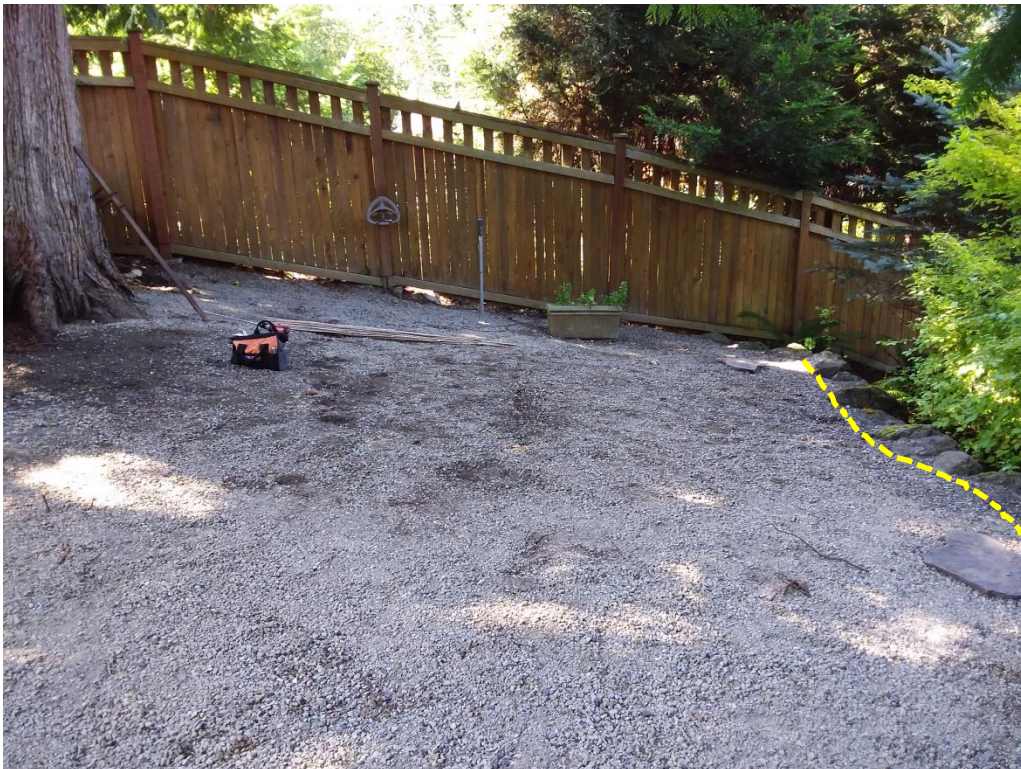
The garden beds between and below the stone walls were renovated during the landscape project but the stone walls were left intact. The area above the upper stone wall was leveled so that raised garden beds could be set up in the corner (Figure 6).

Figure 6. Looking south across the upper area where the raised garden beds were located. They had been here close to 10 years. The upper wall is just visible at the right side of the image (yellow dashed line).

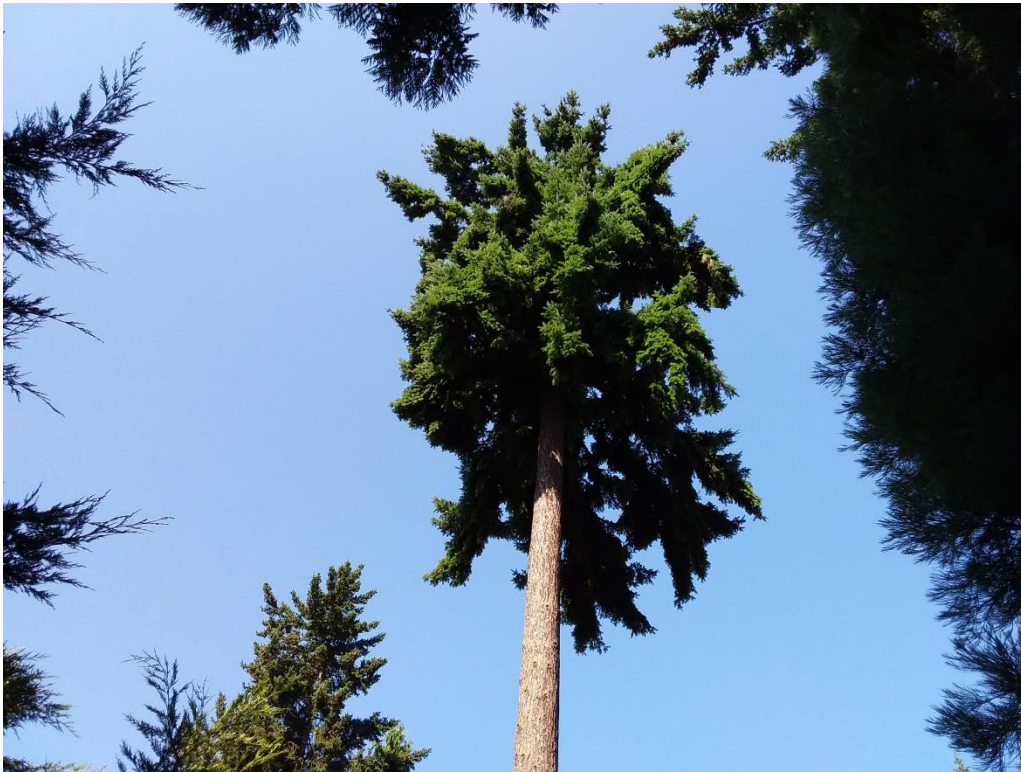
1. Douglas fir (*Pseudotsuga menziesii*) measured at the mid slope average level and found to be 35.5" DSH. Bark is rather heavy low on the column and the more realistic diameter is probably closer to 32 inches. Tree goes to 80' tall. The canopy is above the halfway point, rather dense, and exhibits abundant new growth and good color as shown in Figure 10. The top of the tree has a rather flattened aspect and may have broken out or the tree might have been topped. Tree stands 9' N of the fence, 13' W of the lower stone retaining wall. This is an Exceptional tree.

Figure 10. Looking up and SW at the canopy of the #1 fir.

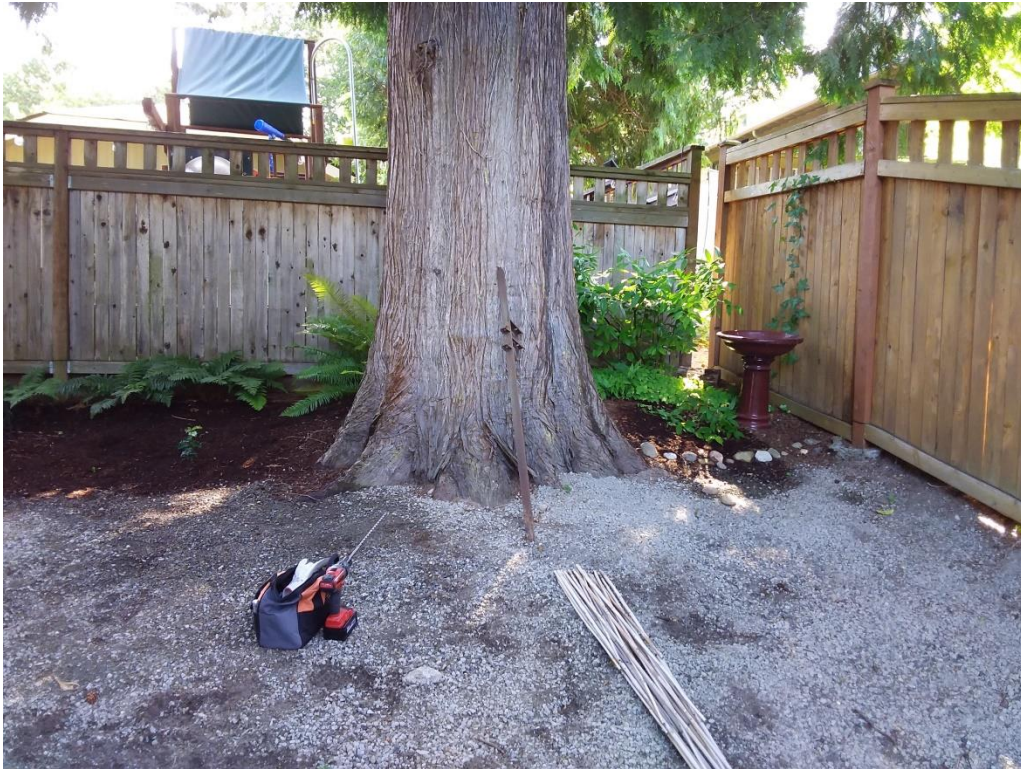
2. Western Red Cedar (*Thuja plicata*) 40" DSH, 75' tall, stands in the SE corner of the yard 6' W of the east fence, 7' N of the south fence, and 18' E of the upper stone retaining wall (Figure 11). The yards on the other sides of the fences have mulch type coverings rather than lawns for at least 18' in either direction and little by way of contour changes. Tree exhibits good new growth and color, canopy comes down to within 14' of the ground. There is a low limb on the north face that is trying to curl vertical to form a subordinate spar. This is an Exceptional tree.

Using the #2 cedar again as the example, with the excavation for the new section of spa foundation located 19' from the tree's base and it having a 40" DSH, there will be impact at a linear distance equal to 48% of the maple's CRZ (19'/40'). The chart in Figure 17 shows that this would theoretically equate to a 32% loss of the cedar's Critical Root Area (CRA) if the cut continued completely across the circle of the root system.

The excavation will only extend 13' north to south however not even entirely across a whole quadrant of the cedar's root system. It will also be set west of the upper stone wall which may have been acting as a root barricade for the cedar as it matured. By calculation the loss should be much closer to 5% of the cedar's CRA. The tree should experience little to no long term detrimental impact.

Figure 11. Looking east across the old garden bed space at the base of the #2 cedar.

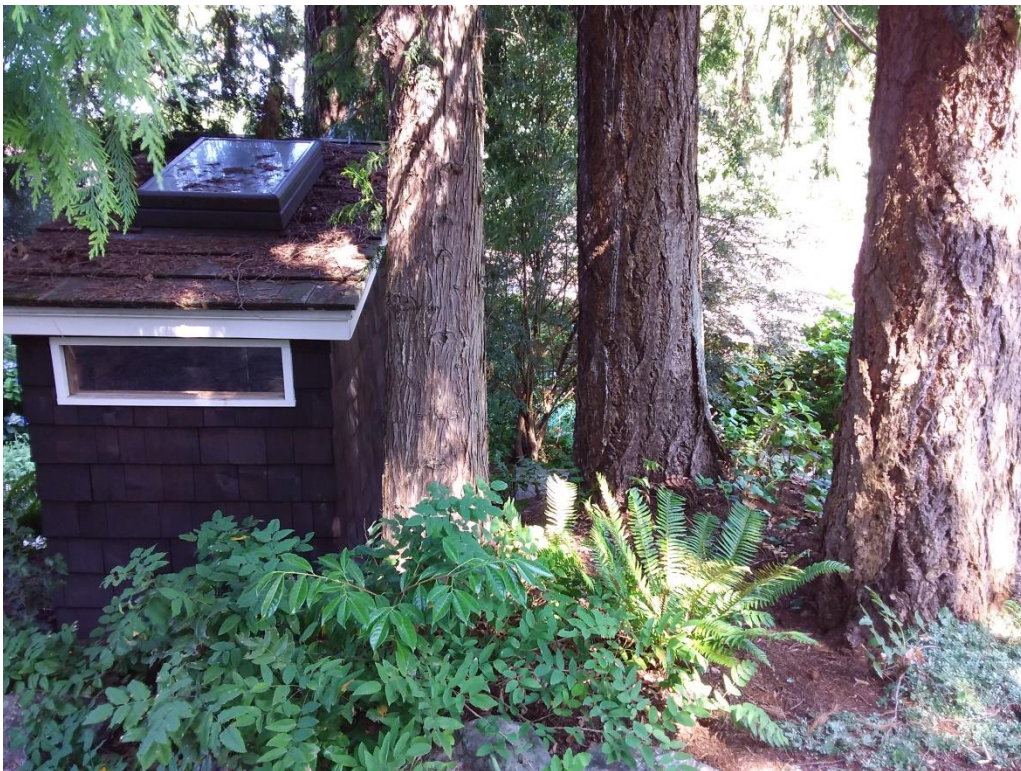
4. Western Red Cedar 13.5" DSH, 40' tall standing at the end / edge of the upper stonewall and 12" off of the east corner of the garden shed (Figure 12). The secondary set of stones leading from the upper wall are 32" S of the base of the cedar. It exhibits average color and new growth. Its canopy comes down to 8' above grade and is stretching out a little far in each direction trying to find light from underneath the larger trees.

Figure 12. Looking NNW at the base of the #4 cedar. The #6 fir is behind and to its right. The #5 fir is at the right side of the image.

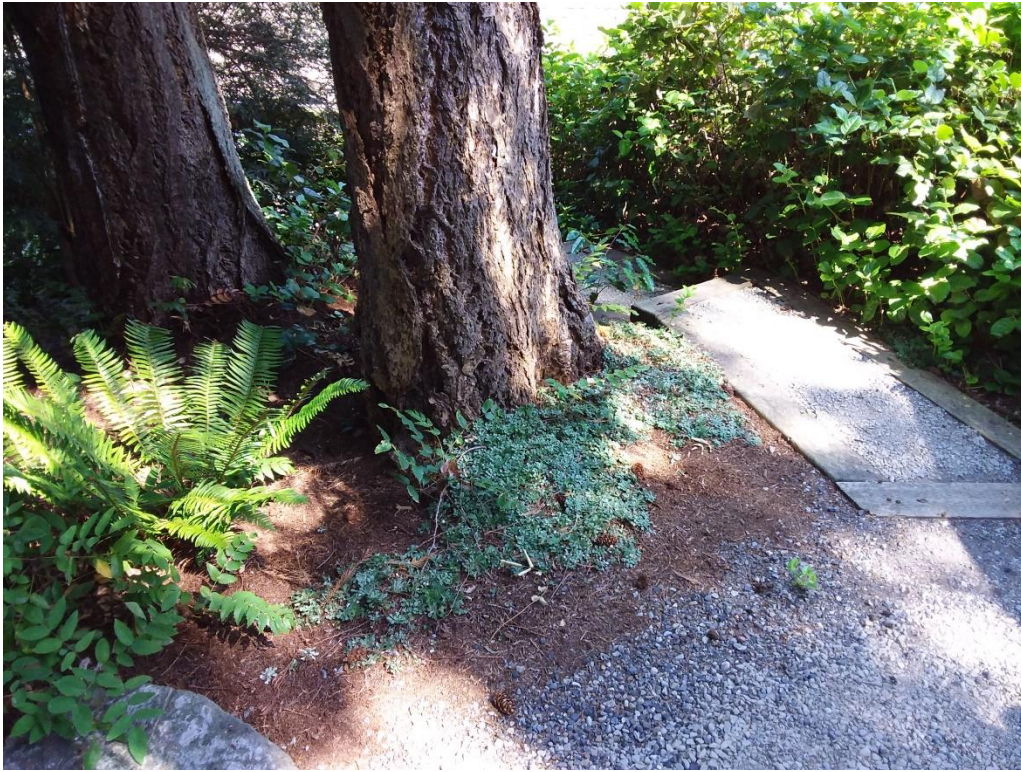
5. Douglas fir standing 34' N of the south fence line, 11' W of the east fence. The stair path curves around its base within 16" and slowly expands that distance (Figure 13). The large stones at the end of the path are just 38" to its south. Tree exhibits an abnormal basal morphology being narrow east to west and much wider north to south. It has two larger fungal bodies; one at 6' level and one at 8' (Figure 14), and then some smaller ones further up the stem which could not be picked up in a photo. Had a 22.5" DSH and is in the neighborhood of 95' tall. Canopy starts near the 40' level and exhibits average new growth and color.

Figure 13. Looking north at the base of the #5 fir showing the proximity of the stair path. Note the large stone at the bottom left of the image.

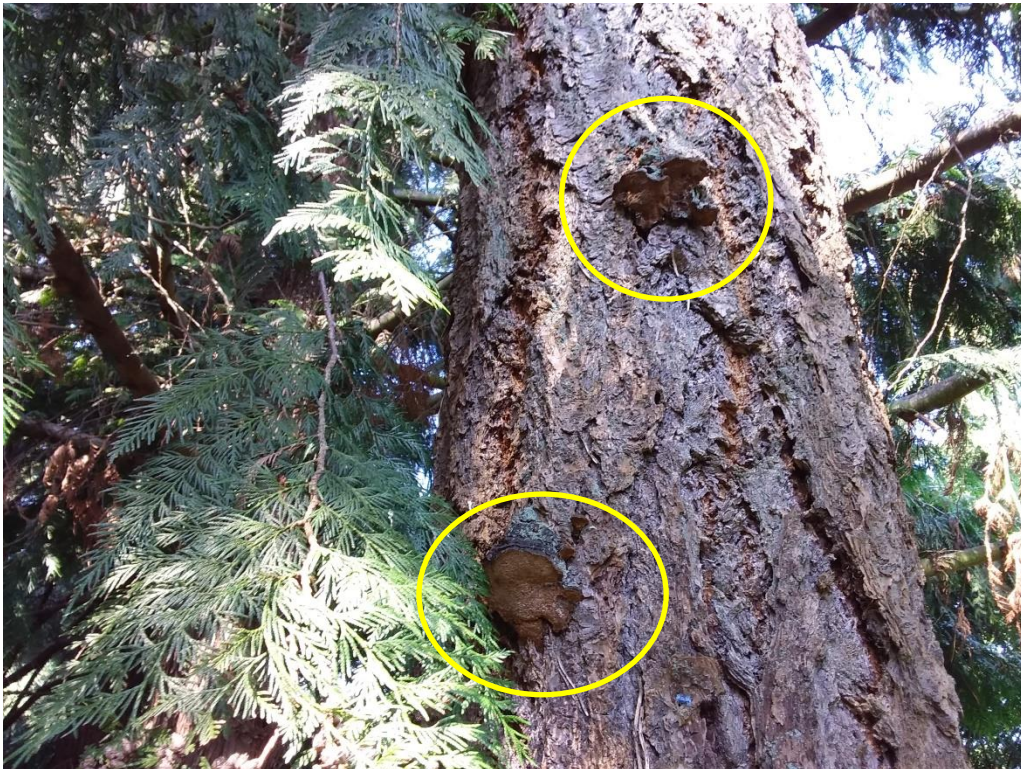
Figure 14. Looking at the fungal bodies low on the column of the #5 fir.

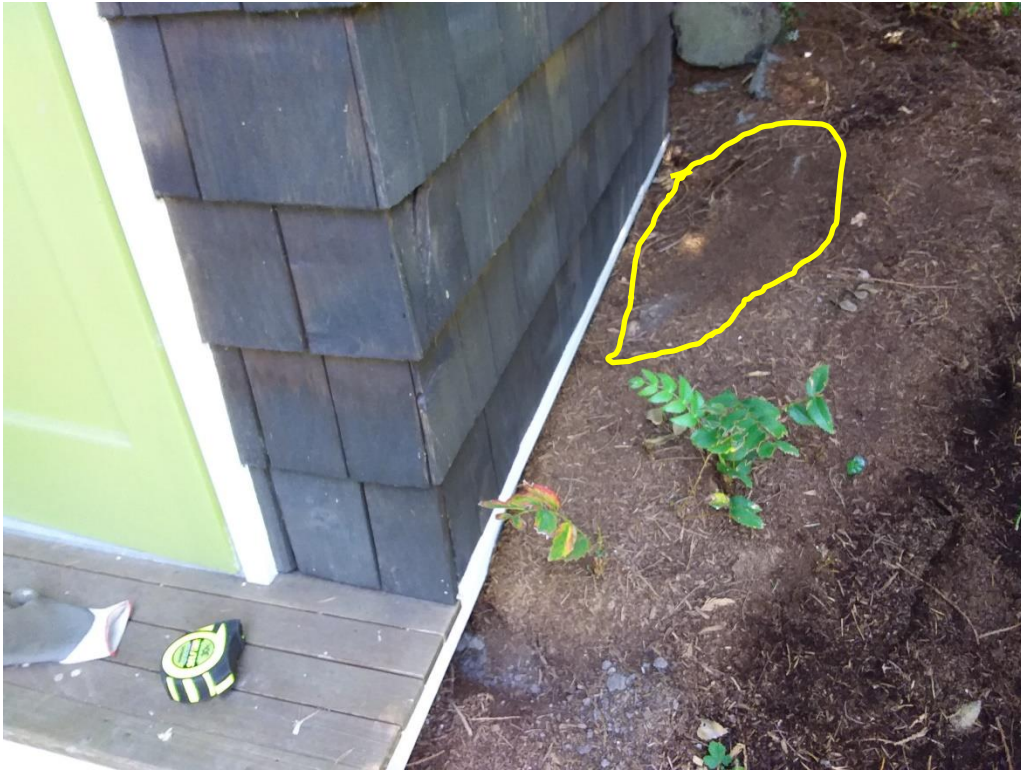
7. Douglas fir 31.5" DSH, 100' tall standing 11' NW of the #6 tree, 24" N of the stair path, and 11' nearly due north of the #3 sequoia. Average new growth and color in a canopy that comes about to the halfway point. One of this tree's roots is visible stretching along the side of the garden shed which indicates they are passing mostly unimpeded by the path (Figure 15). This is an Exceptional tree.

Figure 15. Looking down and SSE at the #7 fir's root running alongside the garden shed.

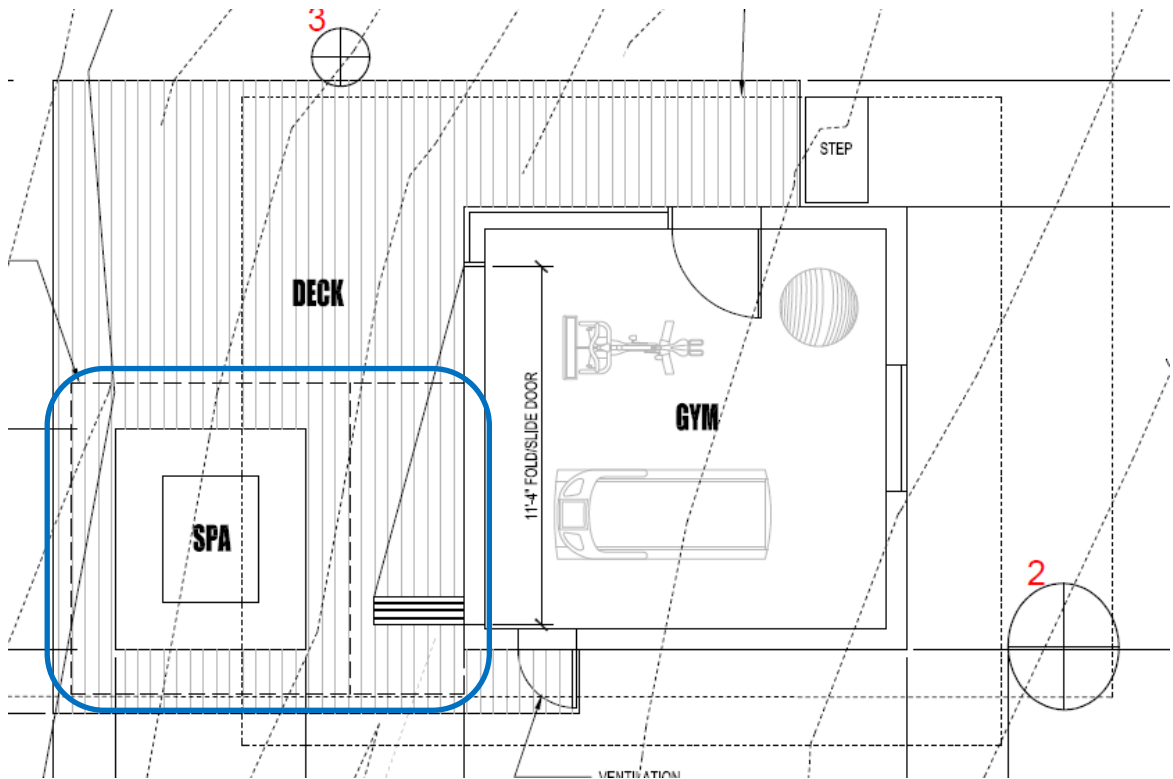
The architect is proposing to float the majority of the building on piles and only digging a foundation type base for the space where the spa will sit (Figure 16). The placement of the piles will be determined by light excavation or air spading to ensure that they do not cut through significant structural elements on the #2 cedar. The same care will be taken when locating the placement for the piles near the #3, #4, and #5 trees.

Figure 16. Enlargement of the plan showing the placement of the spa foundation. The SE corner of the building will be quite close to the base of the #2 cedar but floating on pile posts. Impact should be minimized.

**Recommendations:** The spots where the pile post for the new building are to be placed will have to be inspected in real time to make sure they do not intersect with main roots. If roots larger than 3" caliper cross through the space(s) noted then a different arrangement will have to be designed. No roots of this size or larger can be cut within the Structural Root Plates of the #2 cedar, #3 sequoia, #4 cedar, or #5 fir tree.

The excavation for the spa and the spotting of the pile post sites should be done with arborist oversight.
