Superior NW Enterprises

August 20, 2021

Project: Level 3 risk assessments for four large evergreens at 7845 SE 62nd Street, Mercer Island, WA. Parcel number 4094800130.

Objectives: Formal risk assessment of four Douglas fir trees at the site.

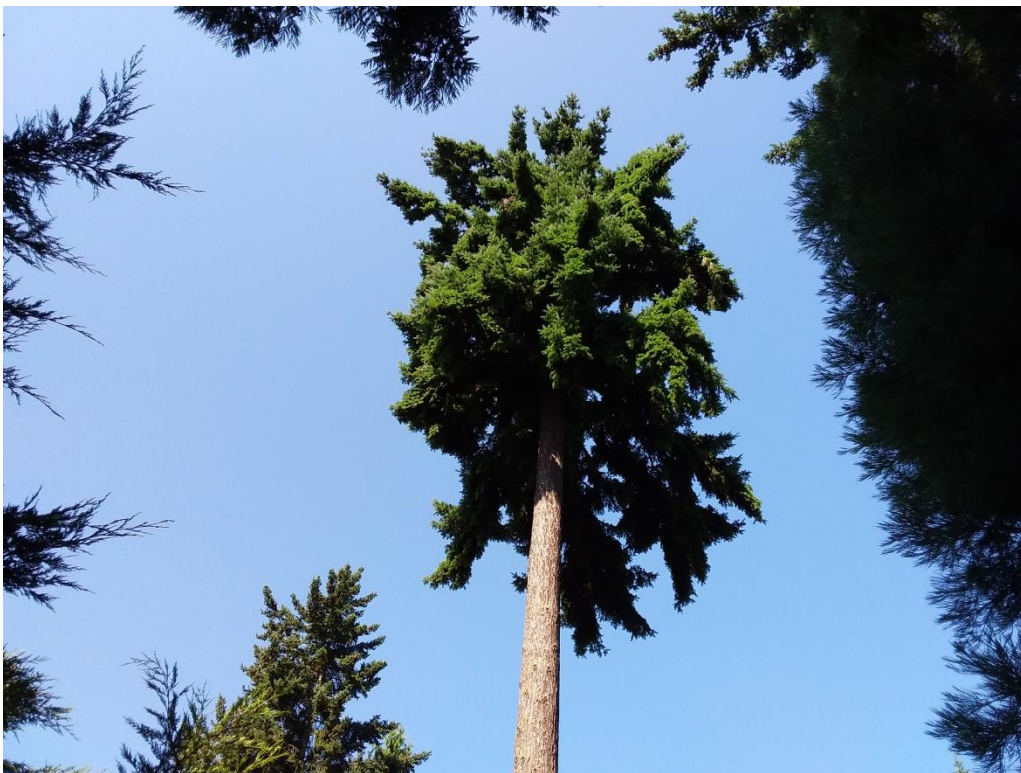
1. Douglas fir (*Pseudotsuga menziesii*) measured at the mid slope average level and found to be 35.5" DSH. Bark is rather heavy low on the column and the more realistic diameter is probably closer to 32 inches. Tree goes to 80' tall. The canopy is above the halfway point, rather dense, and exhibits abundant new growth and good color as shown in Figure 8. The top of the tree has a rather flattened aspect and may have broken out or the tree might have been topped. Tree stands 9' N of the fence, 13' W of the lower stone retaining wall. This is an Exceptional tree.

The #1 and #7 firs have **improbable likelihoods of catastrophic failure** based on their clean basal profiles which are indicative of good integrity at the root crown and few if any compromised structural roots. If either did fail they would have **high likelihoods** of landing on one of the four surrounding homes. This places the #1 and #7 trees in the **unlikely to fail and impact** row in the second matrix. Even though the **consequences** would be **severe** should the trees happen to fail they are still designated as **low risks**.

Figure 8. Looking up and SW at the canopy of the #1 fir. Note the branches reaching out beyond the length of the others in their vicinity.

The #1 tree has branches that are somewhat over extended. These will become increasingly prone to failure from storm wind force loads. It would be beneficial for the tree to have the ends of these branches carefully pruned back to bring them in line with the others in their vicinity. The tree should not be thinned as it needs all the energy it can generate from its limited canopy.
