LAYTON TREE CONSULTING, LLC

ARBORIST REPORT/TREE PLAN

3038 61st Avenue SE
Mercer Island, WA

November 10, 2021

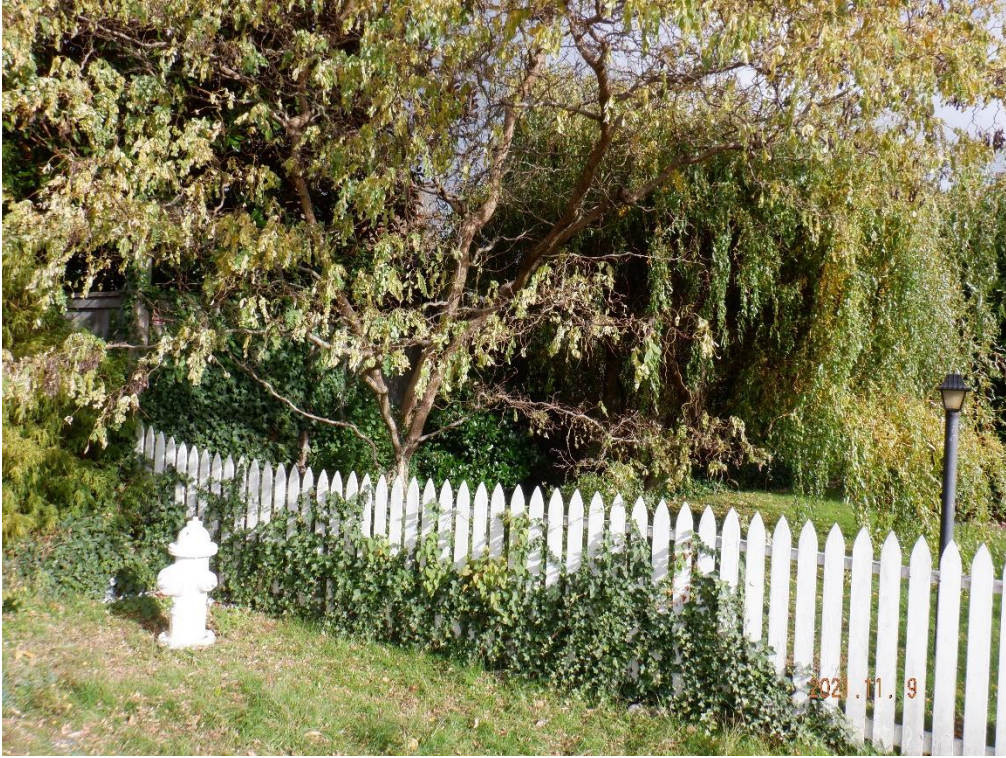
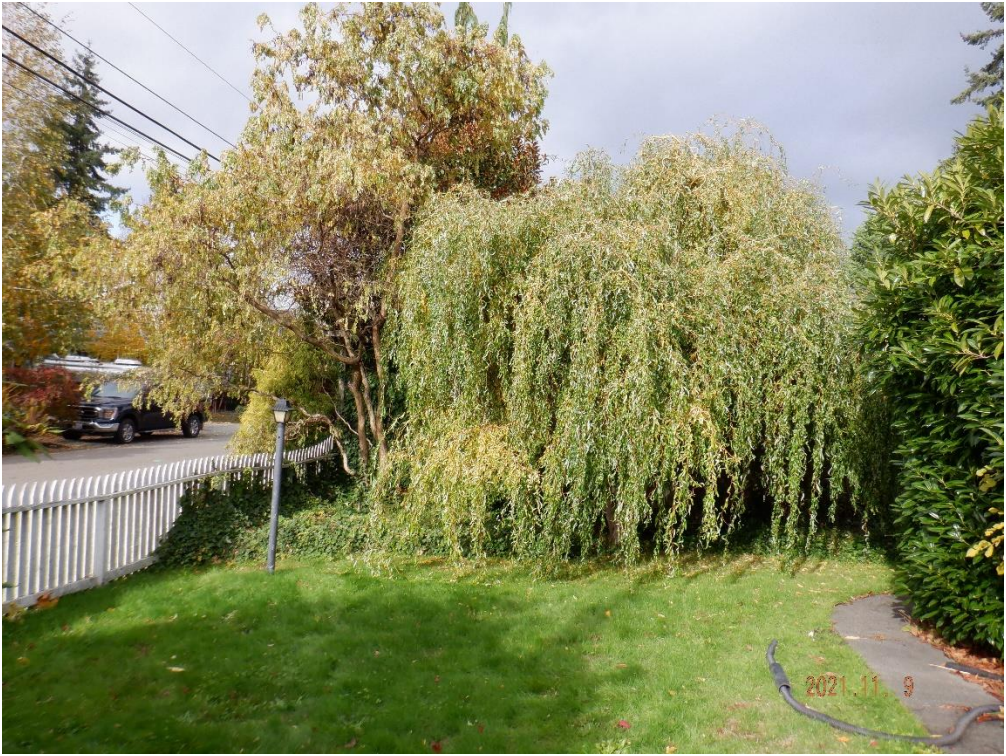
Tree #1 is a young, small, non-regulated cultivated variety of honey locust. It has developed good structural form and is of good vigor. No concerning issues were observed. Condition is 'good'.

Tree #2 is a young cultivated variety of corkscrew willow. It has developed the typical weeping form. The crown is somewhat asymmetric on the south side. Vigor is good. No concerning issues were observed. Condition is 'good'.

Trees #1 and #2 in northwest corner of property

The proposal is to retain Trees #1 and #2 and remove Tree #3. #1 and #2 are well-positioned for successful retention. There is a new driveway proposed roughly 6-feet from the trunk face of #1 and 4-feet from Tree #2. Both will need to be pruned back on the south sides to provide adequate clearance. Use a professional tree service who employs certified arborists to conduct this work. These are small, young trees and should be expected to survive the proposed impacts so long as work is carried out diligently. Securely position a tree protection barrier at the dripline edge as shown on the attached map during the demolition phase of the project. Only move the protection fencing back to the new driveway edge when work there is ready to commence.

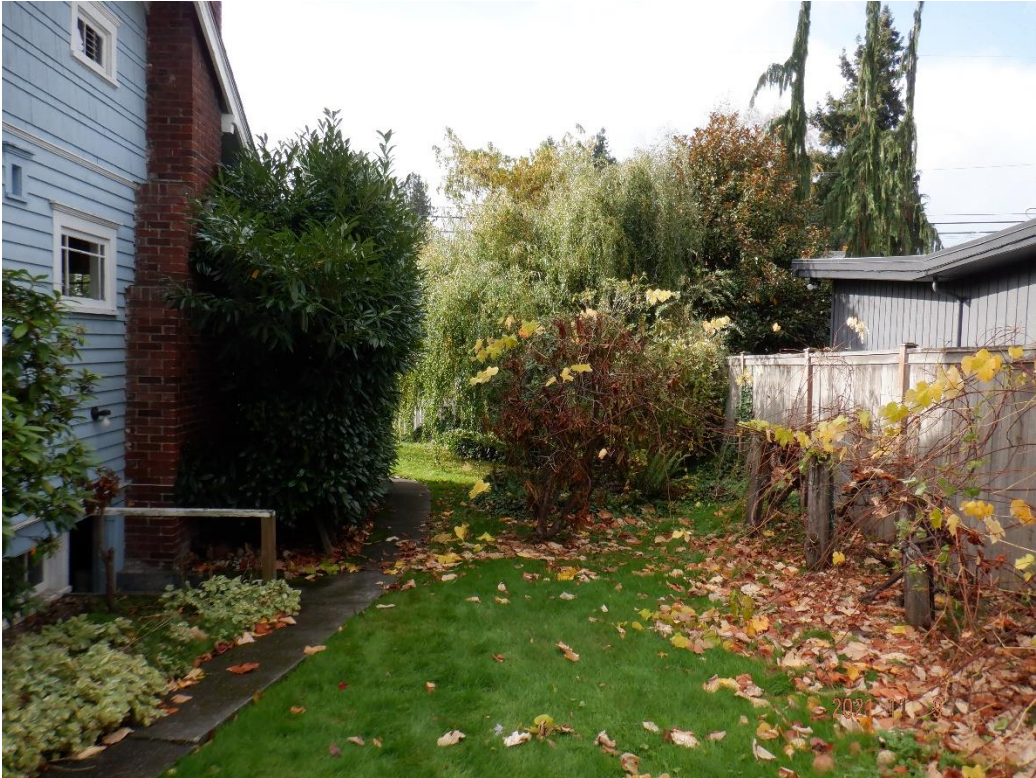
North side of existing house, looking west from backyard, #1 and #2 in background

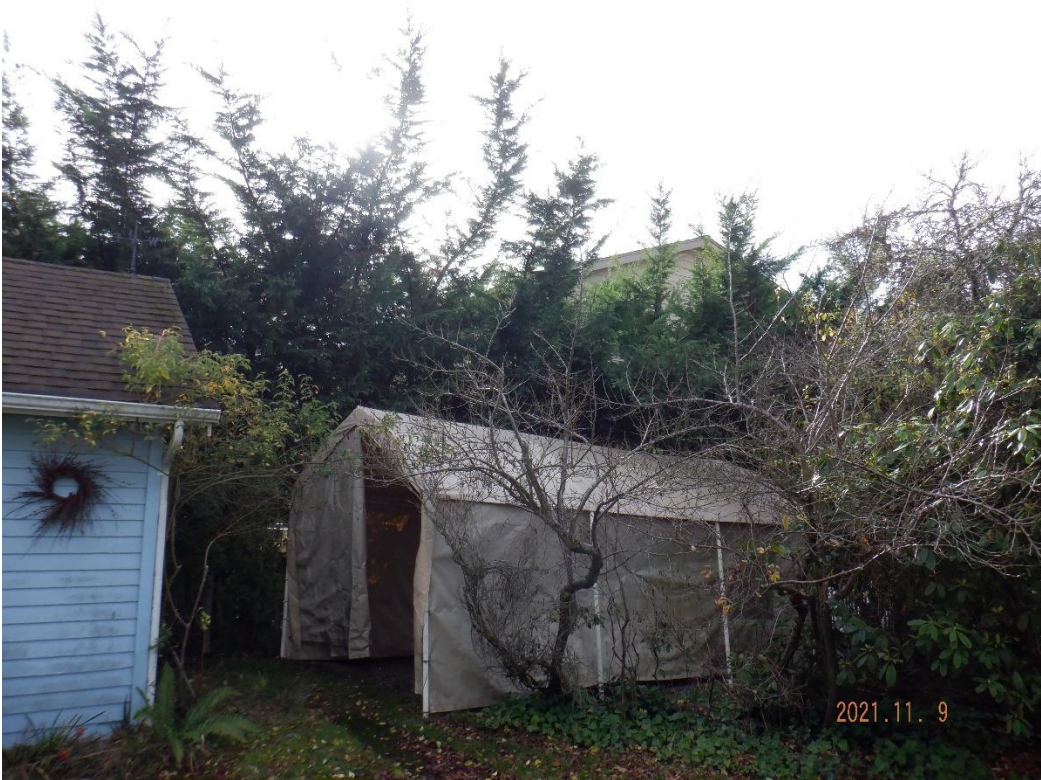
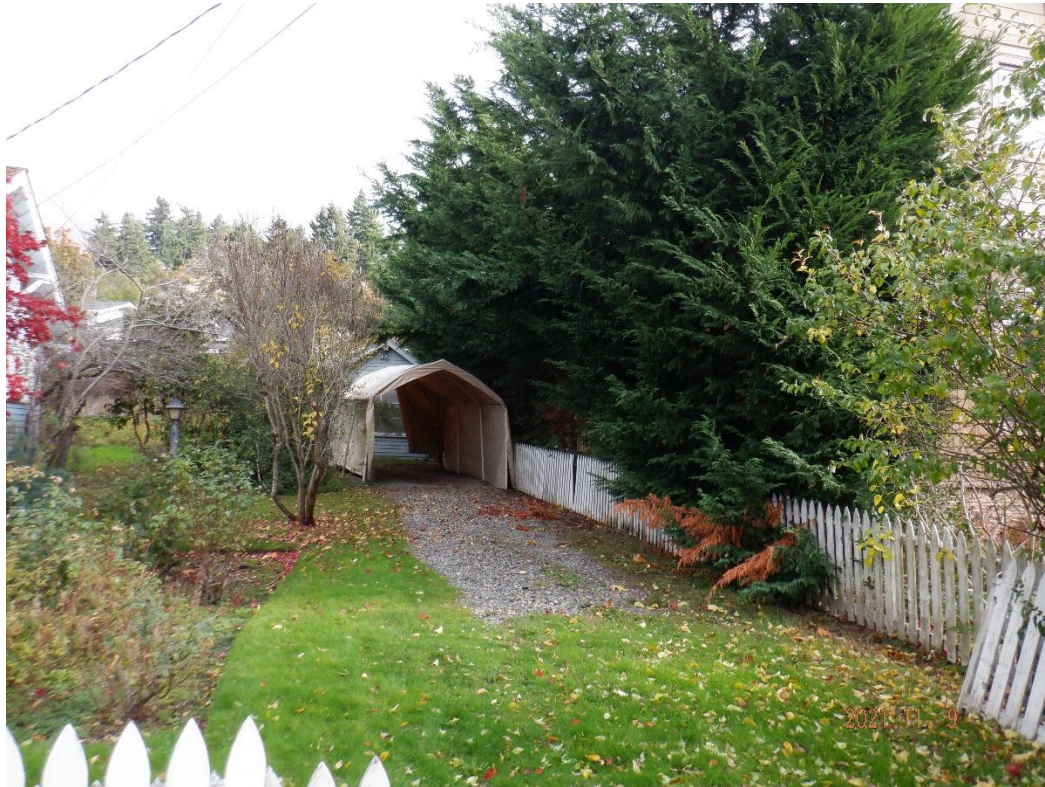
Tree #3 is a young to semi-mature variety of pear. It is comprised of two small diameter stems or trunks. Both have been topped in the past. Condition is 'fair'.

Tree #3 on right, neighbors Leyland cypress in background

Tree #3 on left, neighboring Leyland cypress on right

Two replacement trees will be required for the removal of Tree #3. Consult with your City planner for final tree replacement requirements. All replacement trees are to be planted on site. Replacement trees shall be at a minimum – 1 ½ inch caliper for deciduous species and 6 feet in height for coniferous species.

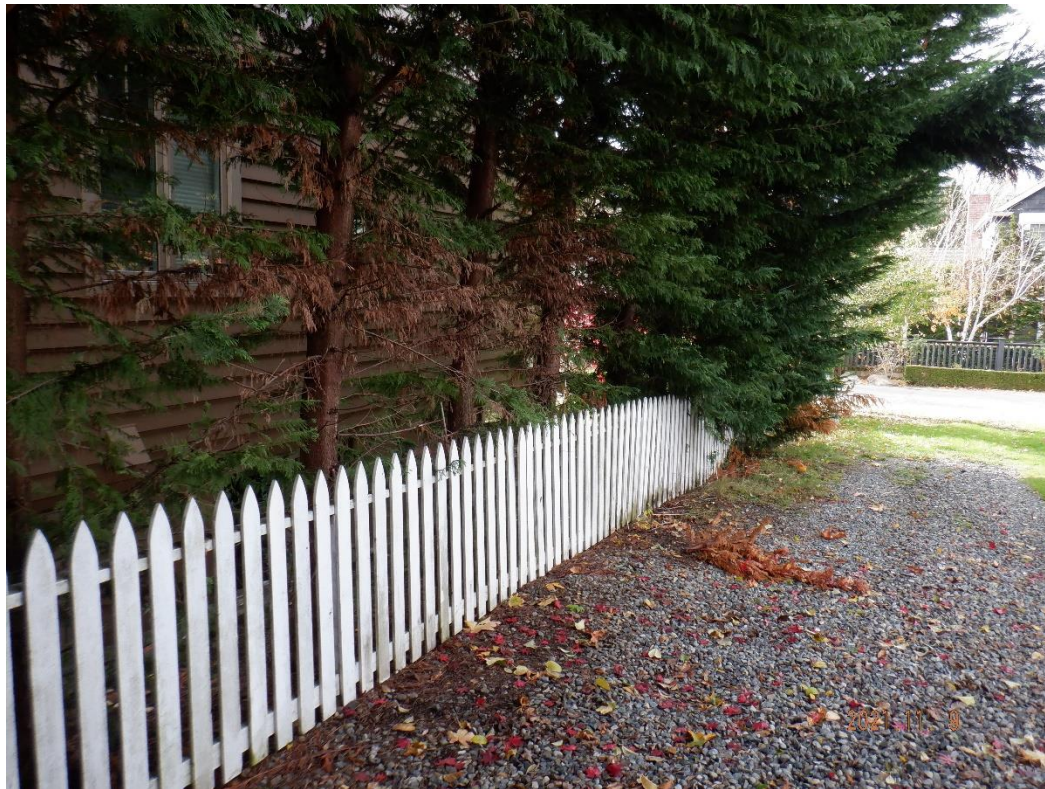
There is a planted row of 13 young Leyland cypress trees on the neighboring property to south within a proximity of the property line. These are 6 to 8-inches in diameter and 20 to 25-feet in height. All have been recently topped and sheared on the south side. They are of good vigor. Condition is 'fair'.

Neighboring Leyland cypress

To adequately protect the neighbors Leyland cypress hedge row, position a tree protection barrier at 10-feet from the property line. Since these have recently been topped, it appears these will be maintained as a hedge row. To create a dense hedge, shear or prune back branches to about 4 to 5-feet from the tree trunks and routinely maintain growth at that point.

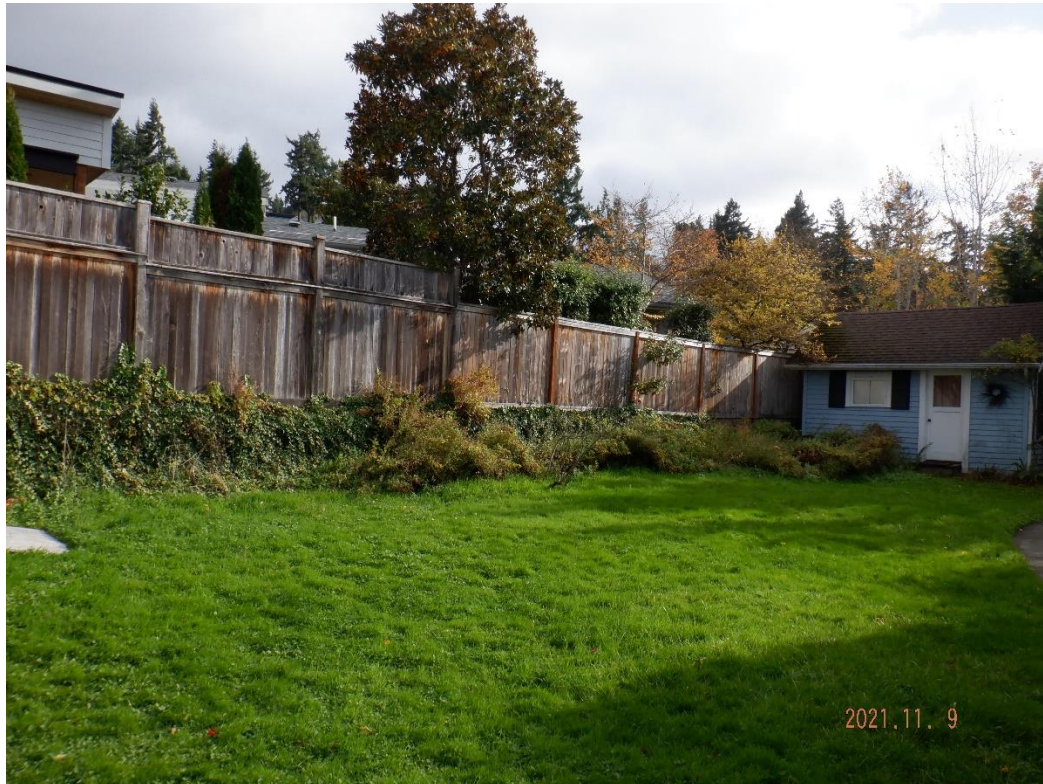
There is a young variety of southern magnolia close to the east property line. It has developed fairly good form and is of good vigor. There is a +/- 3-foot-high concrete retaining wall beneath the fence on the east property line. This tree would not be impacted by ground disturbance on the subject property.

Back or east side of property, neighboring magnolia opposite fence and concrete retaining wall

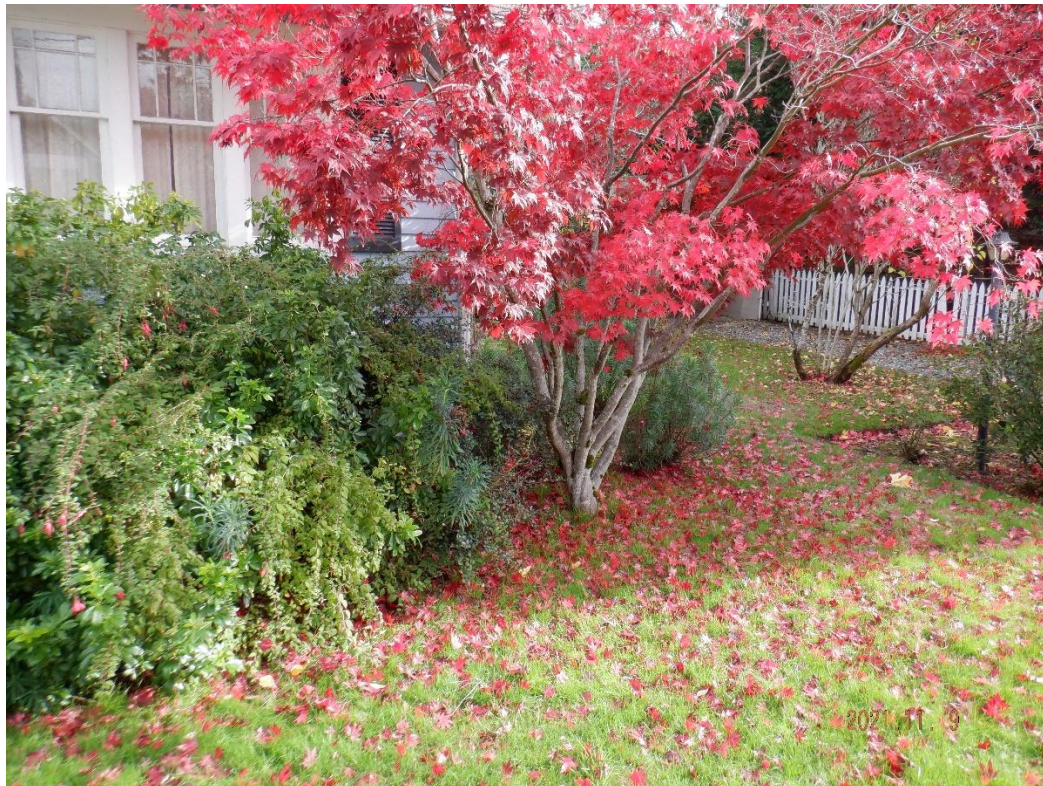
Small Japanese maple at house corner
