Consulting Arborist Services

To: JayMarc Homes, Jay Mesistrano  
Reference: Tree Inventory Report  
Updated with Tomography Results  
Date: September 28, 2021  
Site Address: 45XX 90th SE, Mercer Island 98040  
Parcel: 0191100190

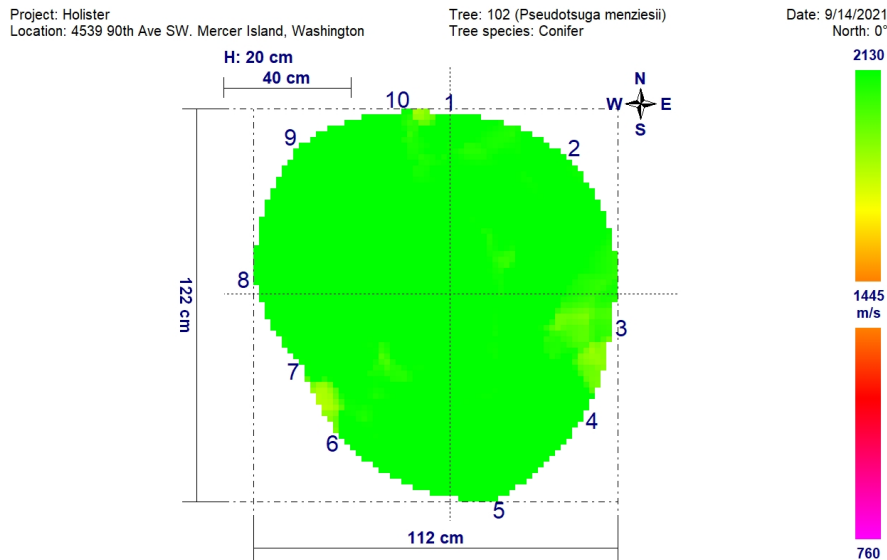
Tree 102 has two superficial cracks in the north and southwest quadrant, and some sapwood decay in the eastern quadrant. Reassessment in five years recommended.

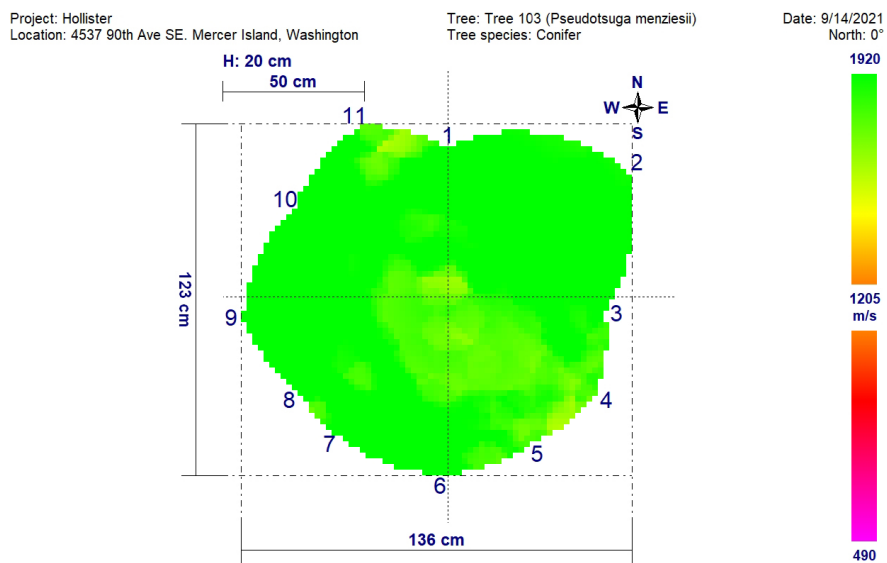
Tree 103 has sapwood decay in its northeast and southwest quadrants, and some heartwood decay emanating to the southeast. Reassessment after planned construction or two years from initial test recommended.

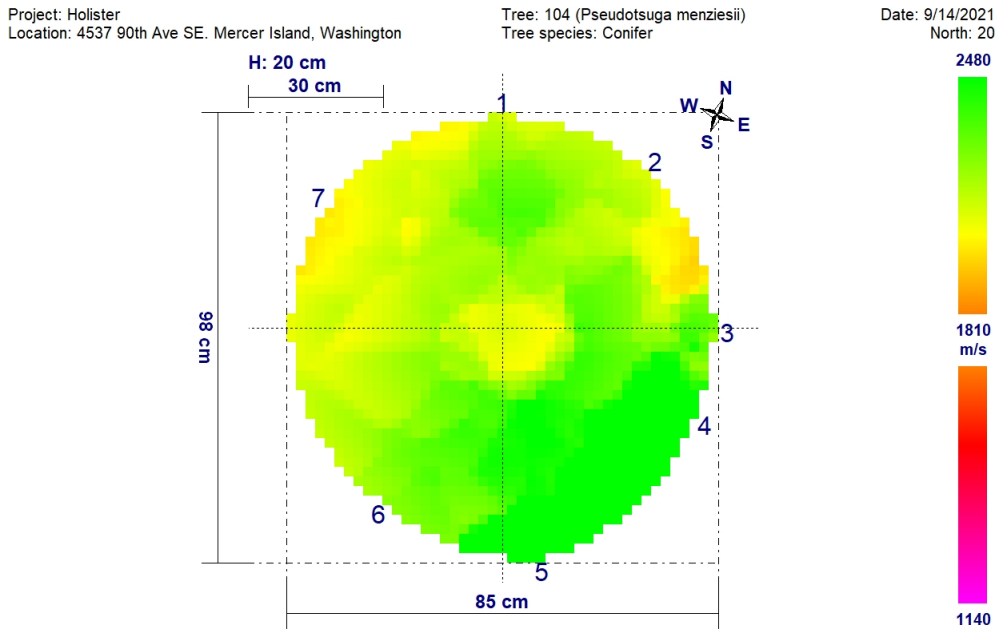
Tree 104 has sapwood decay on its northwest and northeast quadrants, and some centralized heartwood decay. The decay in the tree is estimated to be causing a 13% strength loss. Provide appropriate tree protection during construction. Reassessment after planned construction or two years from initial test recommended.

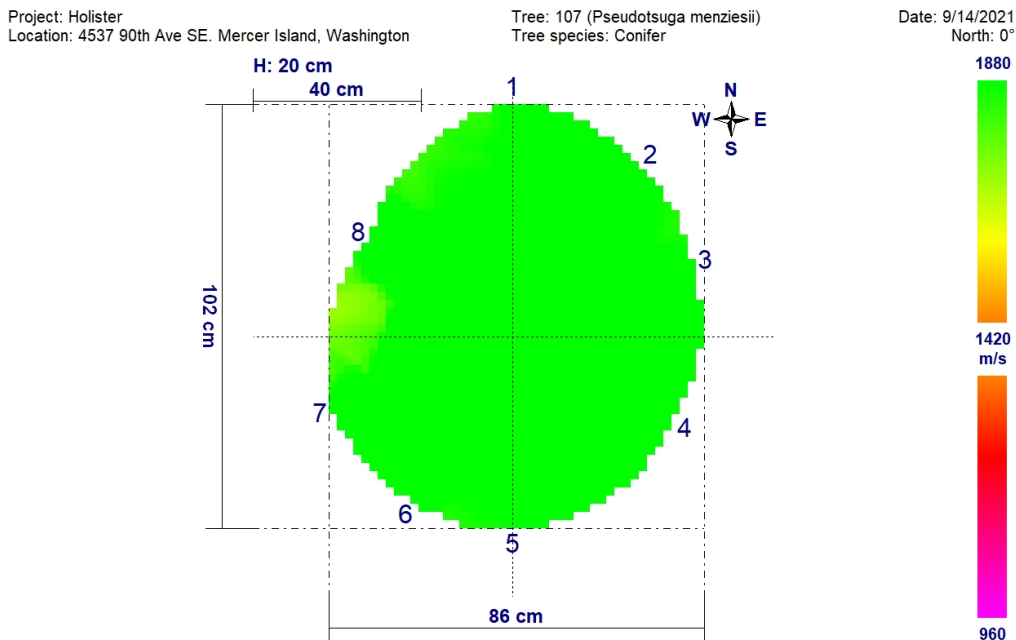
Tree 107 has a superficial crack in the west quadrant. Reassessment in five years recommended.

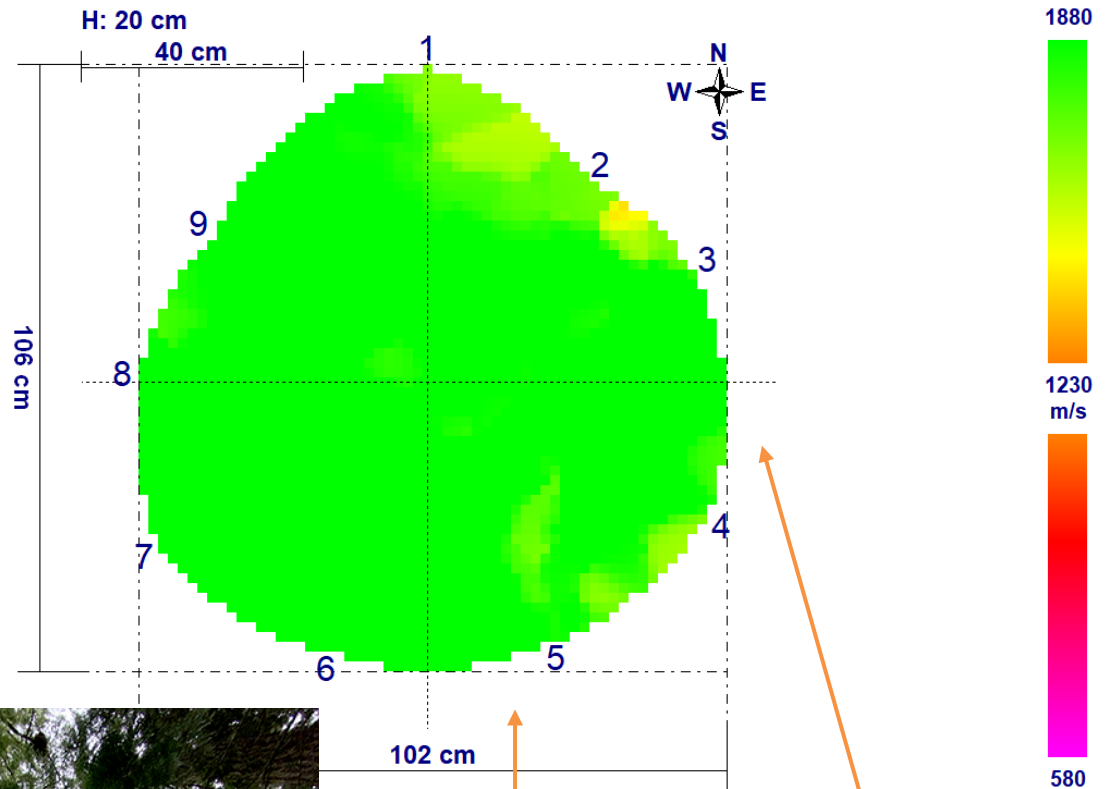
Tree: 108 (*Pseudotsuga menziesii*)  
 Tree species: Conifer

Tree 108 has two superficial cracks in its northeast and southeast quadrants and one area of sapwood decay in its northeast quadrant. Reassessment in five years recommended.

Potential construction impacts East – new foundation, and South – shed demolition.

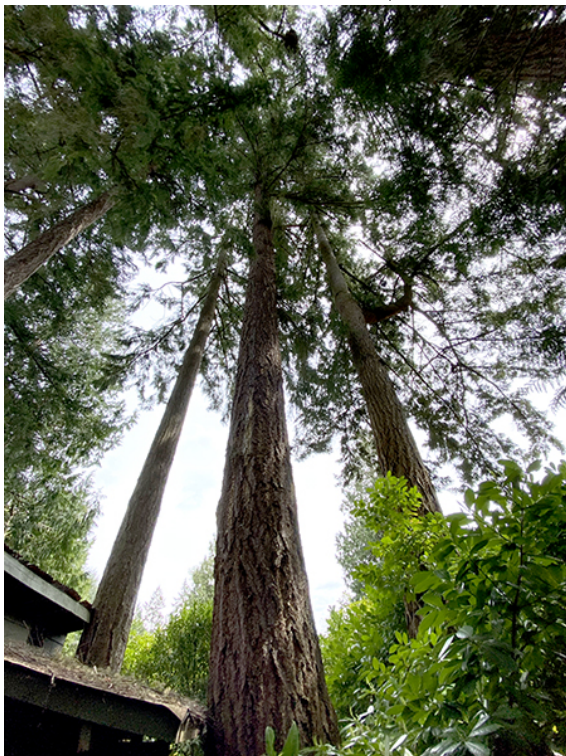
Tree #108, center, a 35-inch Douglas-fir, this page.  
 Tree #107, left of center, a 29-inch, Douglas-fir, page 6.  
 Tree #109, a 20-inch Douglas-fir, in background.

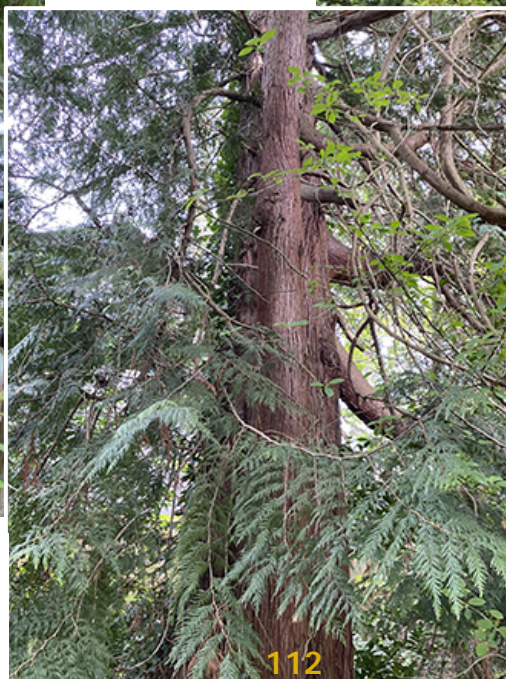
Right: Tree #112, a 50-inch Western red cedar.

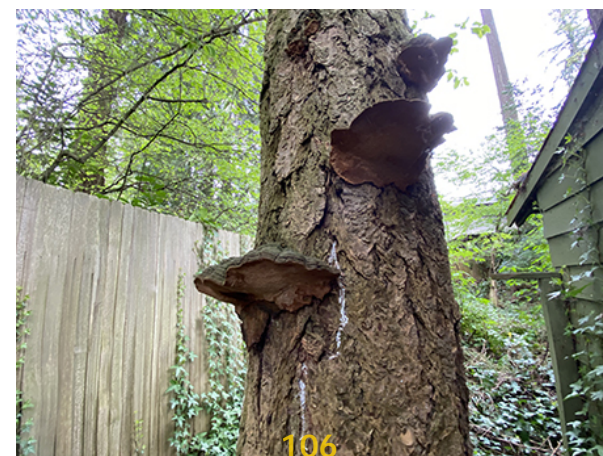
Right: Fruiting bodies or red ring rot on Tree #106 indicates significant internal decay.  
Removal recommended. Level 2/3 Risk Assessment completed on adjacent trees.

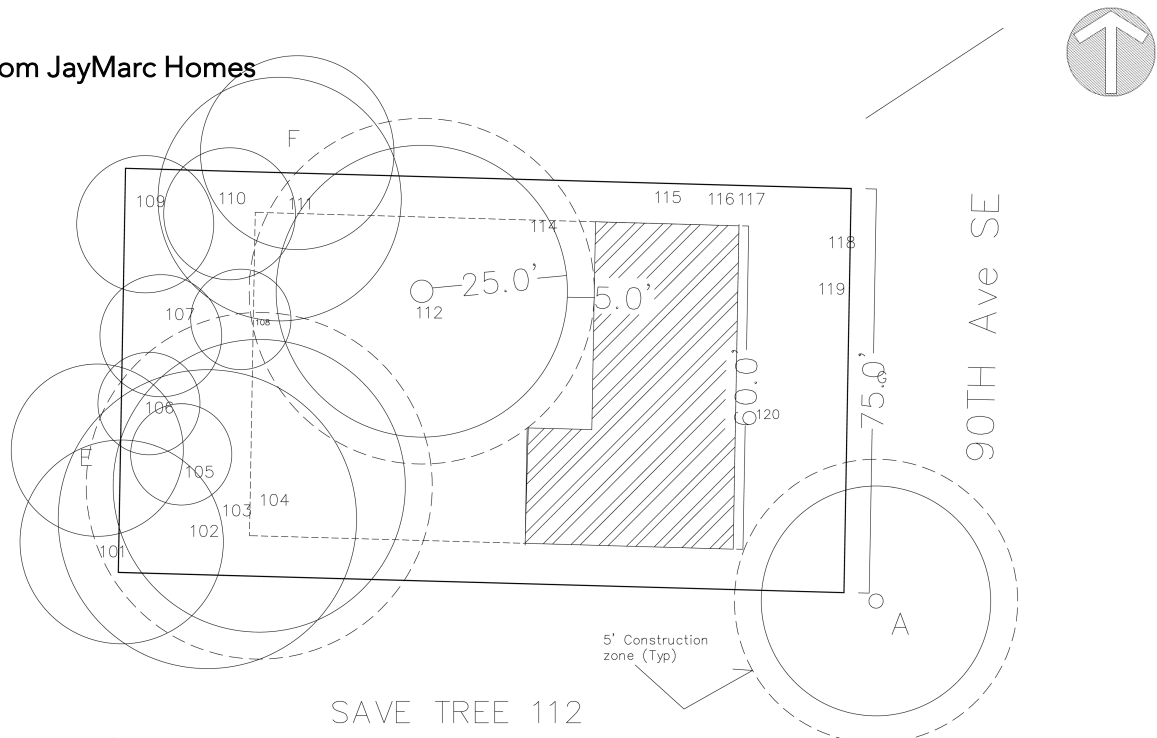
SAVE TREE 112

Tree Protection Zone set at factor of 6, or 25 feet, using Trunk Formula from ISA BMPs.  
 Dripline is 28 feet from trunk center.
