Arborist Report

To: JayMarc c/o Rob de Clerk
Site: 3745 77th Ave SE, Mercer Island, WA
Re: Tree Inventory
Date: February 4th, 2022
Project Arborist: George White
ISA Certified Arborist #PN-8098A
ISA Qualified Tree Risk Assessor
Reviewed By: Joseph Sutton-Holcomb
ISA Certified Arborist #PN-8397AM
Municipal Specialist, ISA Qualified Tree Risk Assessor
Referenced Documents: Preliminary Site Plan: Piha Residence (JayMarc Homes 1/31/2022)
Attached: Table of Trees
Tree Site Map

Table of Trees
3745 77th Ave SE, Mercer Island, WA

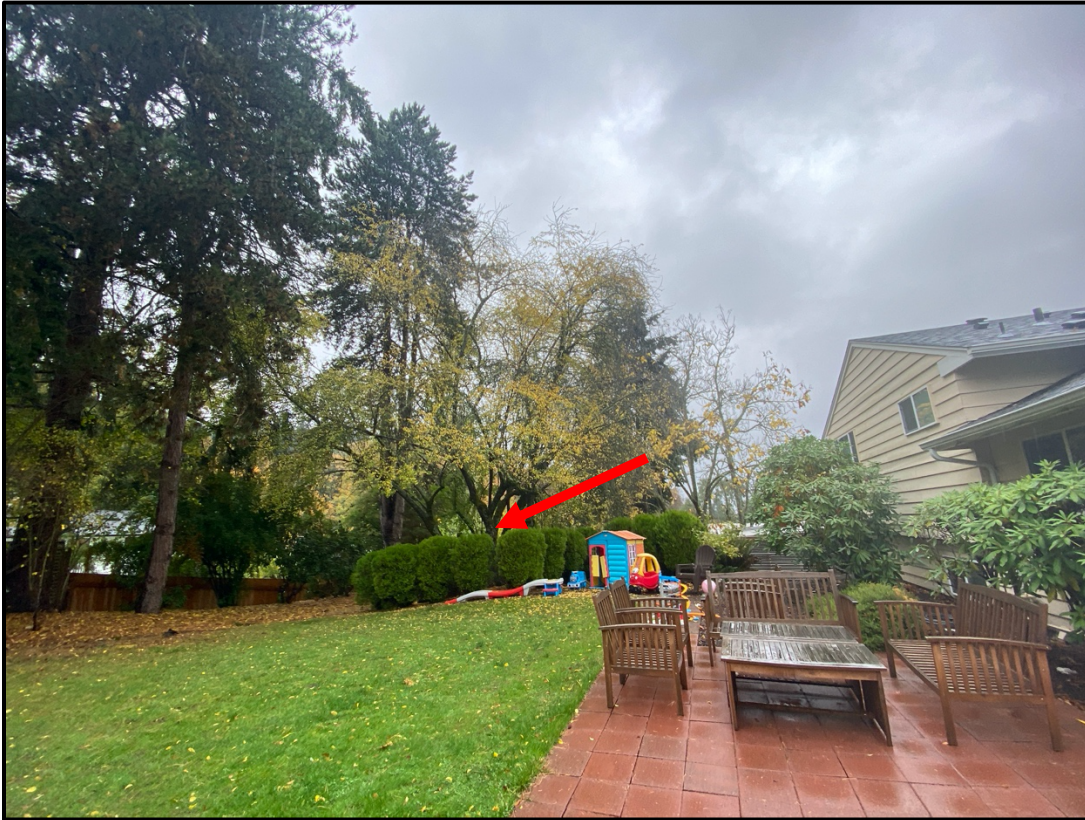
Tree 257 is a 27-inch common buckthorn that is currently proposed for removal (See photo 1). The city of Mercer Island prioritizes trees with a DSH greater than 24 inches for retention. MIMC 19.10.020 requires that this tree must be replaced with three trees planted on site or in the adjacent ROW.

Photo 1. Backyard trees. All trees to remain except tree 257 (indicated with red arrow).

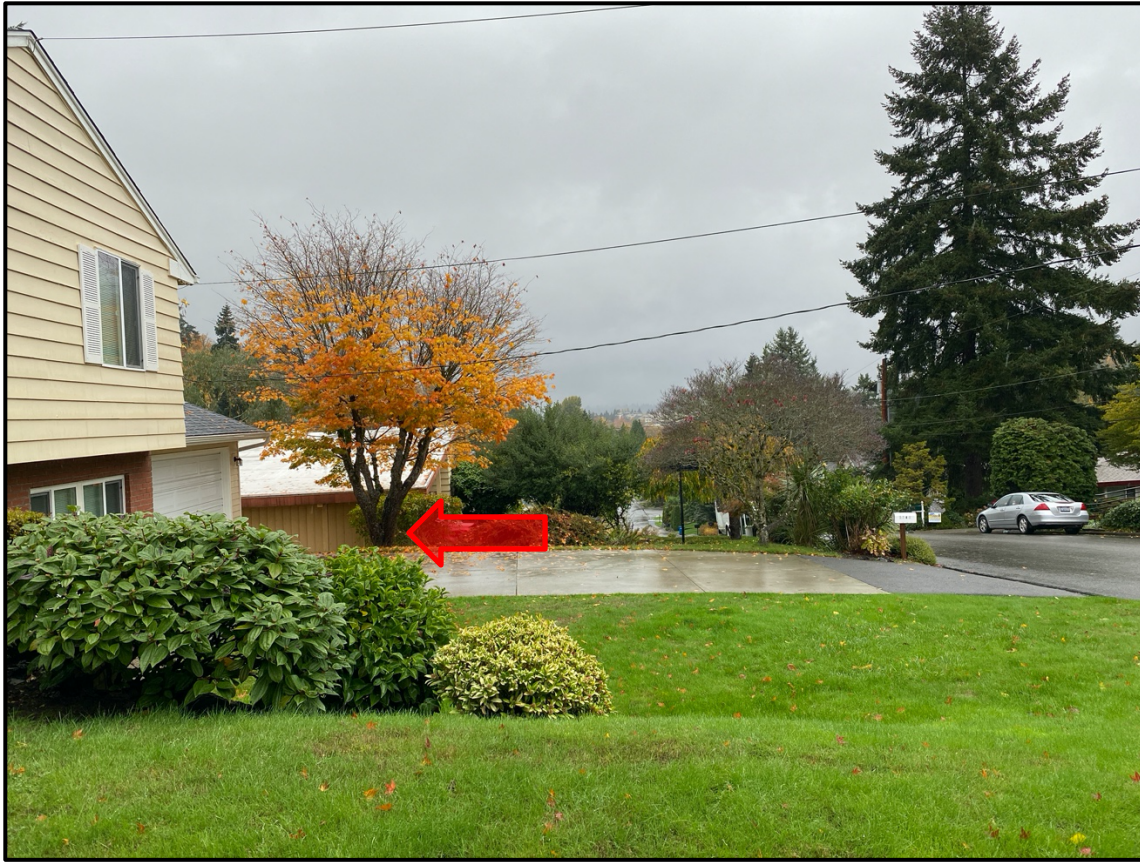
Tree 256 is an exceptional Japanese maple currently proposed for removal (See photo 2). because the footprint of the tree conflicts with the over-excavation and clearance needed to build the proposed garage on the northeast corner of the proposed structure.

Photo 2. Tree 256 (indicated with red arrow). This exceptional Japanese maple is in conflict with the proposed structure and is proposed for removal.

MIMC 19.10.070 requires that each exceptional tree removed as part of a development project must be replaced with six new trees. The trees must be planted on site or in the adjacent right-of-way (ROW).
