Re: Steinborn Project 8435 SE 47th PL, Mercer Island, WA. Permit 2202-225

Project Arborist: Neal Baker ISA Certified Arborist PN1075A since 1990 with the TRAQ qualification obtained when the PNW chapter of the ISA transferred from the TRACE qualification to the ISA International adopted TRAQ program.

8435 SE 47TH PL, MERCER ISLAND, WA 98040

ARBORIST TREE PLAN

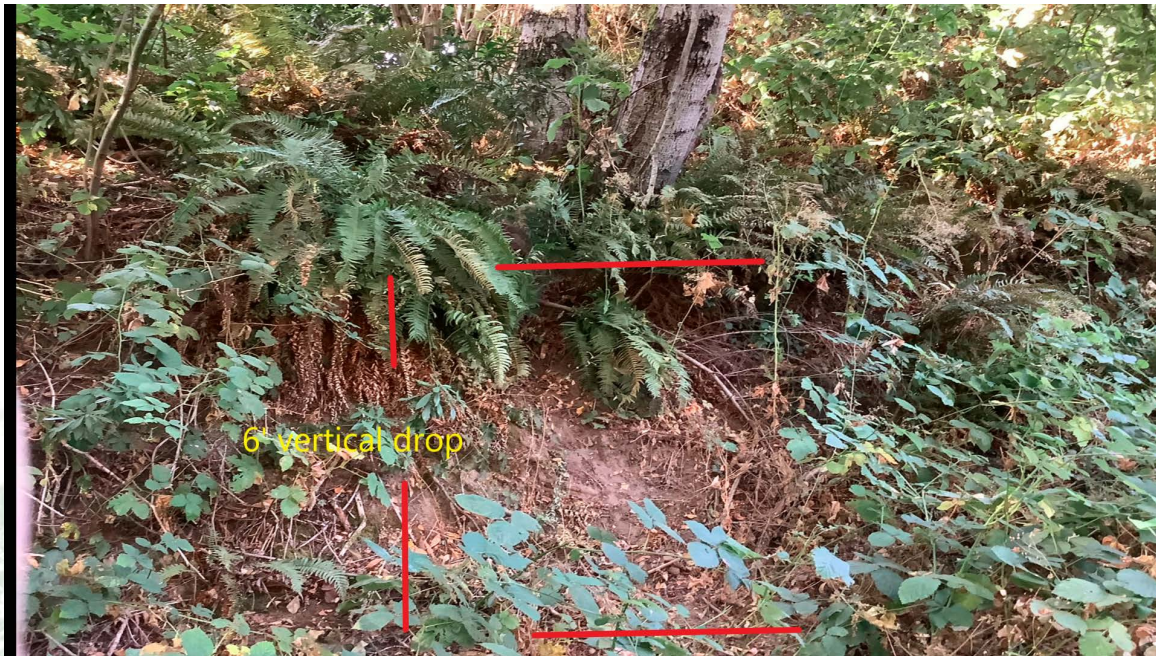
Item 5, All the trees on site are viable short of those needing to be removed for actual construction. Tree 22 is the exception as it is perched on the side of the slope, having grown out of the hill at an angle/lean to get sunlight as larger Douglas Fir trees dominate it. It is conceivable that this tree will eventually fall to the interior of the lot, pulling its root system out of the slope. All the weight of this tree is toward the south and the root structure to the north, with the stump being undermined. Note earlier comment on existing high levels of soil compaction findings. Note attached picture.

T 22 picture of 6' vertical drop at very edge of stump
