June 1, 2021

Project: Tree review and assessment at 8480 85th Street SE, Mercer Island, WA.
Parcel number 0736100155.

Objectives: Evaluate health of existing trees and establish criteria for the preservation of those to be retained.

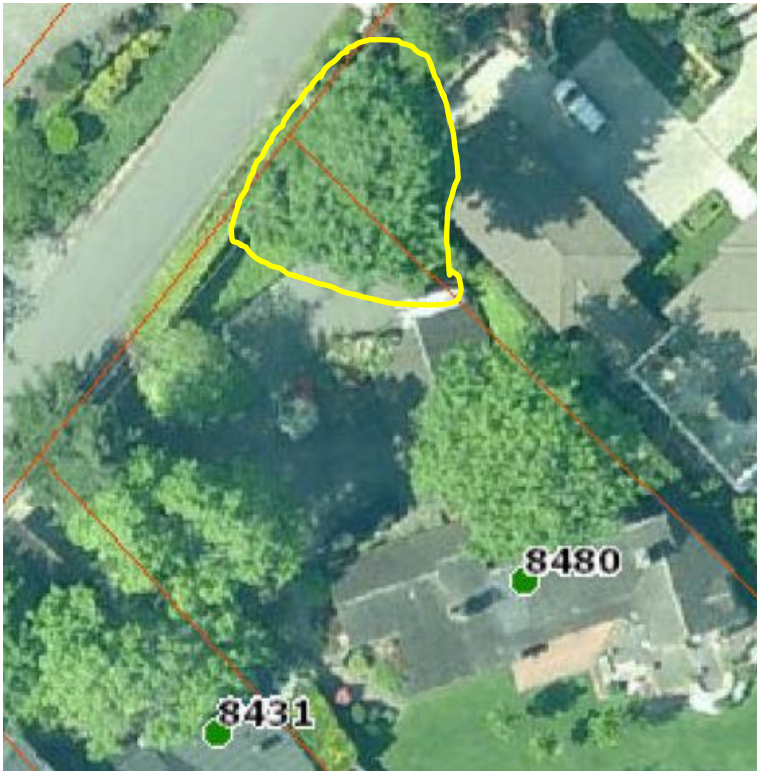
6) Bigleaf maple standing 6' W of the sport court wall, 3' S of its of its NW corner. Tree had been dual stem but at some point between 2009 and 2013 the east section failed and/or was removed (Figures 5 and 6). The remaining trunk is 27" DSH. It goes to 10' and then bends nearly horizontal to the south (Figure 7). The stem reaches out about 8' before turning back toward vertical. It straightens out between the 20' and 24' level and eventually gets to 65' tall on a handful of large scaffolds. The majority of the canopy is in the NW quadrant with only a quarter or so occupying a single spar on the north side as shown in Figure 8. The color is good and the new growth is at least average. As much as half of the limbs on this tree have been removed as indicated by the pruning scars. There is a significant decay point 6' below the main separation point in the column identified by the birds going in and out of it.

Figure 5. Aerial circa 2009 showing the conformation of the #6 maple's canopy (circled).

Recommendations: Based on its condition and placement the #6 maple should be removed along with the #1, #2 and #9-11 trees during the demolition or clearing and grading stages of the project.

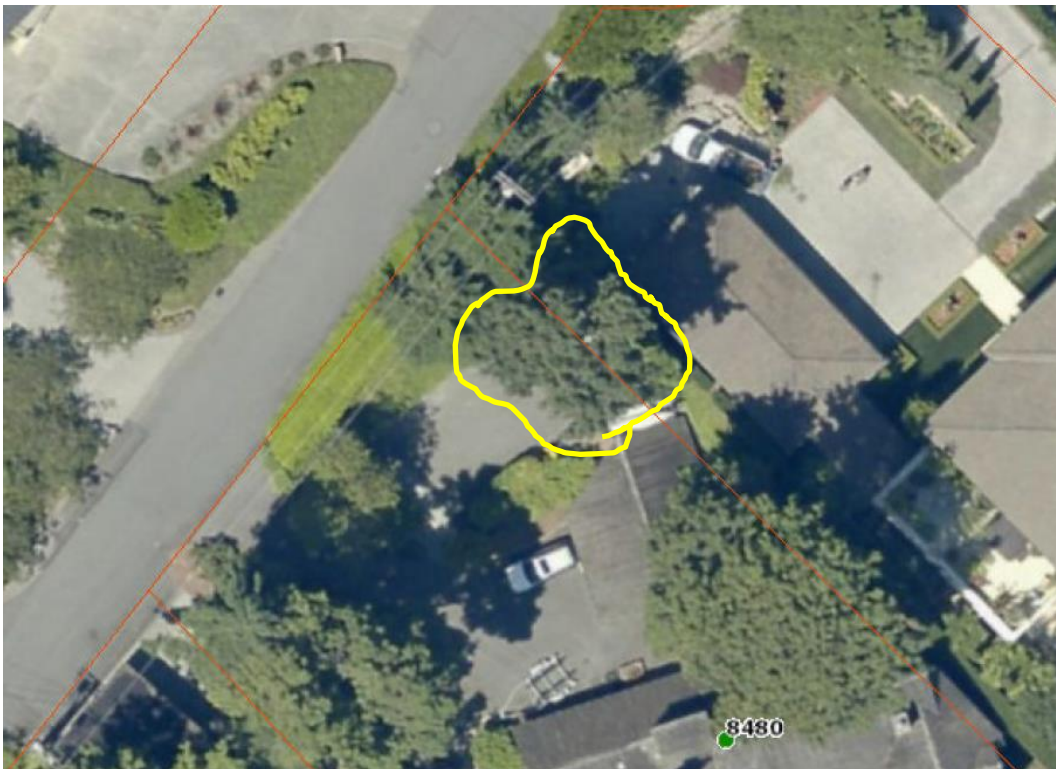
Figure 6. Aerial circa 2013 showing the changes in the #6 tree.

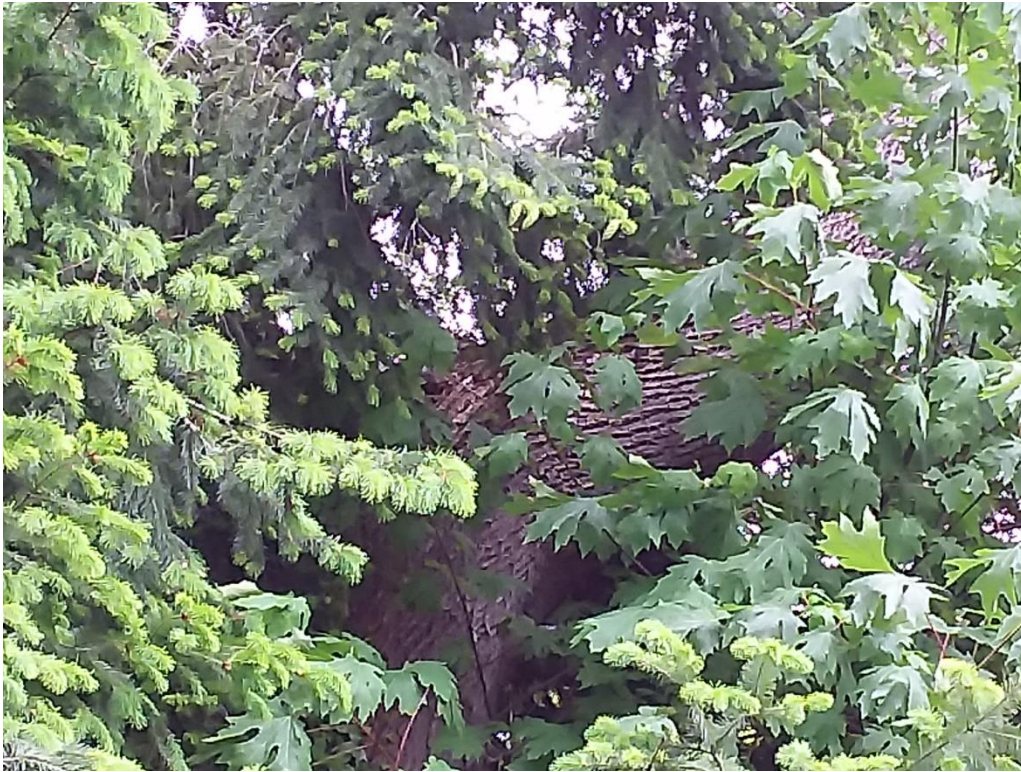
Figure 7. Looking at the bend and horizontal section of the #6 tree's trunk.

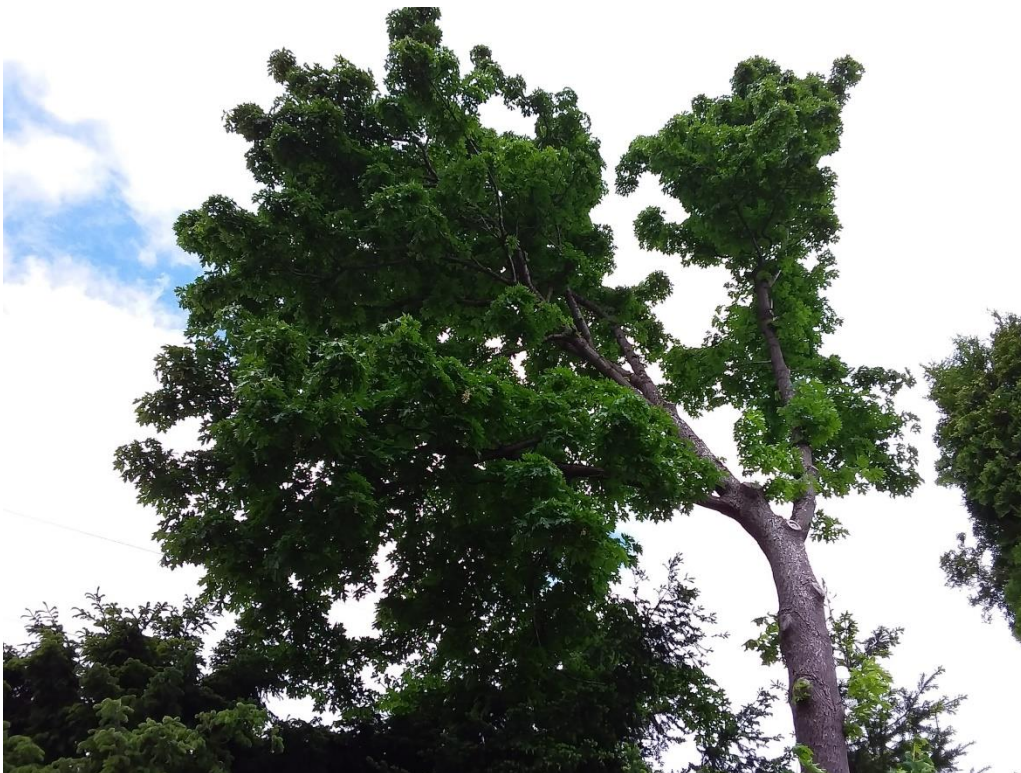
Figure 8. Looking up and to the west at the canopy of the #6 maple. Note how one-sided and rather flat the aspect is.

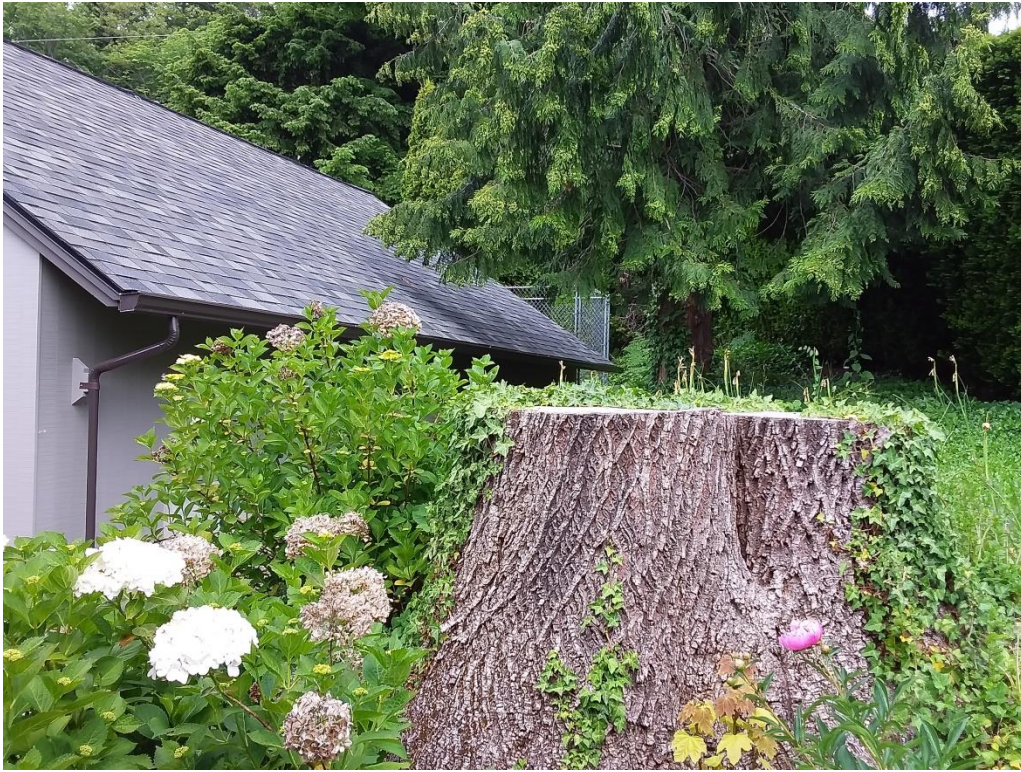
There is a large maple stump sitting in the north corner of 'T' (Figure 9). This tree shows as being present in the 2019 aerial image on which the tree plot is overlaid but it is indicated as stump on the survey plan that bears a November 2019 date. Hence it was removed at least a year before the current owners took possession. The circumstances of its removal are not known.

Figure 9. Maple stump in the corner of the house and garage. This tree shows as being present in 2019.

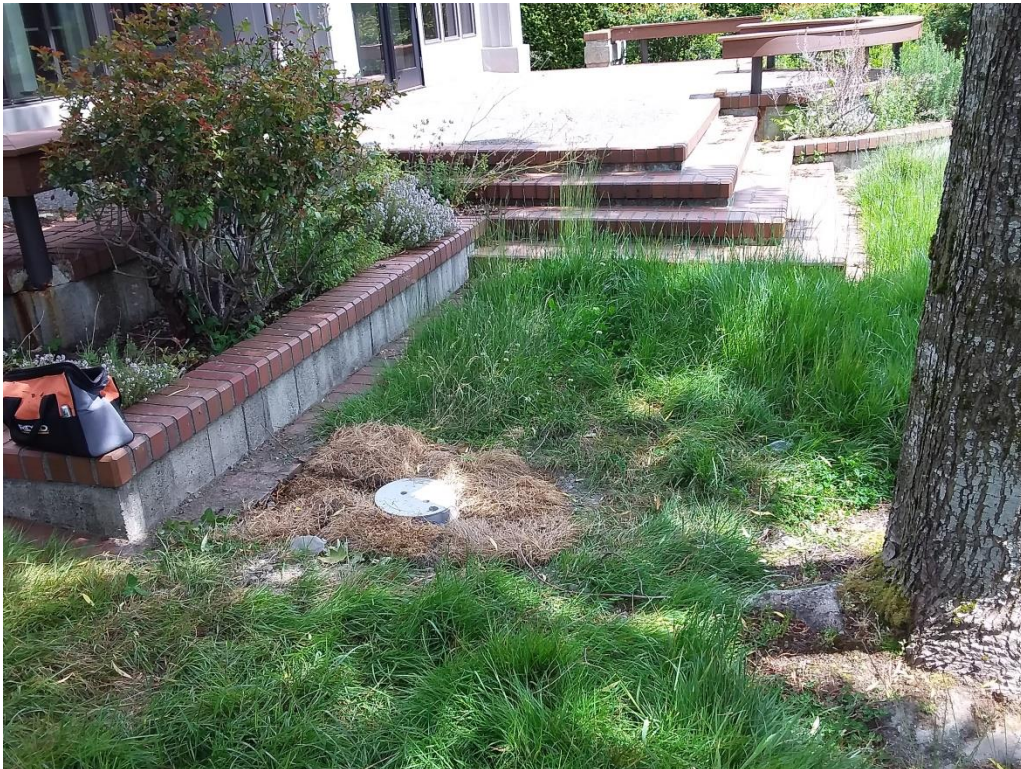
9) Columnar Norway maple (*Acer platanoides* 'Columnare') 17" DSH, 45' tall, 12' radial spread. Tree stands almost in a corner of the existing rear concrete patio. It's 6' E of the outer planter wall and 8' S of the steps (Figure 10). Tree exhibits fair health but has the heavy root crown plate and associated girdling roots common to the species (Figure 11). This tree and its sisters were planted between 2007 and 2009 (Figures 12 and 13). It is likely the trees that had been present (Figure 14) were lost in the 2006 winter storm. The #9-11 maples may have been planted as replacements.

Figure 10. Looking north at the base of the #9 maple.

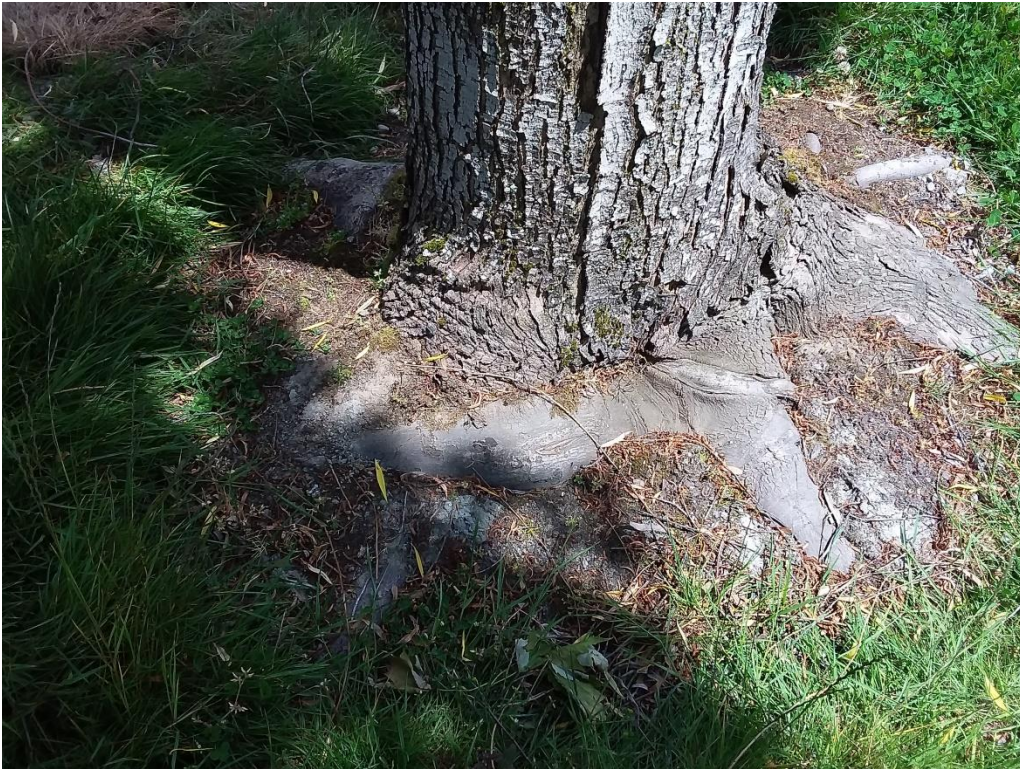
Figure 11. Looking at the plating and girdling roots present at the root crown of the #9 tree.

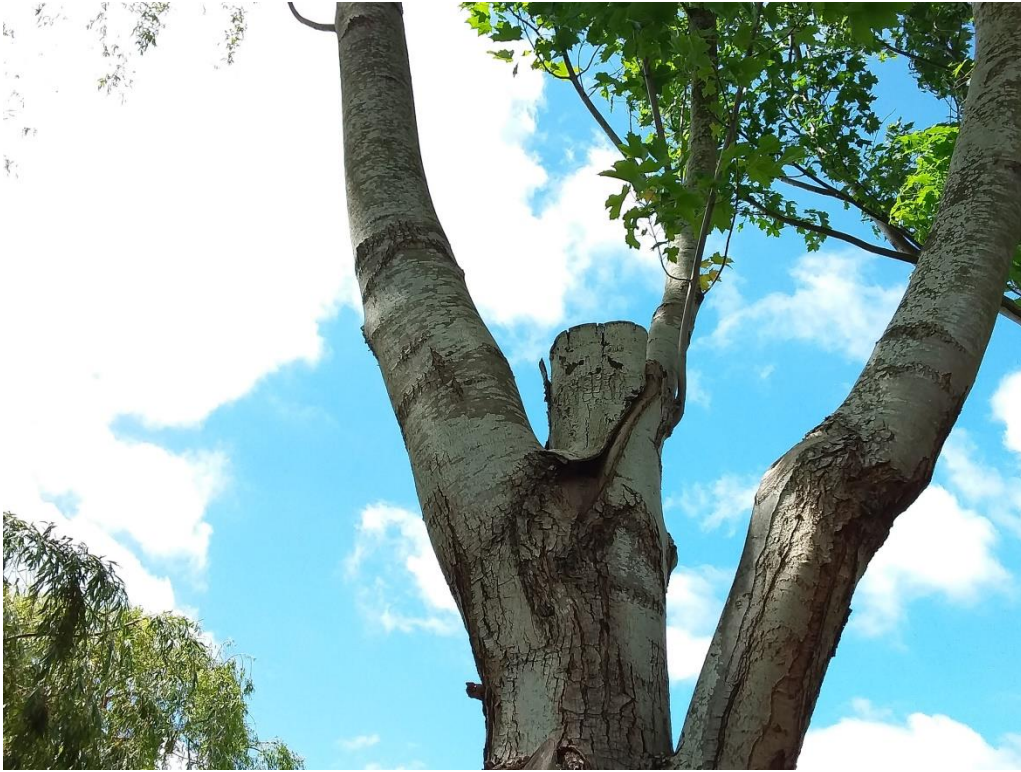
10) Columnar Norway maple 10" DSH, 45' tall, 9' spread standing 13.5' S of #9. This one is more stunted and has a large center stem that died and/or broke out (Figure 15). It also has the girdling roots present (Figure 16).

Figure 15. Looking at the stub of the missing section of the #10 tree

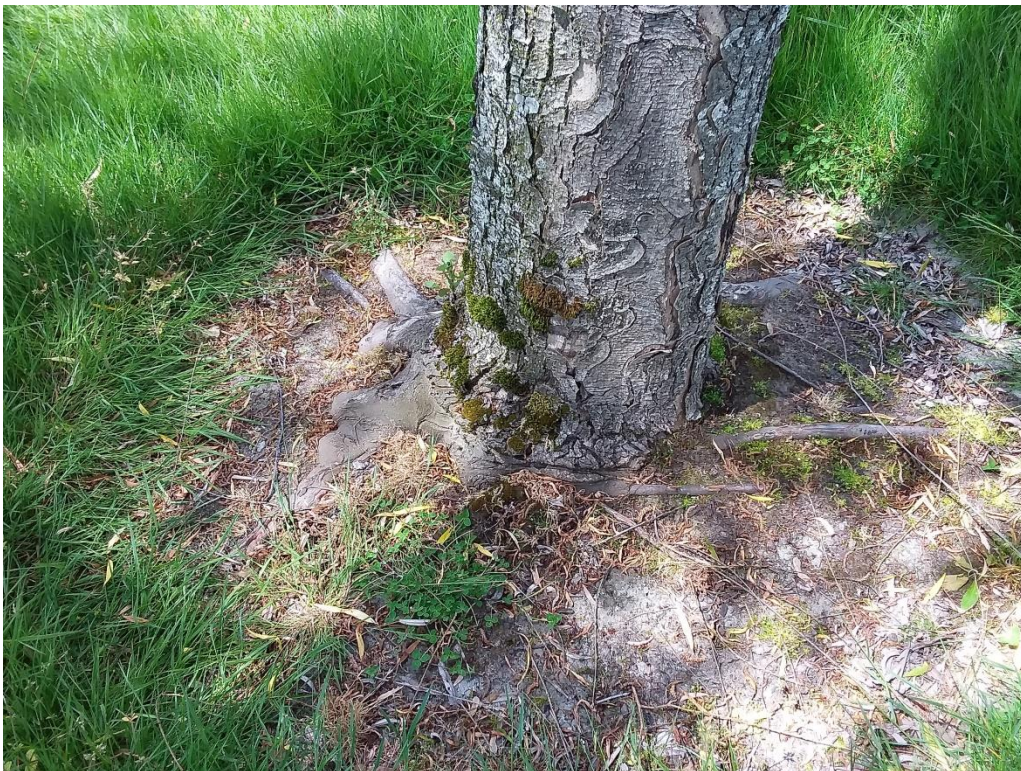
Figure 16. Looking at the base of the #10 maple.

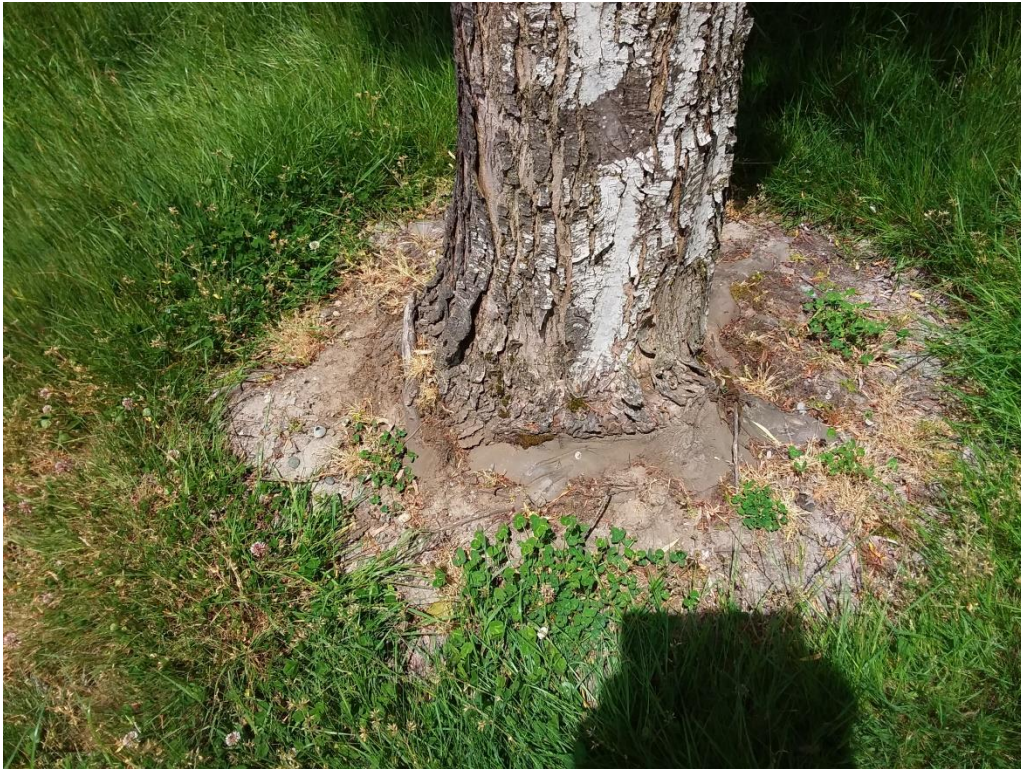
11) Columnar Norway maple 14" DSH, 45-50' tall, 9' spread in fair health. Has more pronounced girdling at the base (Figure 17). Tree stands 11' E of the house foundation and 10.5' SW of #10. The brick work for the stairs at the south end of the patio comes to within 7' of the maples base in its NW quadrant.

Figure 17. Base of the #11 tree. Large girdling root is quite noticeable.

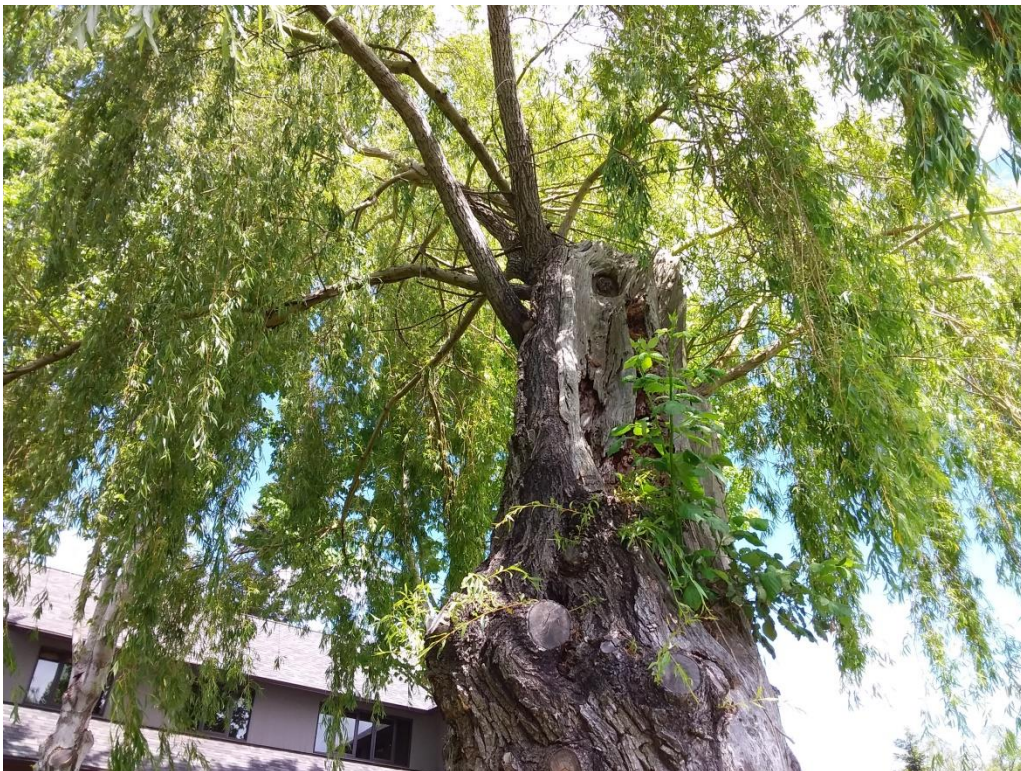
12) Weeping willow (*Salix babylonica*) stub 18' tall, 50" DSH, with epicormic shoots that reach another 10-15' above the break point (Figure 18). The tree has advanced decay from base to stub crown as shown in Figures 19-21. The large exposed surface roots also show extensive rot present (Figure 22). It is highly likely that the entire willow collapsed during the 2006 storm. Figure 14 shows a quite large canopy presence at this tree's location in 2002 and then just a dot in its place in 2007 (see Figure 12). The largest viable section of the existing canopy comes off the very tip of the north face of the tree and has no more than 8" of viable wood supporting it at that point (Figure 23). The tree stands within 15' of the seawall in the SE corner of the yard. Size notwithstanding this is in no way an Exceptional tree.

Figure 18. Looking up into the canopy of the #12 willow.

Fencing can be set in a 20' radial circle around the #12 willow. This will both protect whatever remnant roots the tree has and ensure no workers have a heavy shoot land on them.

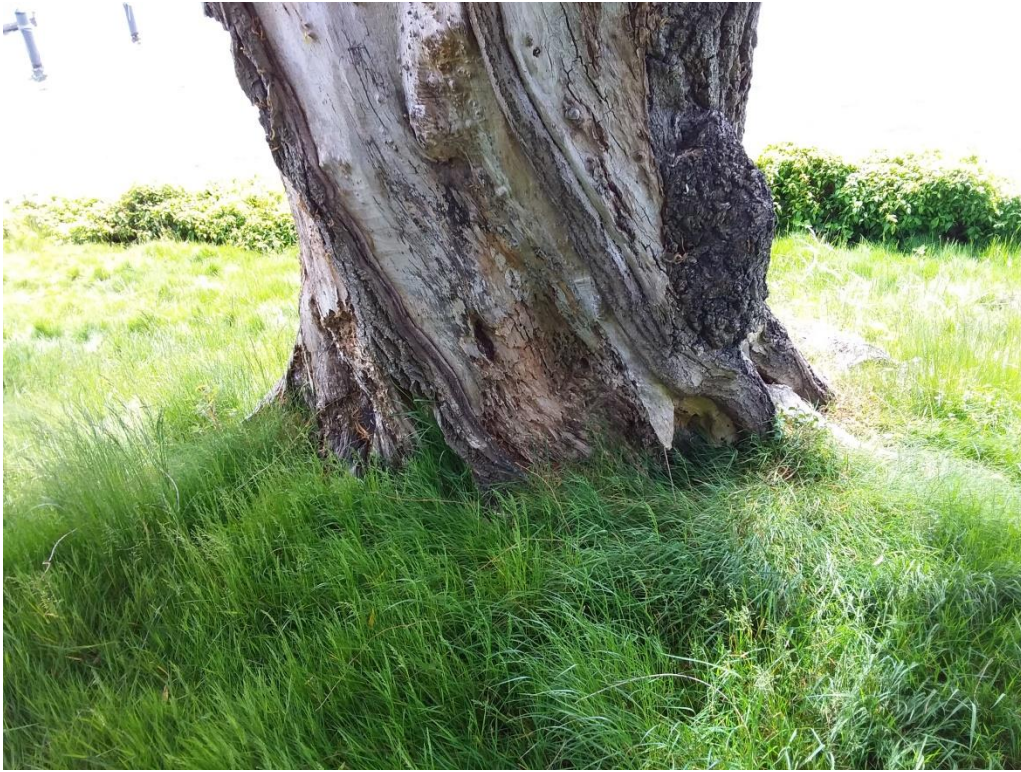
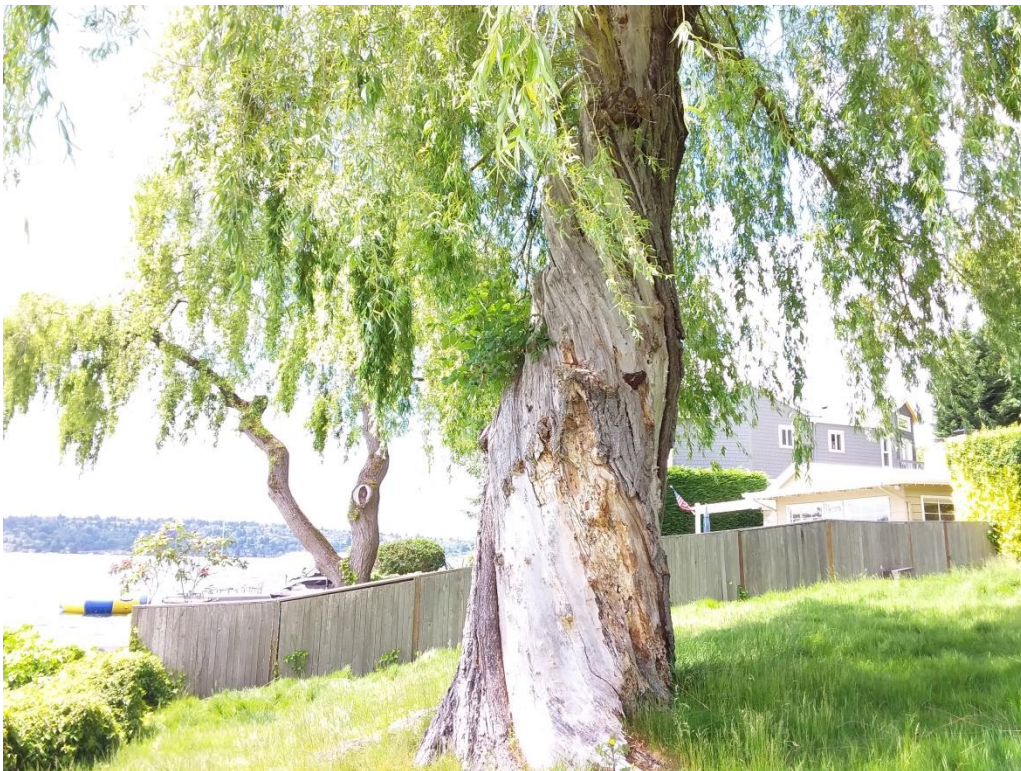
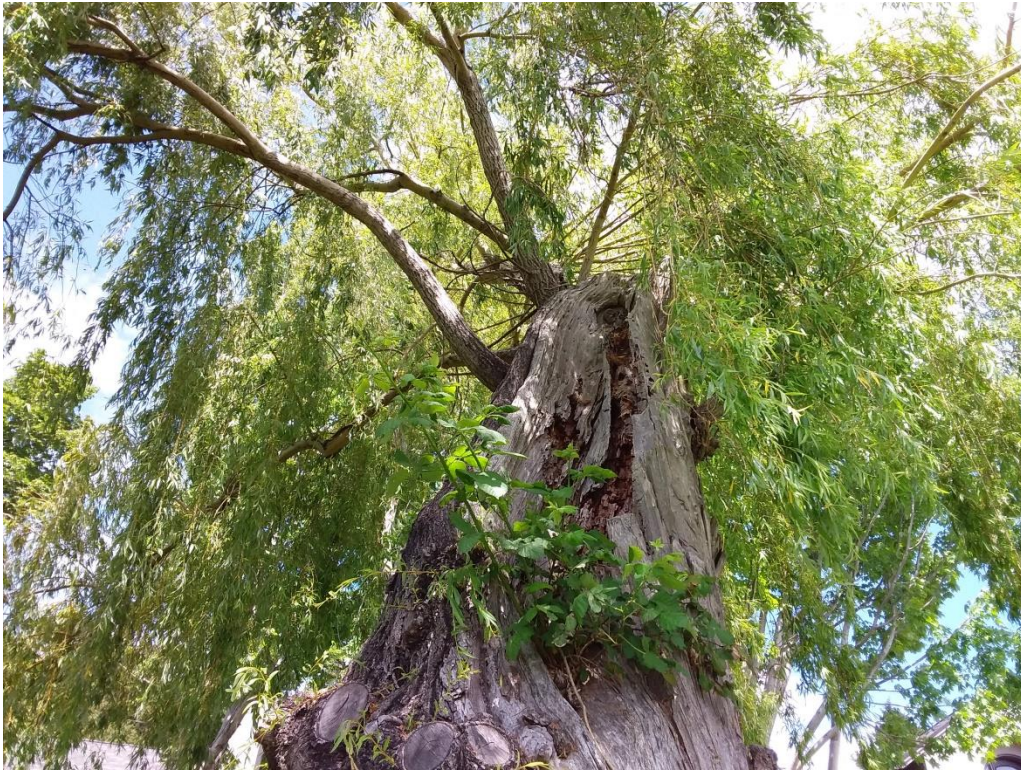
The willow is currently, and has been for some time, failing. Its structural integrity is completely compromised by the decay destroying the vigor of the wood tissue and the significantly compromised holding power of the epicormic attachments. Currently the material on the willow has no targets in reach. Even if the tree failed at the base and fell directly at the existing house only the tips of the tallest shoots would have a possibility of reaching the house. This makes the tree currently **unlikely to fail and impact** making this tree a **low risk** for both partial and catastrophic failure.

Figure 19. Looking at the base of the #12 willow.

Figure 20. The lower column of the #12 willow.

Figure 21. Looking at the extensive decay present in the upper column.

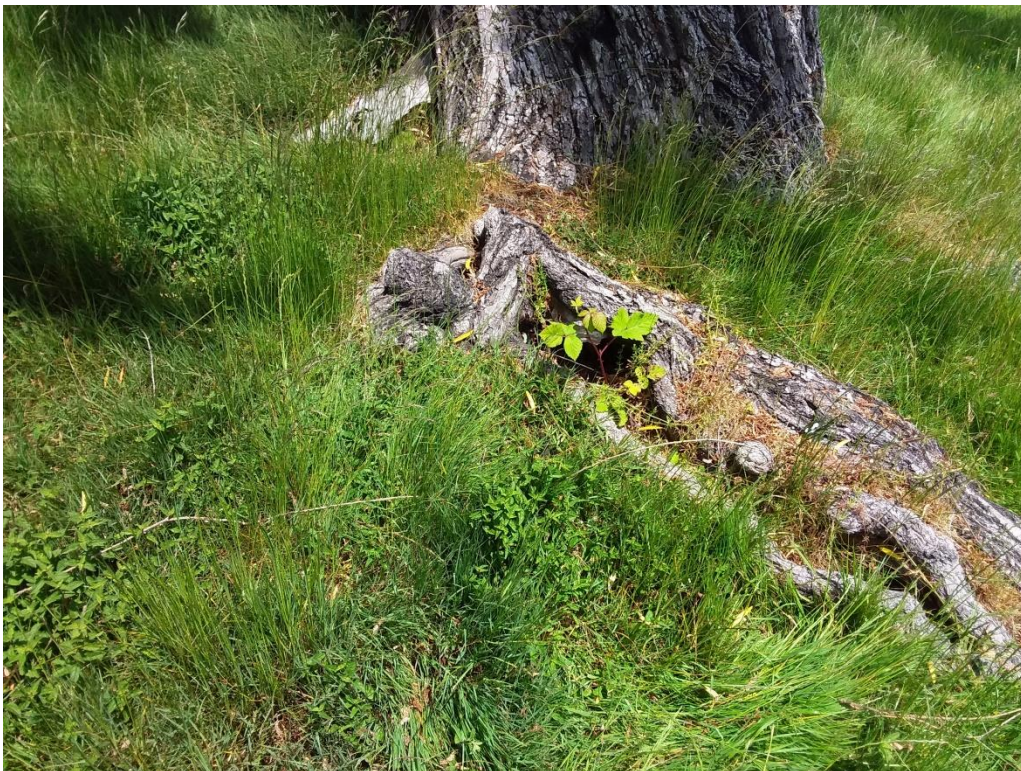
Figure 22. The atrophy and decay present in the #12 structural roots.

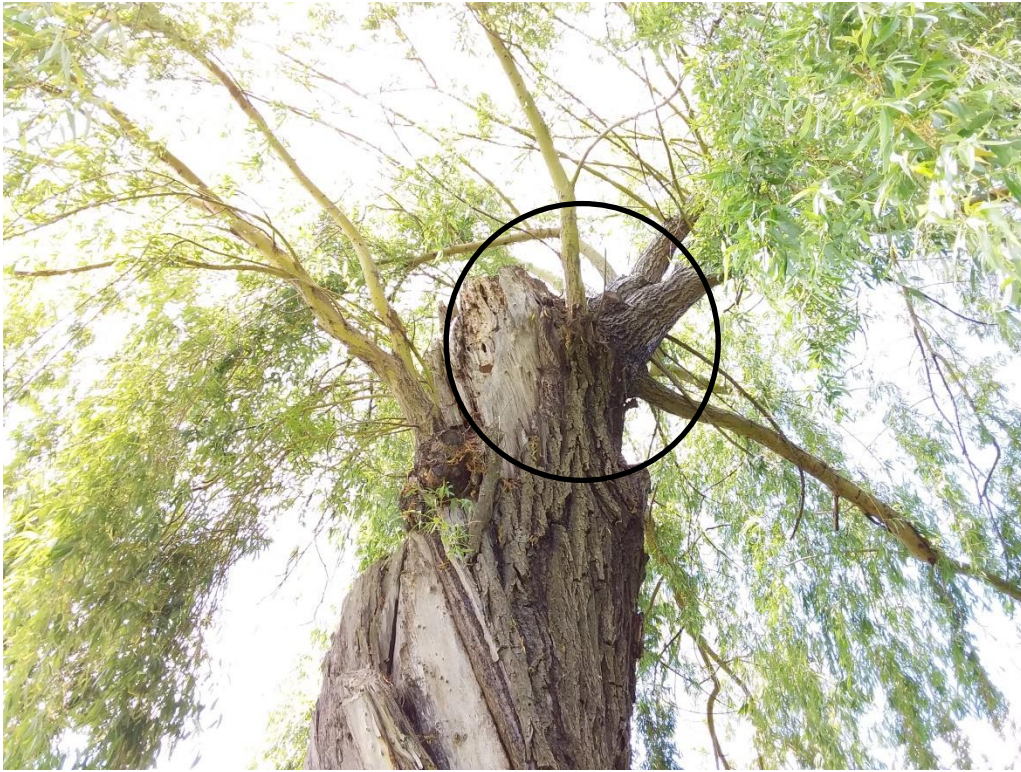
The #3-5 firs, the #6 and #13 maples, and the #12 willow have **probable likelihoods of scaffold or large limb failures** in the 4-8" caliper range. The firs have been topped repeatedly creating a weakened central attachment and over extension of the branches. Both maples have had breakouts at several points already and their scaffolds are carrying too much end weight. They have amorphous conformations leaving single leaders highly exposed. All the material on the willow is quite weakly attached to barely viable sections of live wood.

Figure 23. Extremely weak attachment point of the largest shoot on the #12 tree.

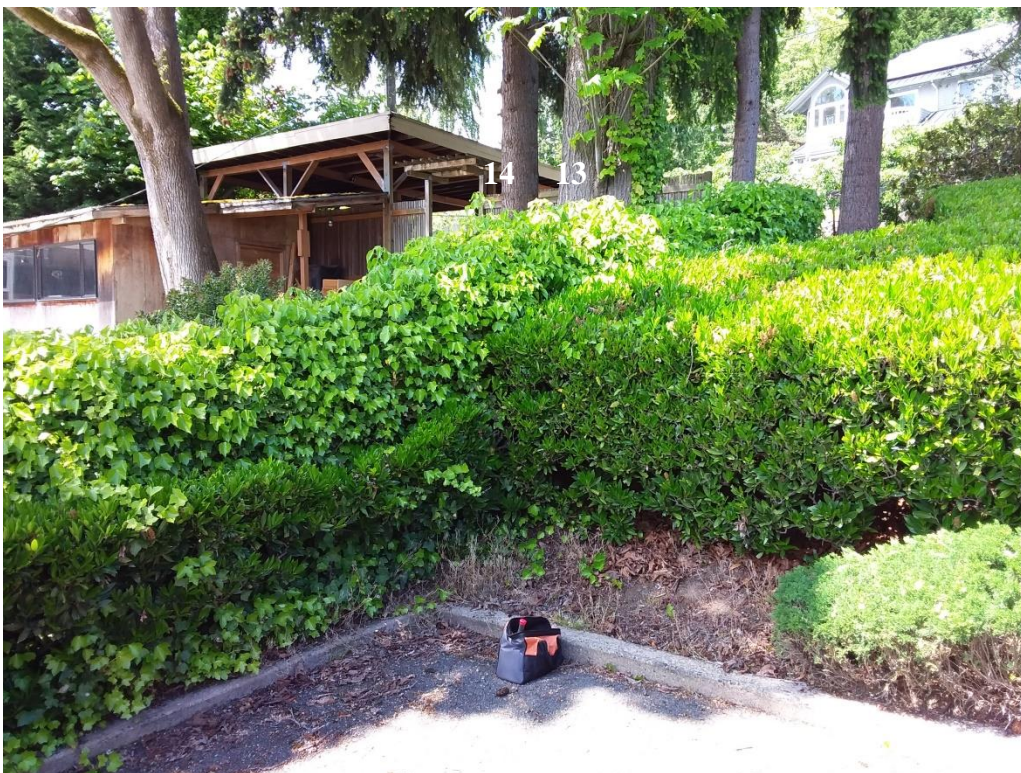
13) Big Leaf maple 32" DSH, 65-70' tall, with a mixed spread width. The tree stands 12.5' WSW of the SW corner of the driveway hammerhead/parking space (Figure 24). Sighting from the SW property corner marker the tree appears to be on or just over the south property line. The survey shows it straddling the line (Figure 25). The tree has large caliper deadwood throughout and the center stem has atrophied and/or broke out as shown in Figure 26. The maple separates into four main leaders at this level. Two of these stretch north over the subject property for at least 20'. A third goes nearly horizontal to the SW and the fourth hooks away from the die off point and goes vertical to form the uppermost canopy. There is epicormic sprouting along the lower trunk and a handful of smaller scaffolding branches below the separation point. Overall the tree is in fair health but exhibits a quite weak structural condition. There are signs of root uplift in the little hammerhead/parking space area and it is more than likely that these roots are from the maple (Figures 27 and 28). Exceptional by definition.

Figure 24. Looking SW at the base of the #13 maple. Note the #14 next to it.

The #13 tree is Exceptional and according to Mercer Island statute must be retained. This will necessitate somewhat of a re-conceptualization of where exactly the driveway entrance will be cut and how the SW corner of the new home will intersect with the proposed garage. To ensure its survival there should be absolutely no impact to the right (south) of the existing driveway. Ideally the asphalt covering the small hammer head would be carefully removed and the tree allowed that space for rooting purposes.

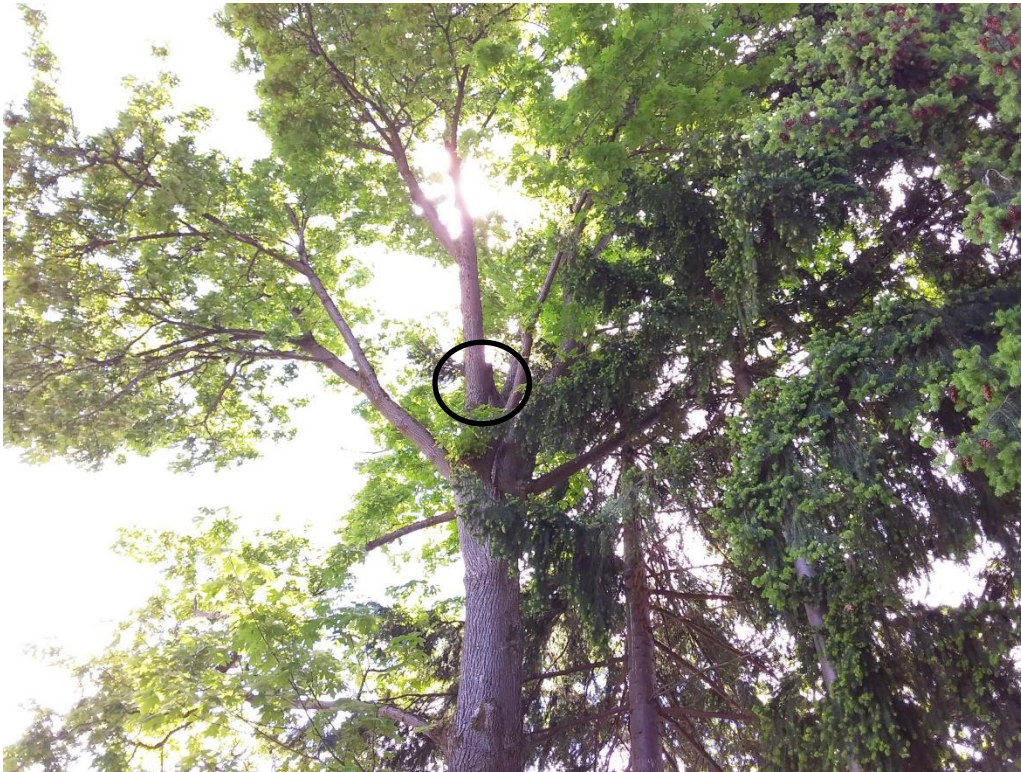
Figure 26. Looking up into the canopy of the #13 tree. The large breakout point is just visible (circled).

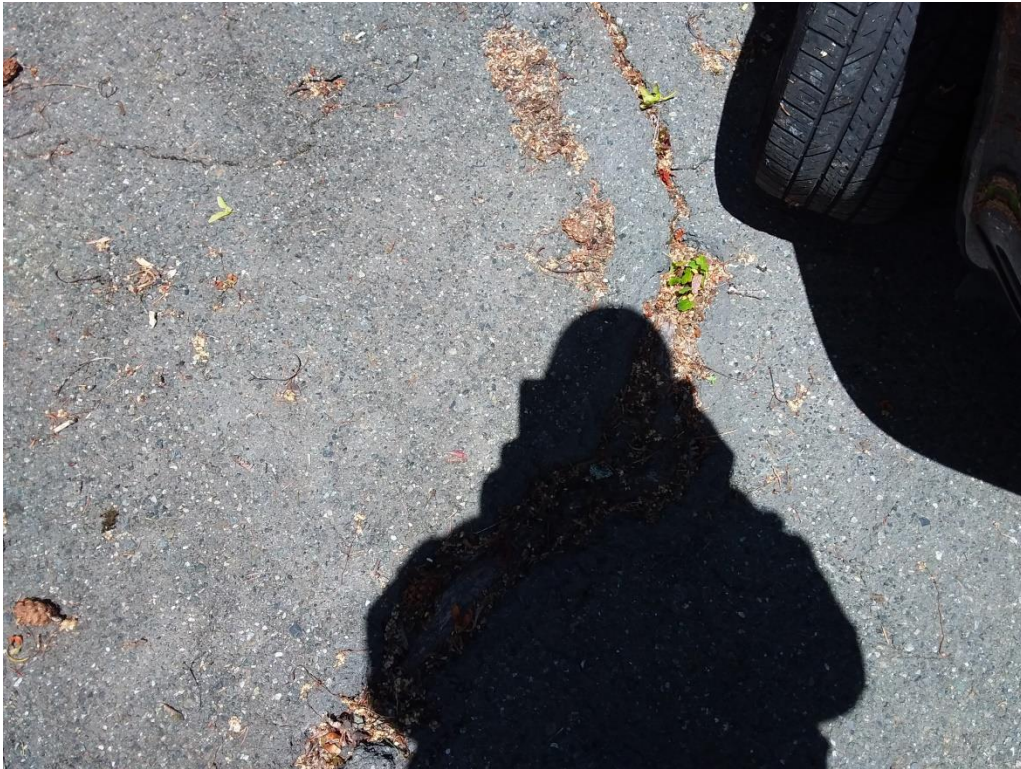
Figure 27. Uplift in the asphalt from the #13 maple roots.

The removal of the asphalt in the driveway should be done with an arborist present so as to document the extent of roots that are present beneath.

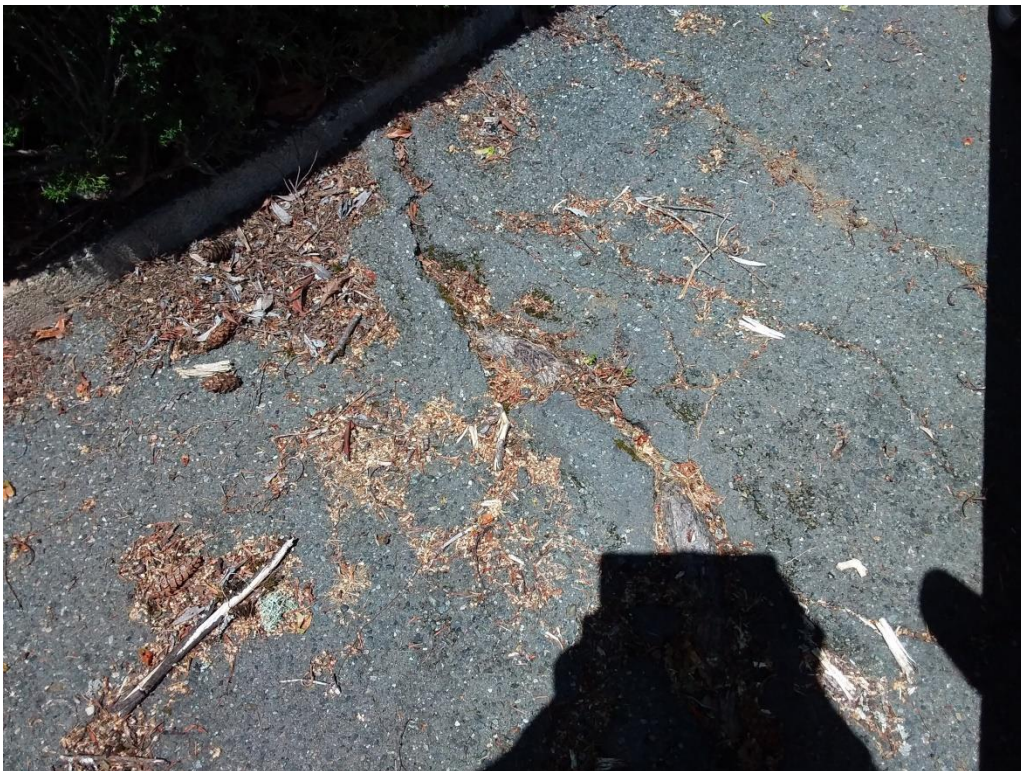
Figure 28. Another uplift point.

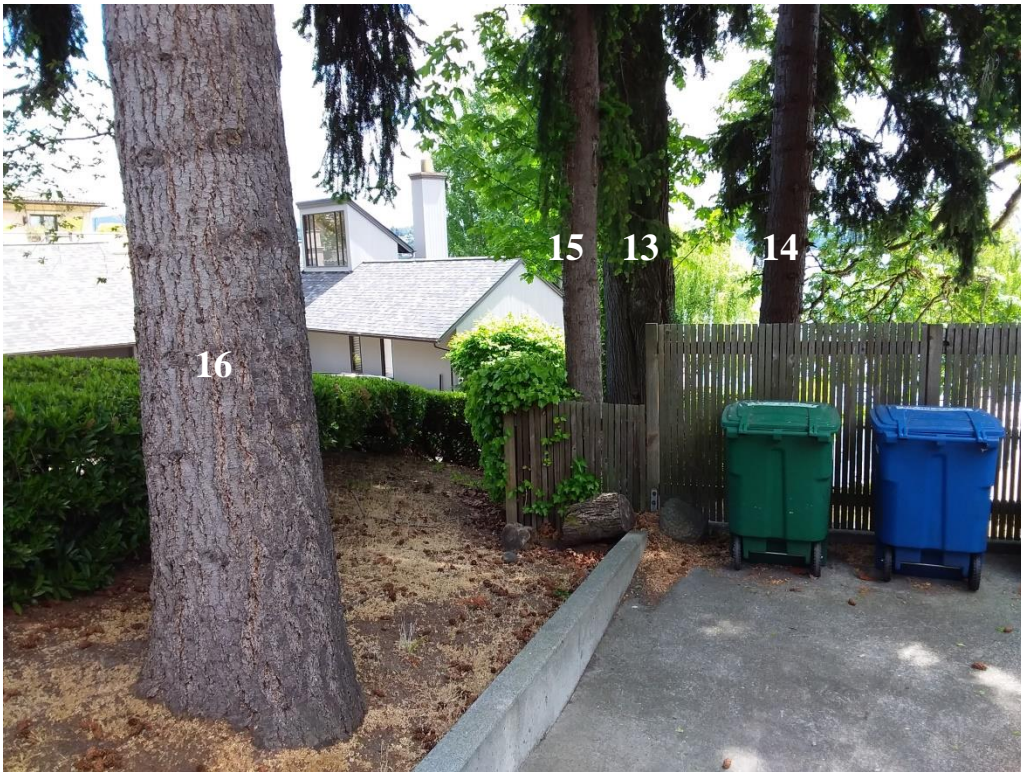
15) Douglas fir 10.5" DSH, 55' tall standing 12' W of the #13 maple and right at the corner of the 8431 parking spot (Figure 29). Fair health. Structure sub optimal because of growing up through the maple.

Figure 29. Locations of the #13-16 trees looking east from the neighbor's parking area.

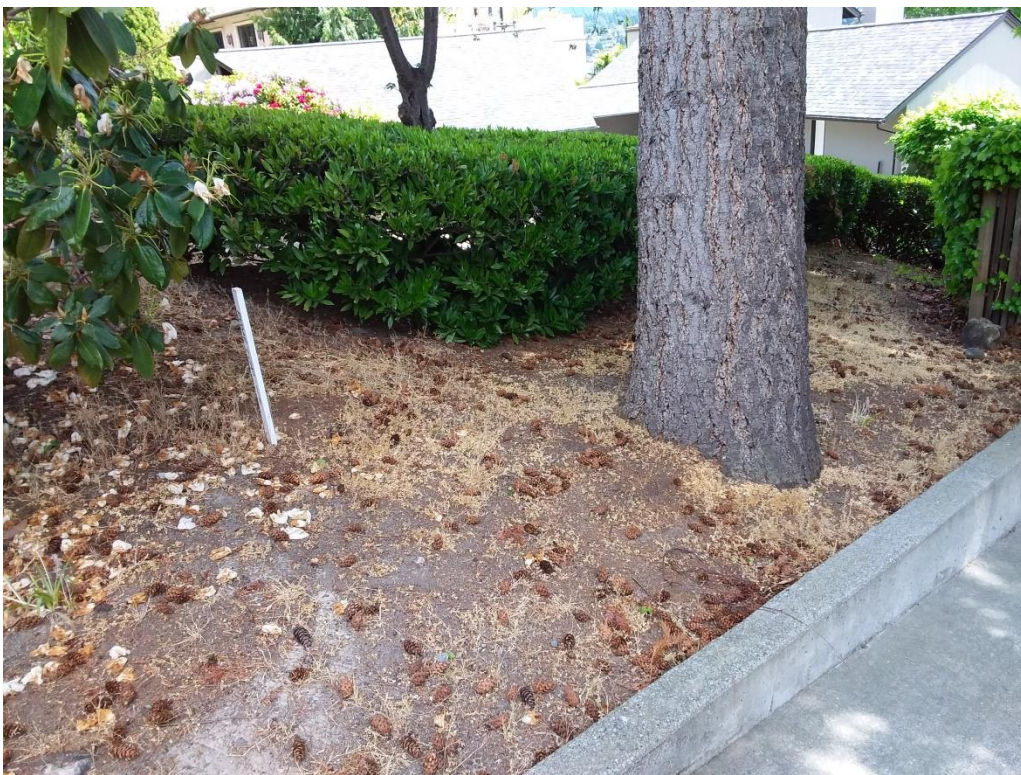
16) Douglas fir 22" DSH, 65' tall standing next to and just south of the SW corner marker (Figure 30). It is 14" N of the of the curb for the 8431 parking and 11.5' S of the curbing for the existing driveway entrance to the subject property (Figure 31). The current driveway curves to the south and intersects with 85th Avenue 15' W of the tree. It exhibits average new growth and color. The west side of its canopy has been notched to create clearance for the power lines.

Figure 30. Looking at the base of the #16 fir. Note proximity to the SW corner marker and the curb for the neighbor's parking pad.

At this juncture the #16 tree also has to be retained as it belongs to the neighbor. Like the #13 maple it must not experience any impact to its existing rooting space if it is to survive this project.

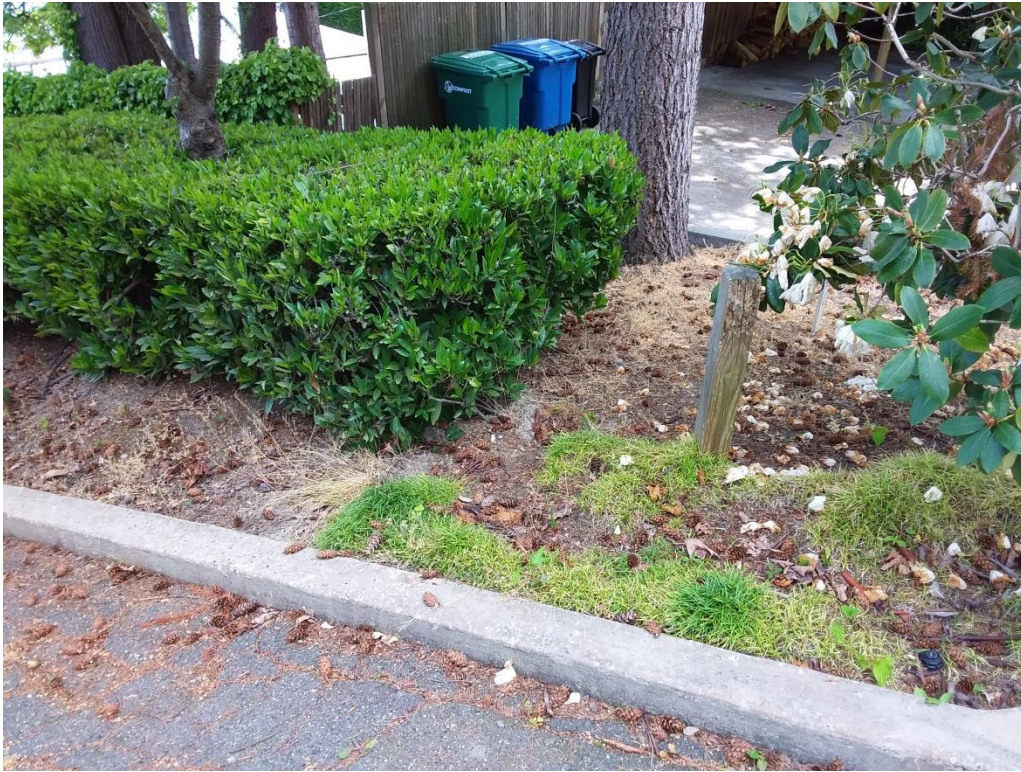
The #16 tree grew up in very limited rooting space and has adapted to its circumstances. The curbing along the subject driveway has most likely acted as a root barricade for this tree and prevented it from stretching into the asphalt of the existing driveway. The curbing to its south side definitely has prevented root growth in that area. Like the #13 maple its roots are highly likely to be much more concentrated within its available space than what is normally found. Any incursion within the space will result in an amplified impact.

Figure 31. Looking south at the base of the #16 tree showing subject curbing. It is only 11.5' away at the point.

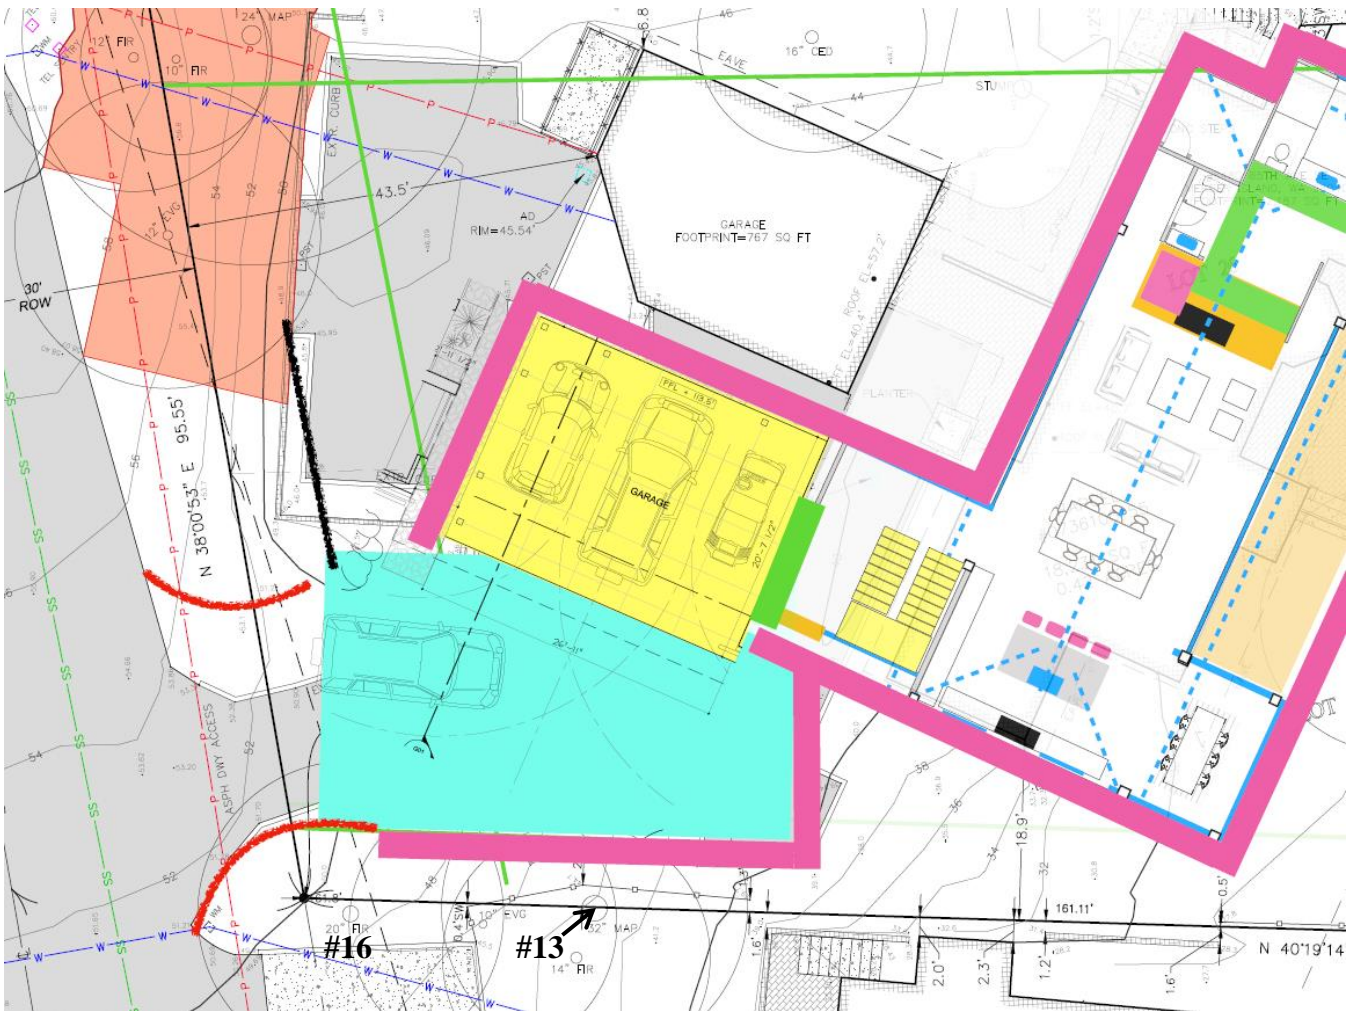
The #13 maple, at 32" DSH, has the full 10' SRP. As shown in Figure 35 the proposed limits of excavation come to within 4' of the base of the maple. This would necessitate its removal due to destabilization resulting in a high risk of catastrophic failure for the tree.

The #16 tree has a 9' SRP according to the table. As shown the excavation may come to within 5' of its base in the NE quadrant and the proposed curve for the driveway entrance will start 8' to its north resulting in potentially severe damage to the trees SRP.

Figure 35. Conception sketch of the proposed new home and driveway entrance. The heavy pink border represents the excavation limits. Tree #13 and #16 are noted to bring clarity of impact potential to the fore. The excavation cut will be as close as 4' to the #13 and 5' to the #16. This is within the 10' SRP non-intrusion region for the maple and the 9' SRP for the fir. Neither would survive this damage long term and both are likely to fail catastrophically in the short term.
