Tree Report

4045 W Mercer Way

August 27, 2020

Prepared By: Russell + Lambert
Mary Ellen Russell
WA Landscape Architect #1149
ISA Tree Risk Assessment Qualified
(206) 898-6312

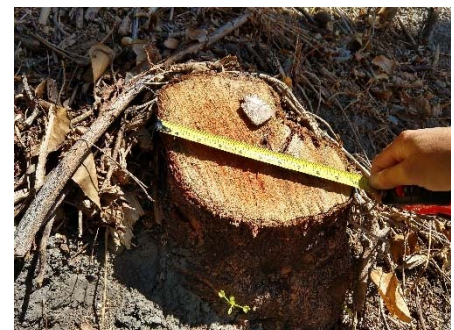
Stump A is 10" wide at its widest point. Since trees are wider at the base than at 4.5' from the ground, this tree would have been less than 10" DBH before it was removed.

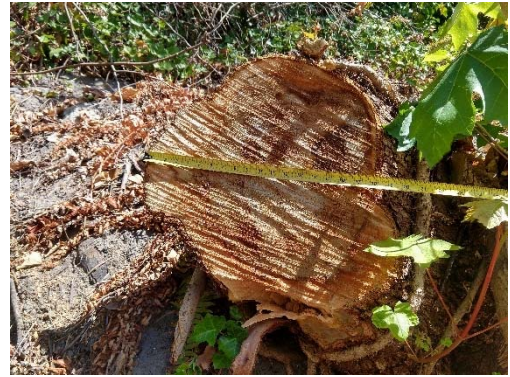
Stump B had (3) stems that measure 7", 8", and 20" at the base. This tree was larger than 10" DBH, with a maximum possible DBH of 23", (and likely several inches smaller). The largest stem emerges from the ground at a 45 degree angle toward the existing house. Aerial photography shows that this tree leaned far over the house. The uniformly poor condition of the other Bigleaf Maples on the site suggests that this tree was likely to have had decay and/or broken branches.

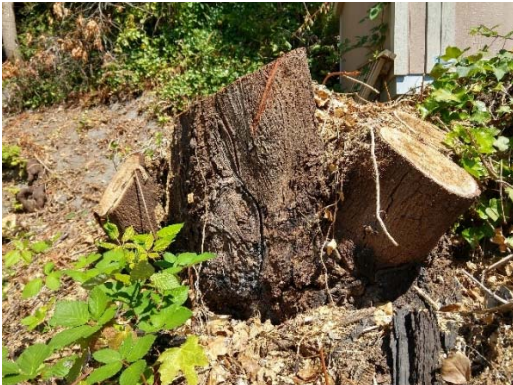
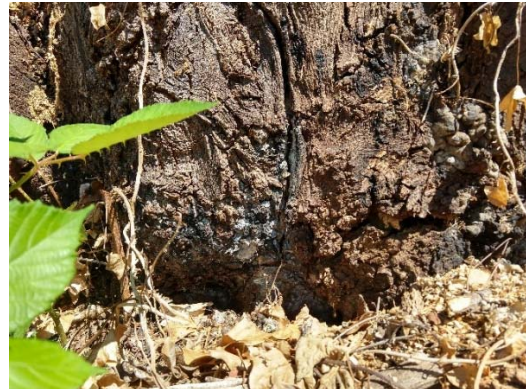
Stump C had (6) stems that measure 8", 10", (2) 11", 14", and 16" at the base. This tree was larger than 10" DBH, with a maximum possible DBH of 29", (and likely several inches smaller). This tree has extensive evidence of decay on the downhill side of the base including fungal fruiting bodies. This tree was in poor condition with a probable likelihood of failure within the next five years.

The largest of the removed trees, Stump C, was diseased with numerous fungal fruiting bodies at the base. The other (6) removed trees were cleared in order to allow equipment access to demolish the existing derelict house. In addition to being potentially dangerous, the house has no significant habitat value. Removing the house and invasive species on site and replanting the cleared area around the house with a diverse mix of native species will improve habitat value and enhance ecosystem functions on site.

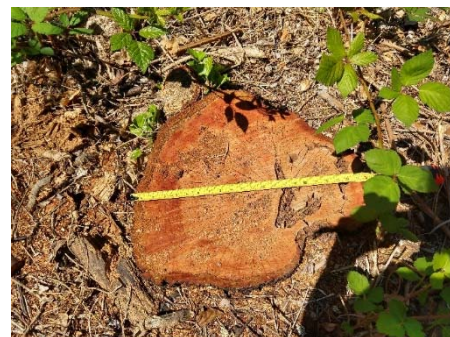
Stump D is 21" at the widest point of the base. This tree was likely greater than 10" DBH. Aerial photography showing the tree in bloom was used to confirm the species identification. There is no remaining evidence of its condition.

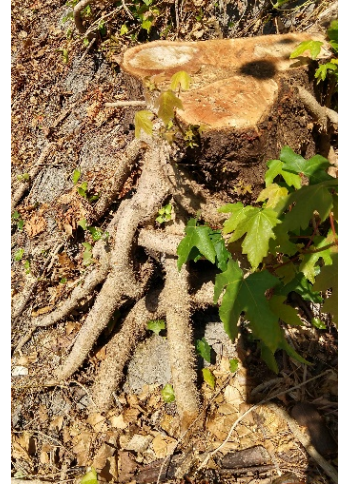
Stump E had (3) stems that measure 10" and (2) 9" at the base. This tree was larger than 10" DBH, with a maximum possible DBH of 29", (and likely several inches smaller). The stump is circled by the remains of thick English Ivy vines. The uniformly poor condition of the other Bigleaf Maples on the site suggests that this tree was likely to have had decay and/or broken branches.

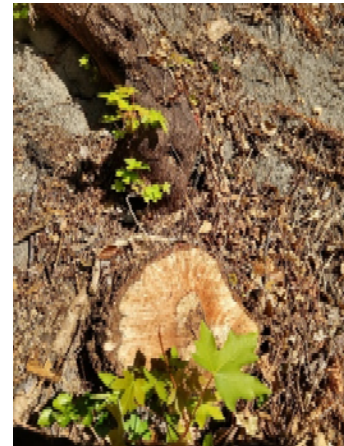
Stump F is located near a large swollen root extending from stump B and may be a sucker from the same root system. It measures 16" at the widest point of the base and emerges from the soil at a 45 degree angle down slope. The uniformly poor condition of the other Bigleaf Maples on the site suggests that this tree was likely to have had decay and/or broken branches.

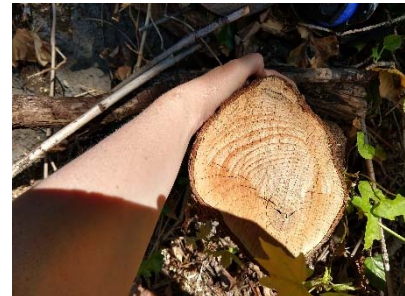
Stump G measures 9" at its widest point. This tree was a young Bigleaf Maple with a DBH less than 10".
