December 5, 2021

RE: Addendum to May 26, 2021 arborist report for Brindley PN 3206000050

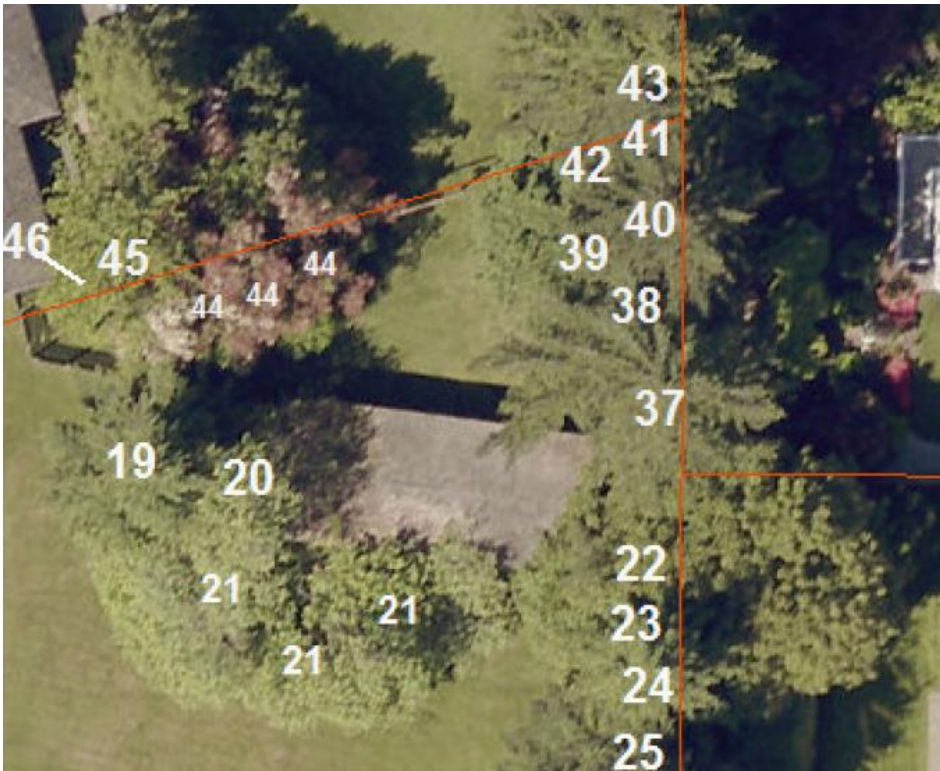
Figure 1. Tree plot for the NE corner. The #19-25 trees are listed and described in the original report.

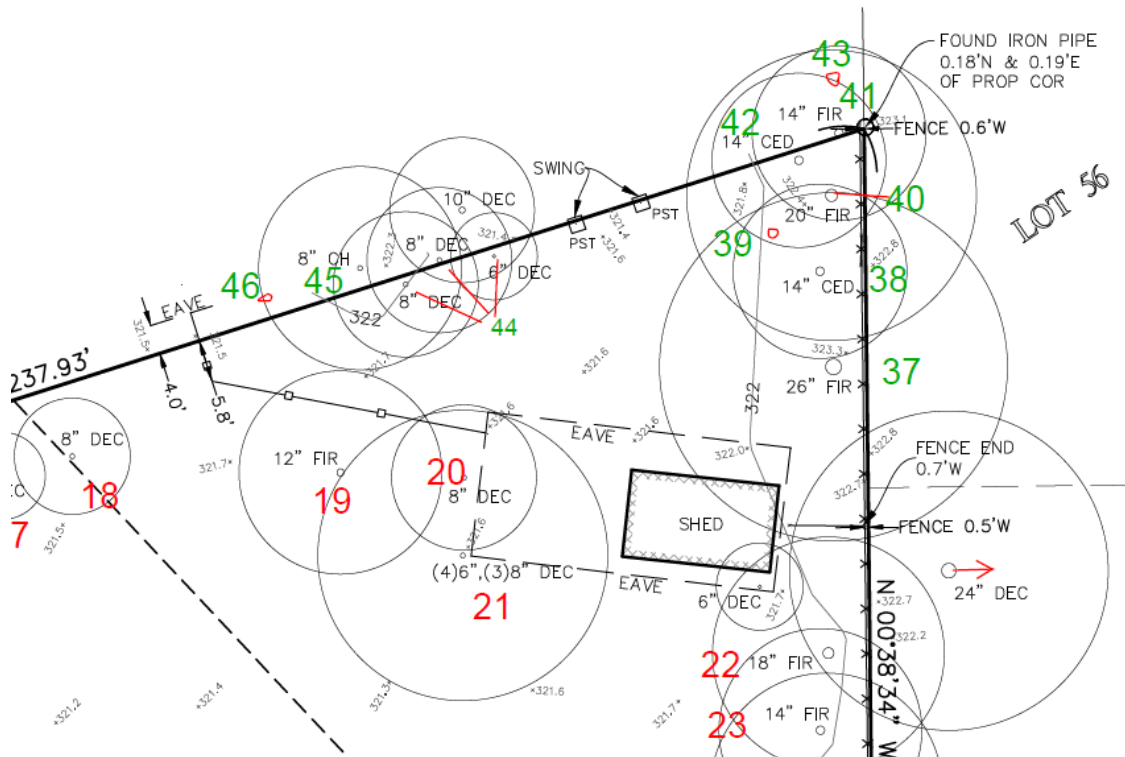
Figure 2. Excerpt from the survey showing the same area. The green numbers are the trees listed in the addendum. Those in red are from the original report.

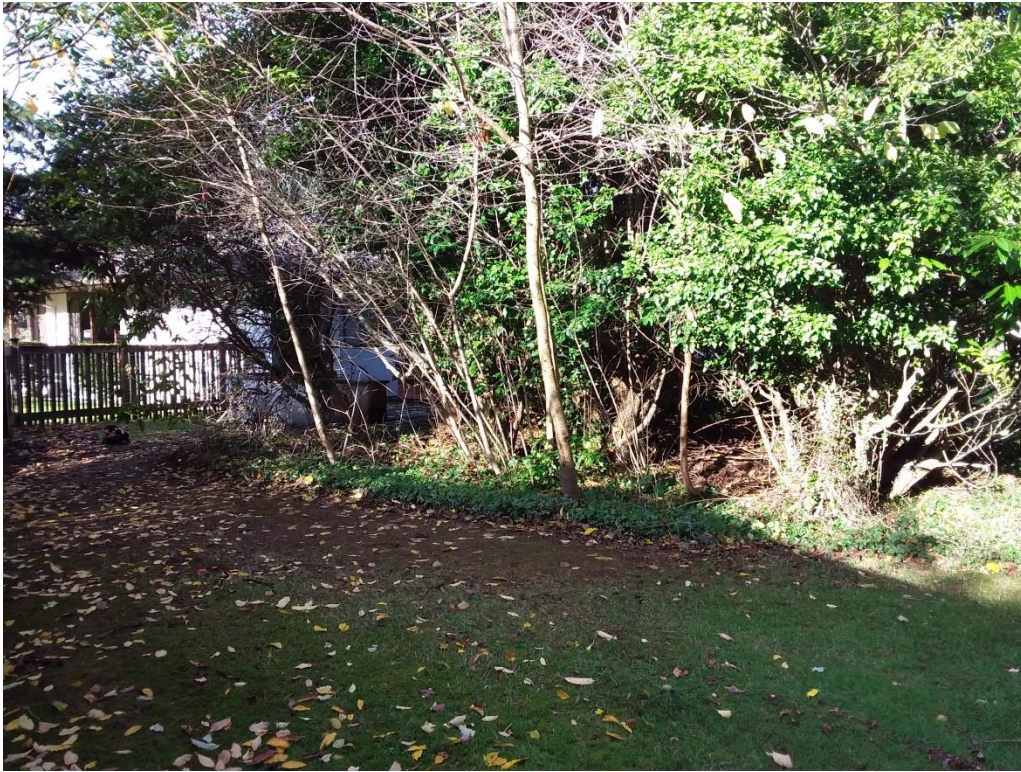
44. Three feral photinia standing on the south side of a semi-circular row of about seven of the plants (Figure 3). They appear to be some kind of old garden formation that is no longer cared for. They have been cut back to no more than 2' tall and allowed to grow back a least a couple of times and are now more than 14' tall and up to 8' across. Heavy ivy is growing through the plants and they are in weak condition. About a dozen volunteer cherries, all less than 3" DSH, are growing along their south side and are intertwined with their canopies. The property line cuts through or quite close to the three plants

Figure 3. Looking NW at the mixed photinia and volunteer cherries along the north side of the described region.

The construction perimeter fence on the north side will potentially run quite close to the three photinia. As it will do double duty as a protection fence for the #45 and #46 trees it should be pulled at least 6' S of the vine maple and 9' S of the cherry and then can tuck back toward the north line. The volunteers and the photinia can be cut back out of the way of the fence as necessary.

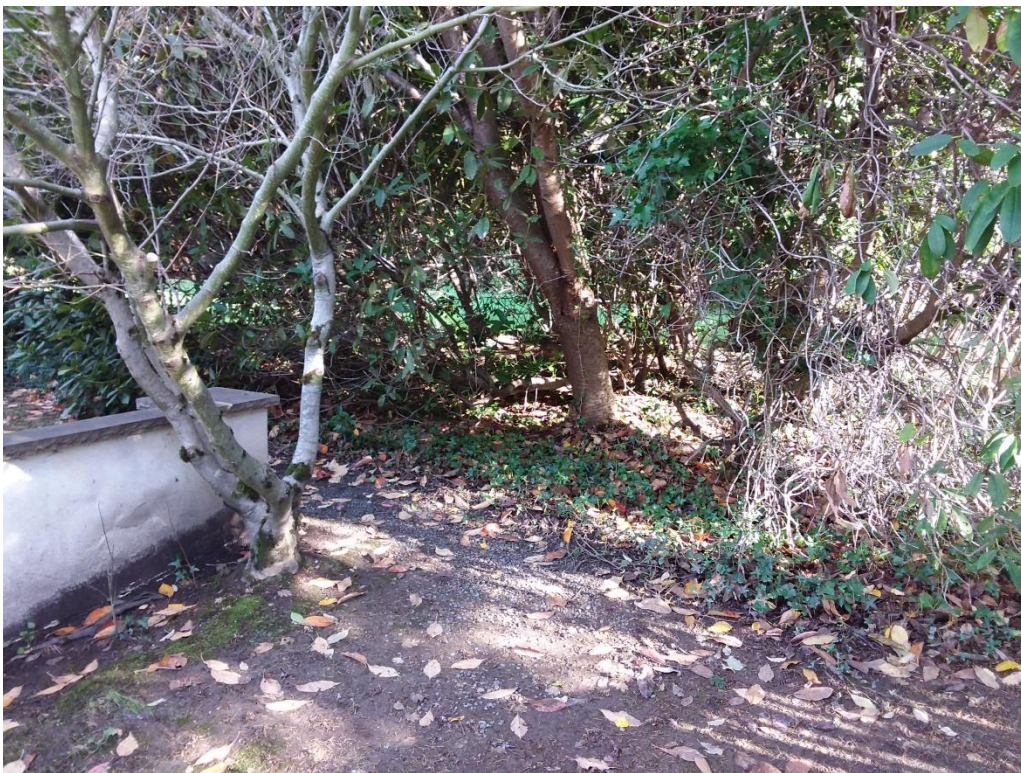
45. Flowering cherry (*Prunus serrulata*) 13" DSH, 22' tall, 8' spread standing 10' E of a short pony wall at the south side of the 7808 rear patio (Figure 4). It leans somewhat to the west from its base and is in fair condition.

46. Japanese vine maple (*Acer palmatum*) with four stems rising off an 8" caliper base. They measured 2.5", 2.5", 3", and 3" DSH and reached 12' high overall. The tree has been pruned back on the sides for clearance. It is in fair condition and stands next to the pony wall on the south side of the patio (see Figure 4).

Figure 4. Looking ENE at the base of the #46 vine maple and the #45 cherry.
