Superior NW Enterprises

Project: Pre-construction assessment for lot development at XXXX 79th Avenue SE, Mercer Island, WA. Parcel number 3206000050.

Objectives: Addendum to Superior NW report dated May 26, 2021. Document the placement of the root system of the #10 Douglas Fir after airspading.

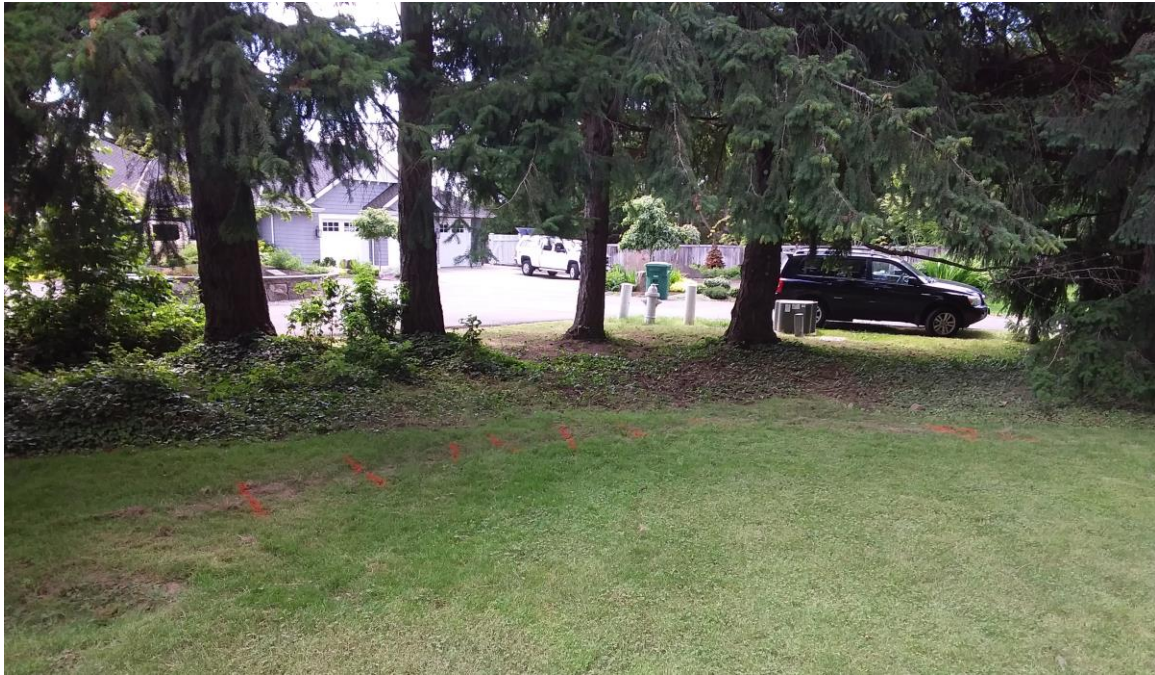
A trench 12-14” deep and 6” wide was created using an airspade on July 6 and 7, 2022 as shown in Figure 1. The trench started 28’ ENE of the base of the tree, curved to within 12’, and ended 28’ N of the tree. It followed the proposed curve of the drive shown in Figure 2. The soil in the area of the trench was found to be densely compacted to the point that simple stones could not be loosened by hand and the point of a pick had to be used to break the soil matrix for the first 6” of depth. Any roots exposed that were near 1” caliper were marked with orange tagging paint. Starting at the east end of the trench there was a ¾”, a ½”, a ½”, and a 2.5” caliper root in the first 5’ of length (Figure 3). A ½”, 2”, 3”, 1.5”, and ¾” follow within the next 9’ (Figure 4). At the north end there is a 3” and a 1” caliper that probably belong to the #7 tree rather than the #10 based on the distance they are removed from it (Figure 5). The two larger roots in the trench closest to the subject fir are barely sub-surface and are big enough around that they might be off the ends of the structural set.

Figure 1. Looking WSW at the airspade treated region and the orange strips indicating where significant roots crossed through.

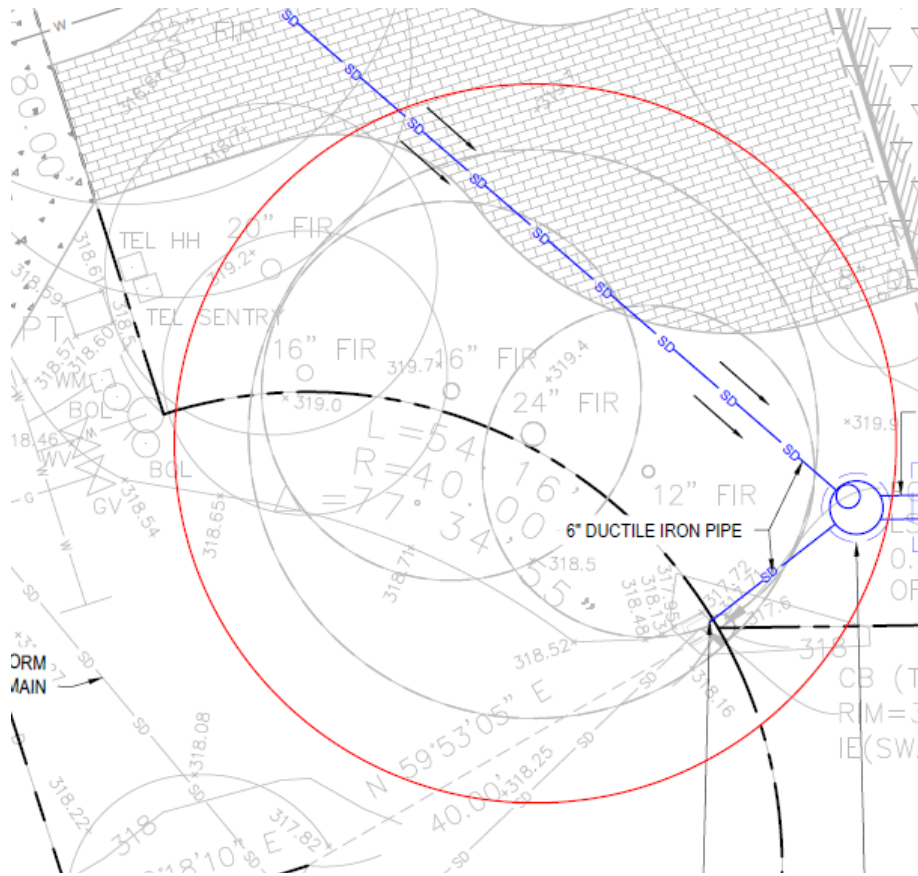
Figure 2. Excerpt from the plan set showing the proposed changes within Critical Root Zone of the #10 fir (red circle)

Setting the driveway as shown in the plan set should not present an insurmountable detrimental impact to the tree. However, it is highly advised that the tree receive a deep root feed which will both provide a nutrient boost and decompaction around the tree. The sod, ivy, and all other debris have to be removed from within the preserved portion of the tree’s CRZ. A layer of arbormulch 8-10” deep must be laid throughout the cleared space around the tree. Rehabilitating the area under the #10 fir should result in a net positive for the tree year over year.

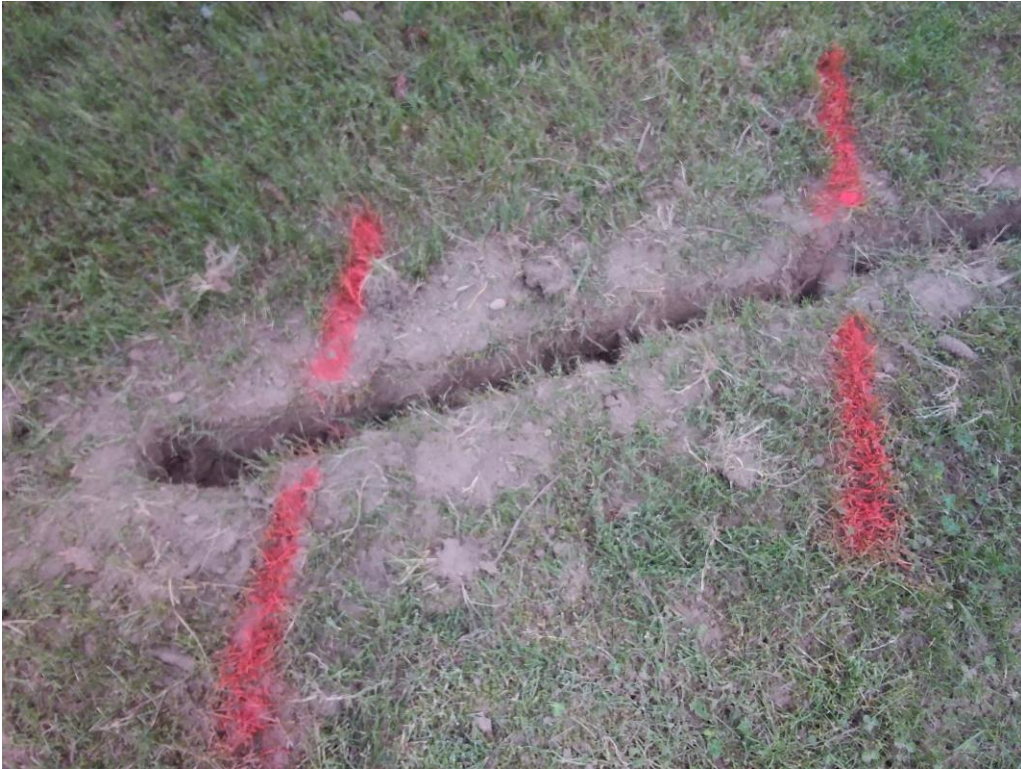
Figure 3. East end of the trench.

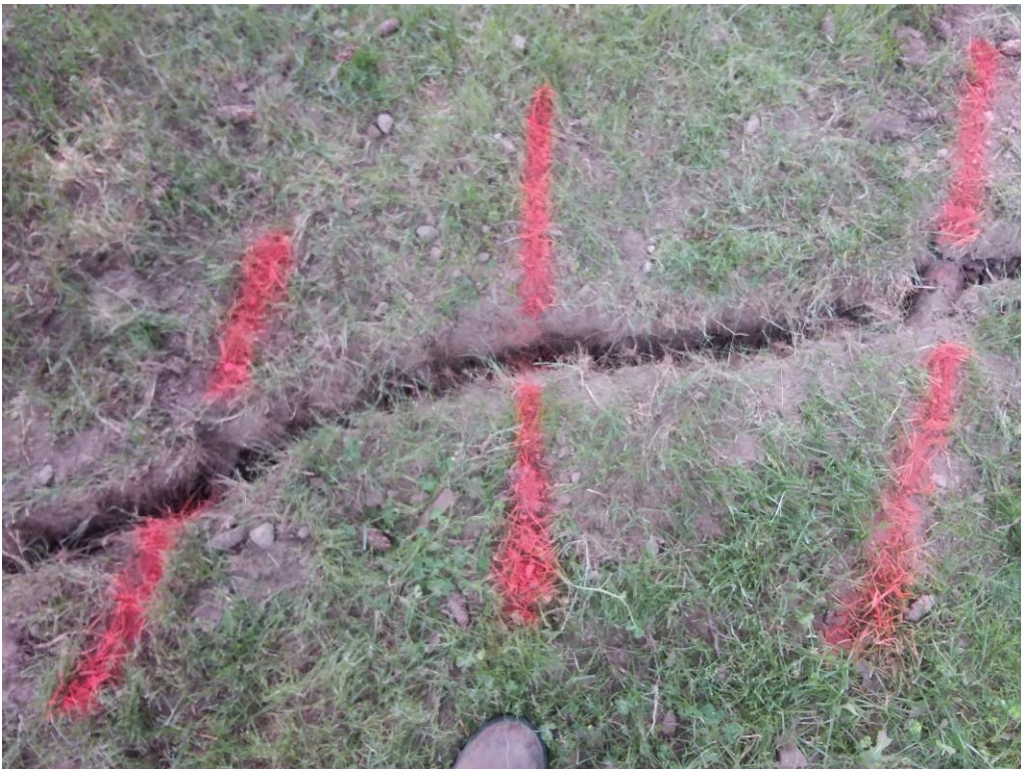
Figure 4. First three roots in the center set.

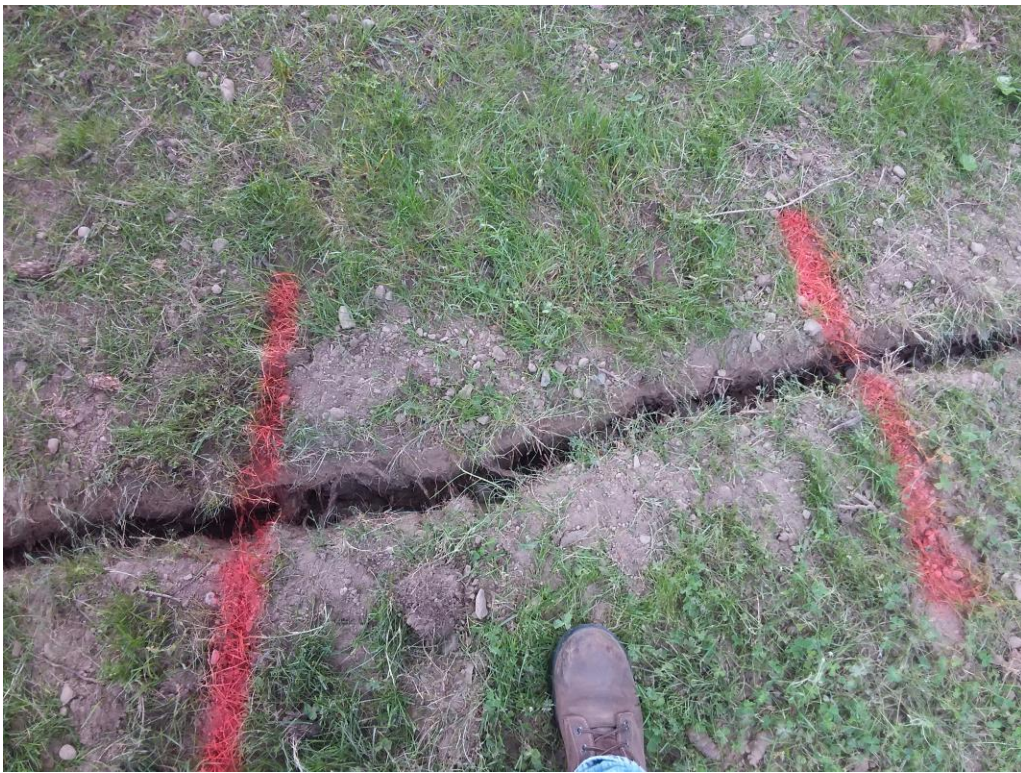
Figure 4. Last two roots in the center set of roots.

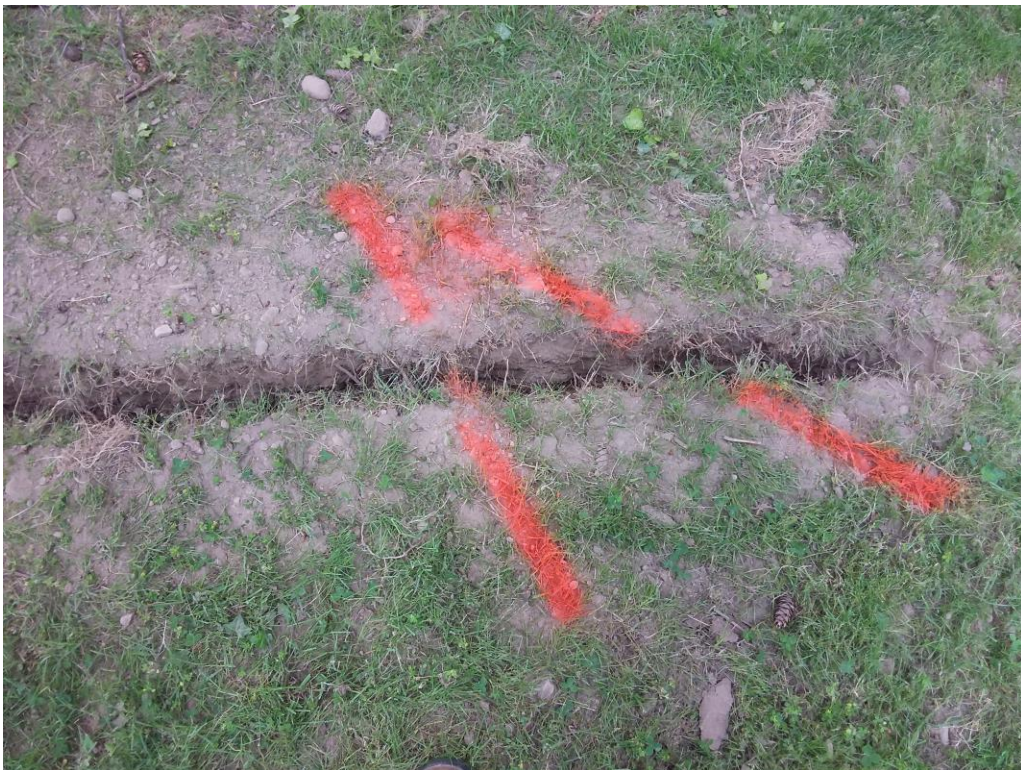
Figure 5. Roots at the north end of the trench.
