Corinne R. Hollister

Consulting Arborist Services

To: JayMarc Homes, Jay Mesistrano
Reference: Tree Inventory Report
with tomography results on offsite trees
Date: September 23, 2021
Site Address: 4537 90th SE, Mercer Island 98040
Parcel: 0191100195

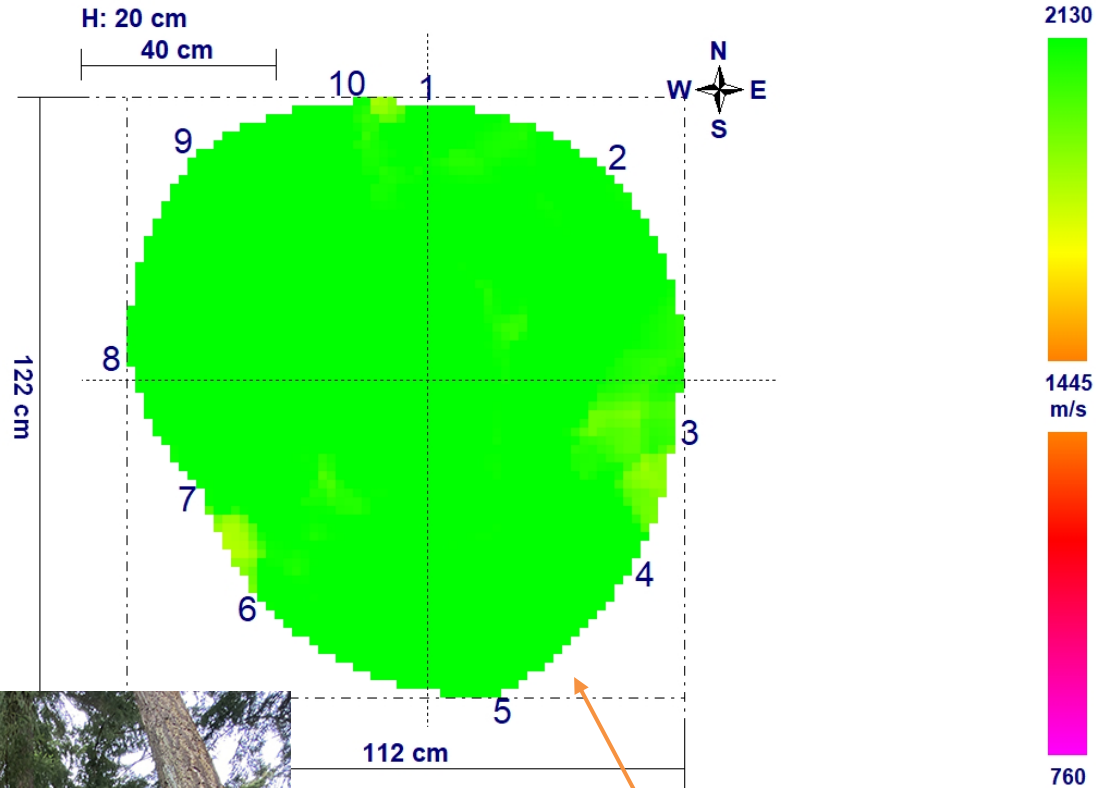
Tree: 102 (*Pseudotsuga menziesii*)
 Tree species: Conifer

Tree 102 has two superficial cracks in the north and southwest quadrant, and some sapwood decay in the eastern quadrant. Reassessment in five years recommended.

Construction impacts from SE – new foundation.

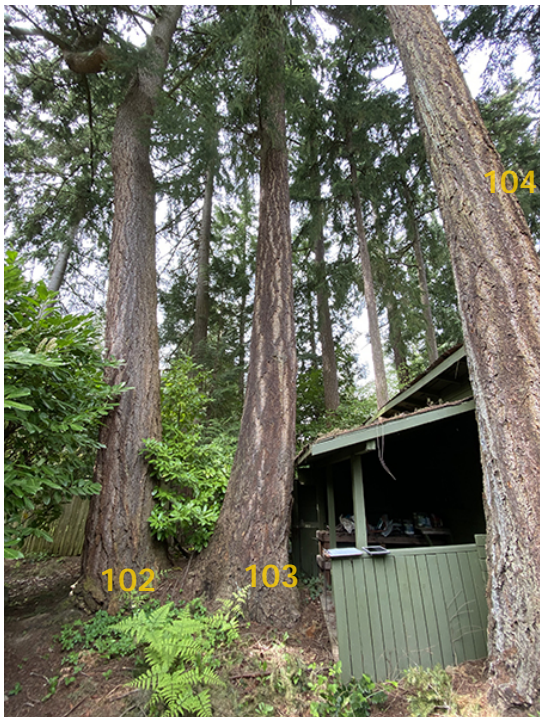
Looking west near the property line where offsite trees with overhanging branches are located:

- Tree #102, far left, a 36.5-inch Douglas-fir, see this page.
- Tree #103, center, a 40-inch Douglas-fir, see page 5.
- Tree #104, right, a 30.5-inch Douglas-fir see page 6.

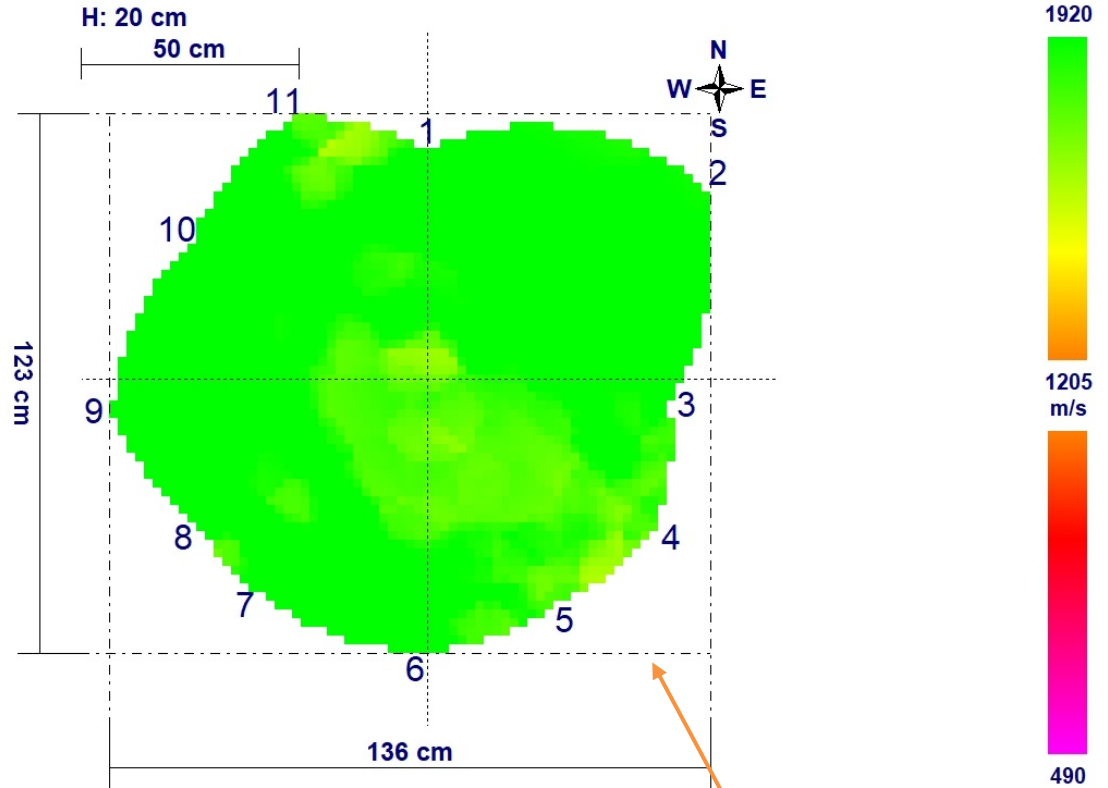
Tree: Tree 103 (*Pseudotsuga menziesii*)
Tree species: Conifer

Tree 103 has sapwood decay in its northeast and southwest quadrants, and some heartwood decay emanating to the southeast. Reassessment after planned construction or two years from initial test recommended.

Construction impacts from SE – new foundation.

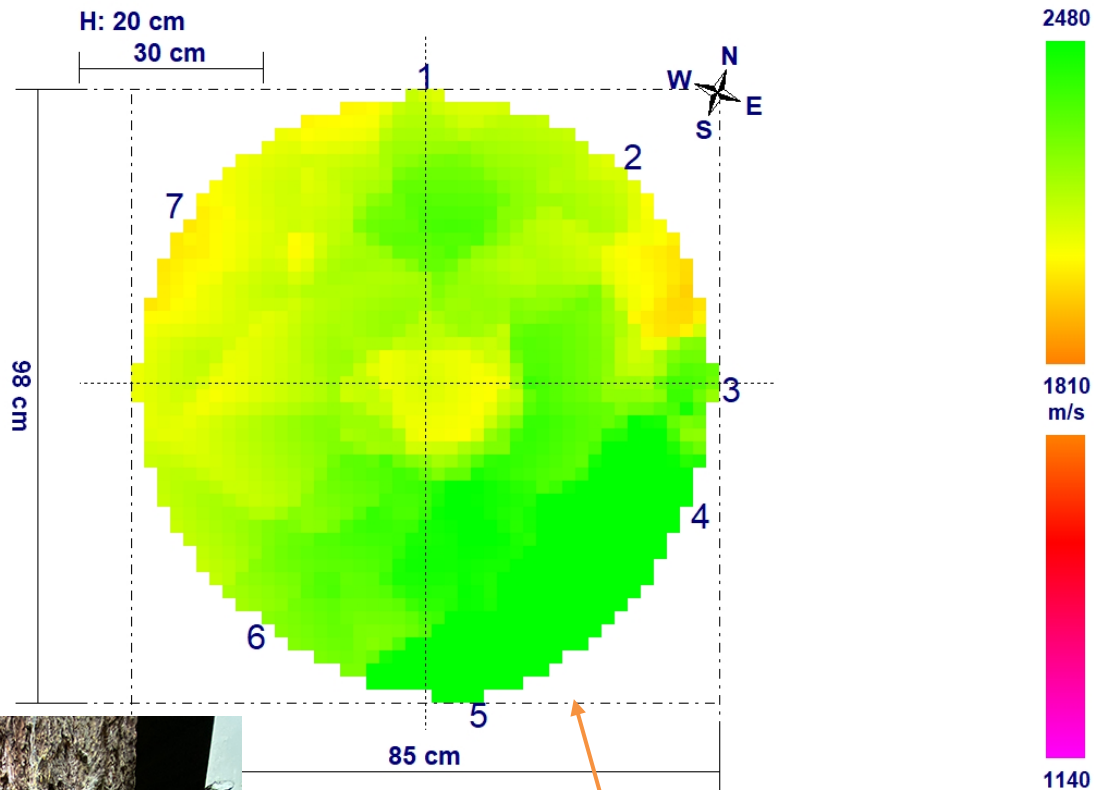
Tree: 104 (*Pseudotsuga menziesii*)
 Tree species: Conifer

Tree 104 has sapwood decay on its northwest and northeast quadrants, and some centralized heartwood decay. The decay in the tree is estimated to be causing a 13% strength loss. Provide appropriate tree protection during construction. Reassessment after planned construction or two years from initial test recommended.

Construction impacts from SE – new foundation.

Tree #104 requires increased protection due to minor decay indicated in tomography results.

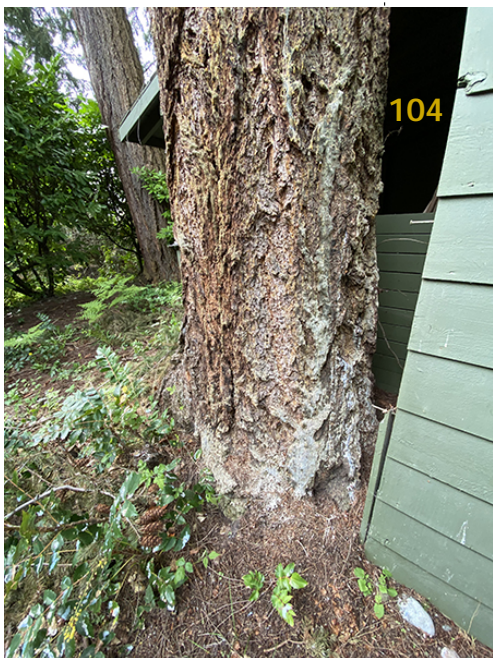
Tree #104, a 30.5-inch Douglas-fir located adjacent to an existing shed at the back of the parcel.

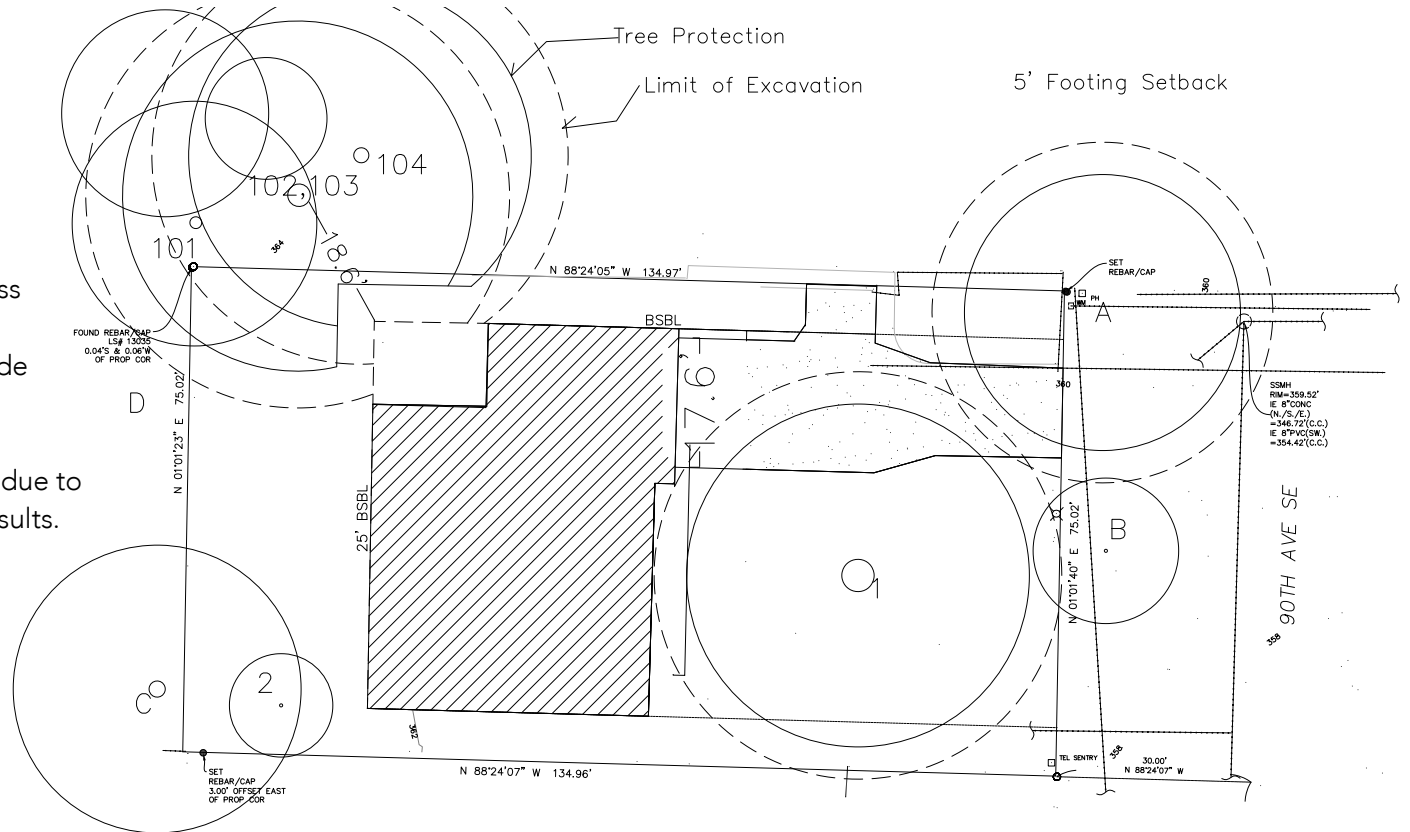
Attachment 6: Preliminary Site Plan

#102	36.5 in. Douglas-fir	18 feet
#103	40 in. Douglas-fir	20 feet
#104	30.4 in. Douglas-fir	20 feet

Proposed disturbance does not cut across root plates and can be accommodated with construction guidelines which provide maximum protection.

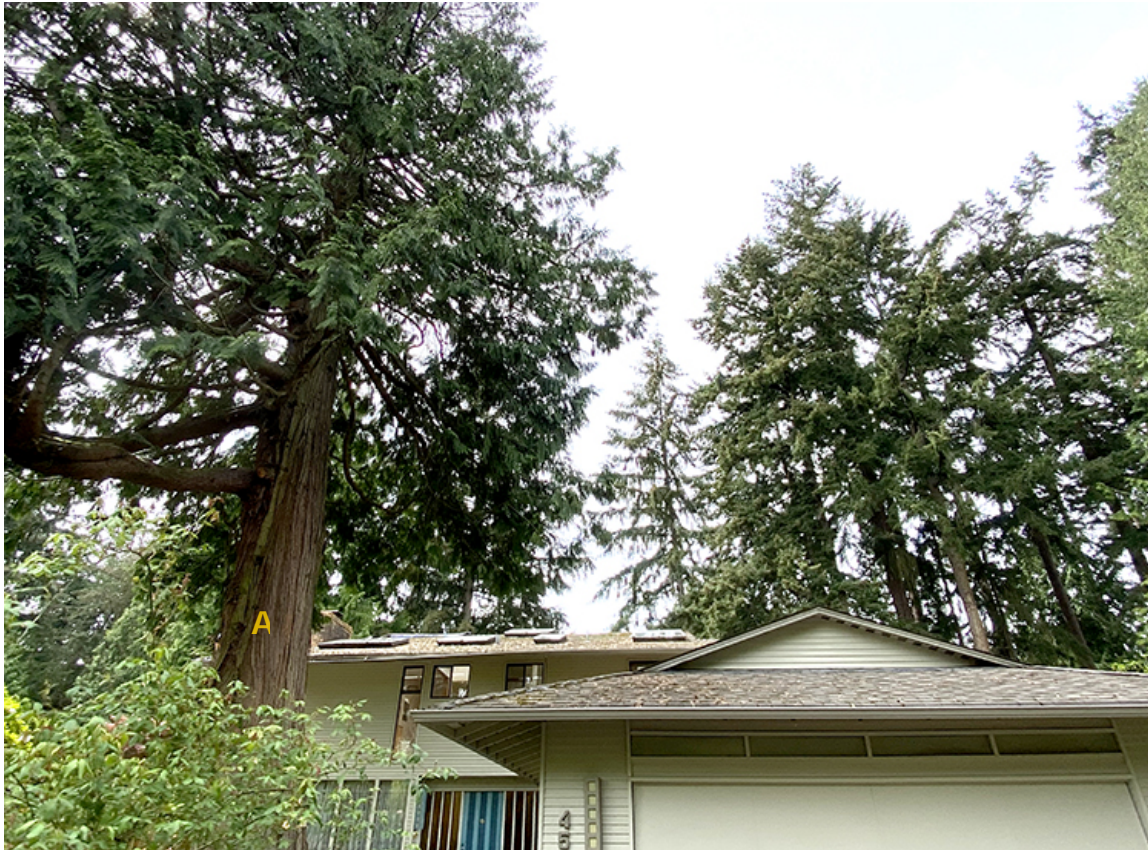
Above: Looking west. Tree #1, an exceptional Western red cedar on the left. A tree grove is located off-site to the west/northwest.

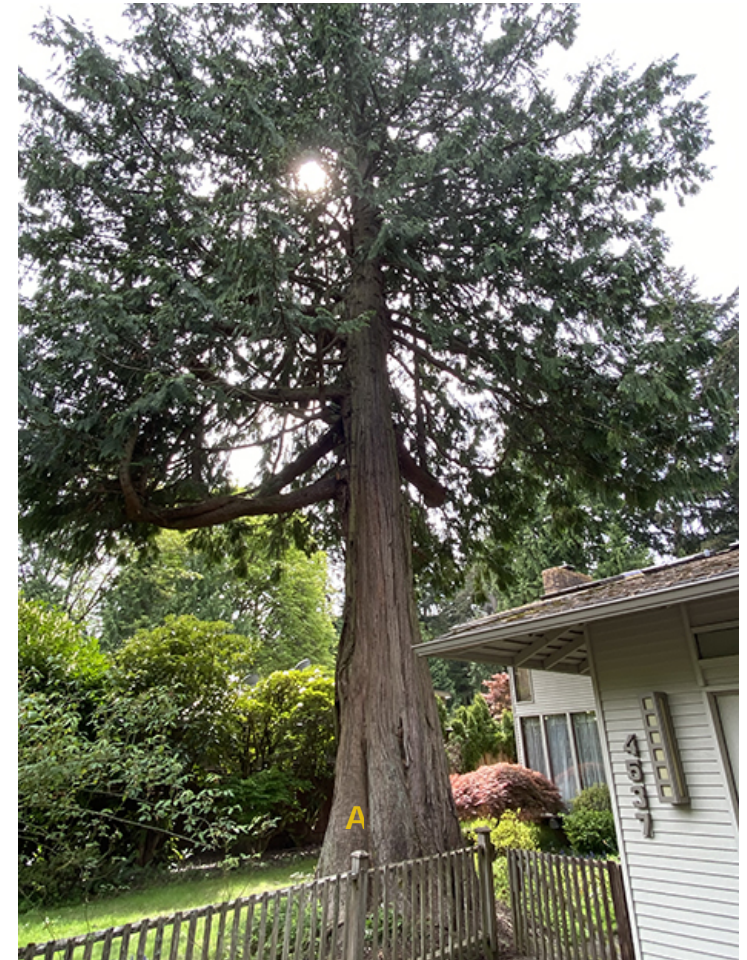
Right: Tree #1, adjacent to existing home.

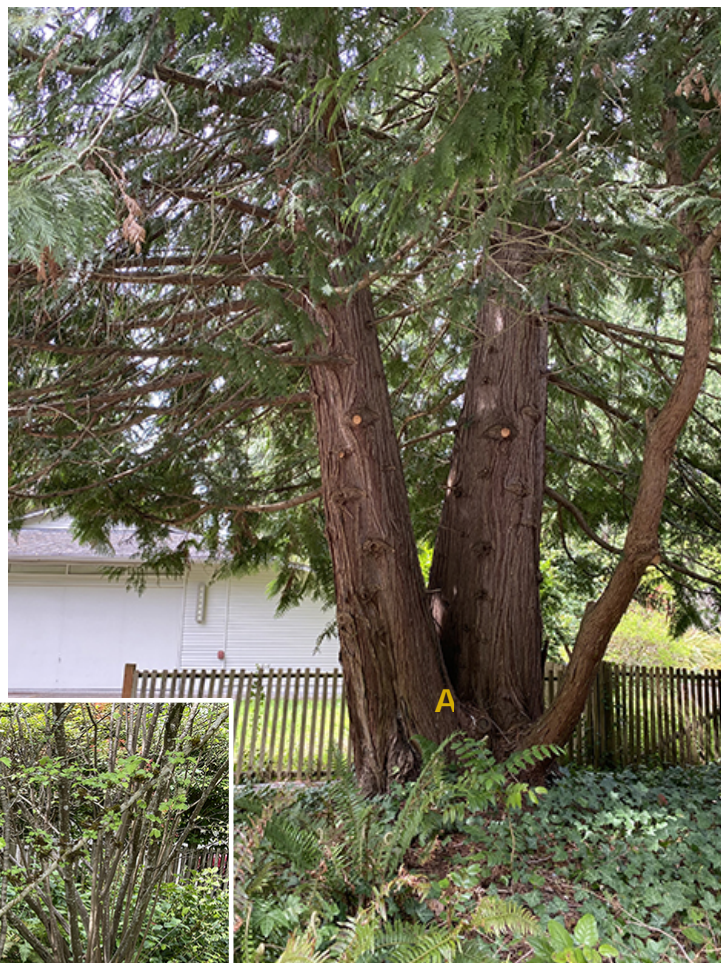
Above: Looking west. Tree A, an exceptional Western red cedar located in the ROW.
