# Greenforest Incorporated

REFERENCE: Arborist Report

PROJECT ADDRESS 6427 East Mercer Way, Mercer Island WA

DATE: December 18, 2020

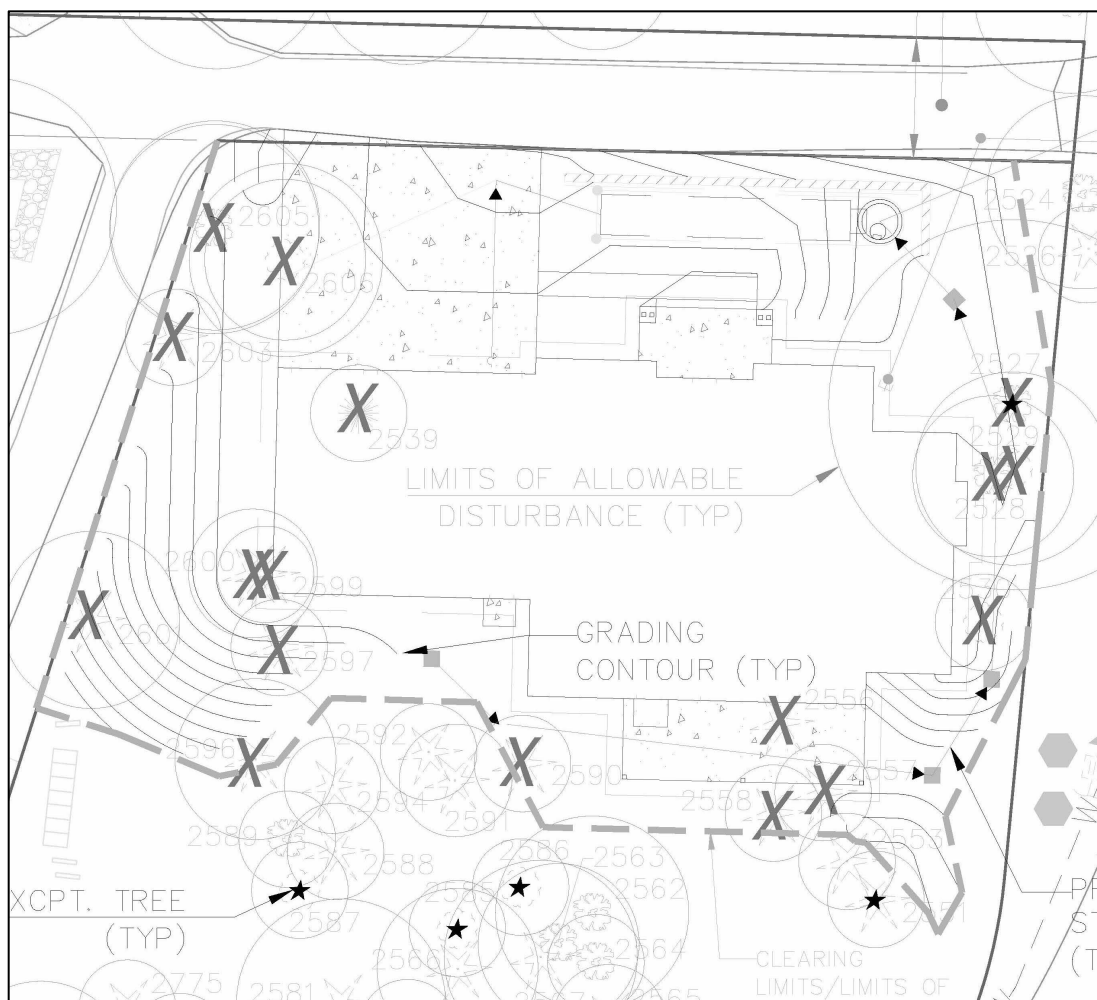
The following trees are exceptional: 10 from grove designation, and 1 trunk size, and are proposed for removal. The following exhibit displays all trees proposed for removal, and their limits of allowable disturbance in relation to the proposed house.

Tree #	DBH	Species	Reason for Removal of Exceptional Tree
2527	47"	Western red-cedar	Excavation for foundation inside LOAD, excavation for stormwater connect at base of trunk
2528	19"	Western red-cedar	Excavation for foundation near base of tree
2529	23"	Bigleaf maple	Excavation for foundation near base of tree
2557	10.5"	Western hemlock	Inside house footprint. Tree is visibly declining, canker on trunk, not viable for retention.
2596	13, 16"	Douglas-fir	Extensive grading inside LOAD
2597	11"	Douglas-fir	Extensive grading inside LOAD
2600	16.5"	Douglas-fir	Excavation for foundation near base of tree
2601	21"	Black pine	Extensive grading inside LOAD, tree is visibly declining, double leader with included bark, not viable for retention.
2603	8, 9"	Mugho pine	Extensive grading inside LOAD
2605	25"	Western red-cedar	Extensive grading inside LOAD
2606	19.5"	Sweet cherry	Driveway over base of tree
