Lonson Arbor Care

Brumbaugh Residence
4124 83rd Ave SE
Mercer Island, WA 98040

Re: **Tree Report** for the address above (Parcel #36265000030).

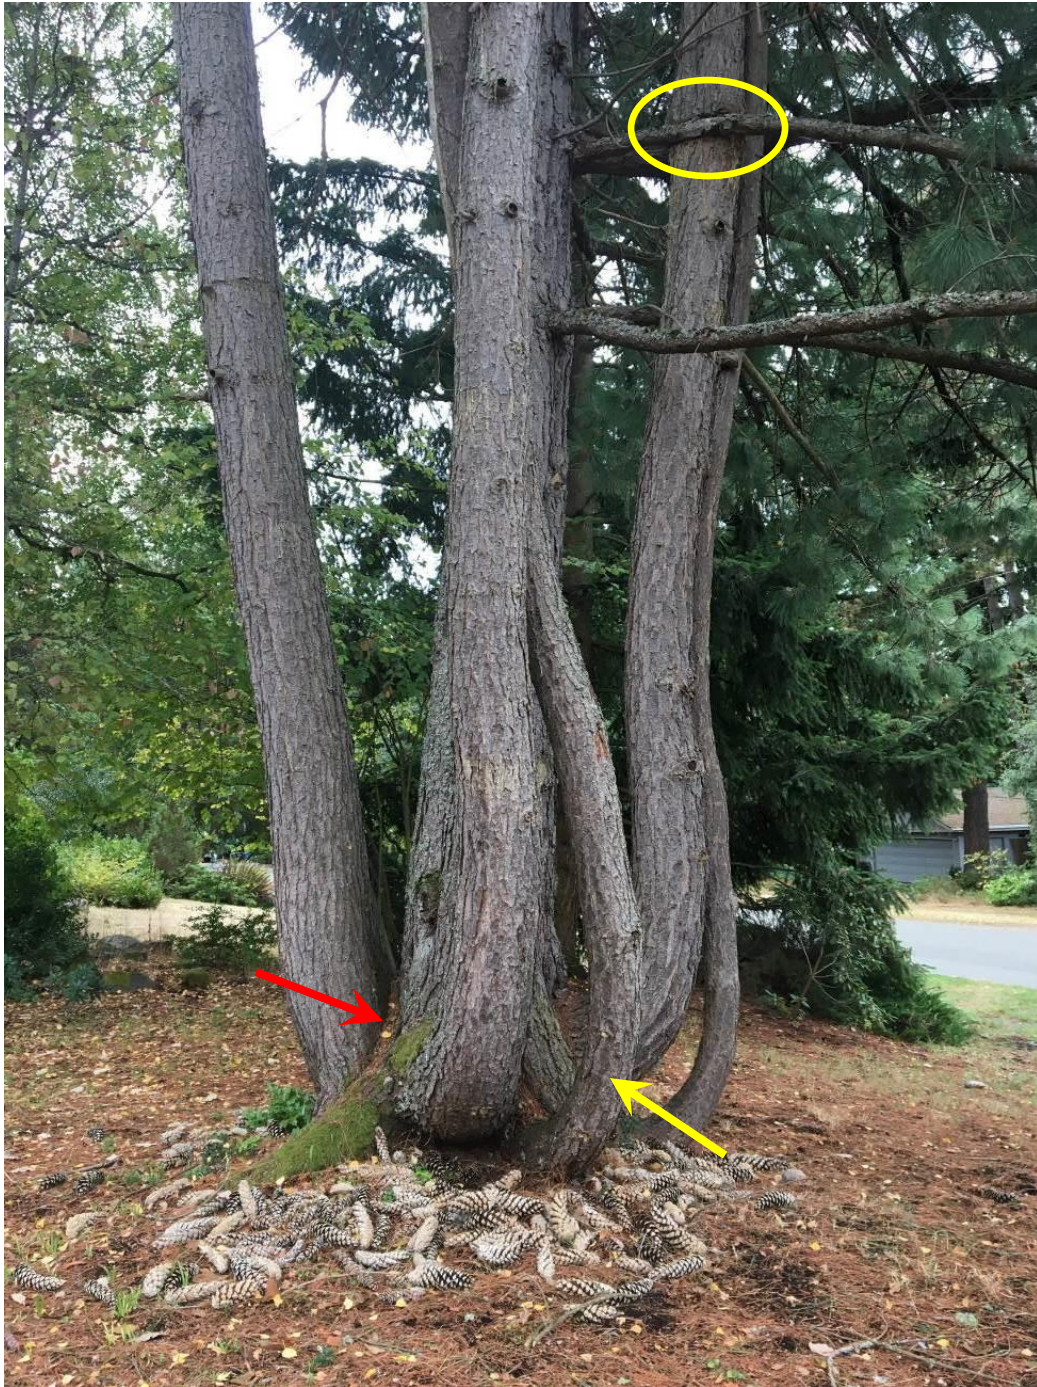
Eastern White Pine Pictures:

- Multi-trunked tree with included bark between trunks. The tree has a dead trunk down to the base indicating heartwood decay near the root collar. Side branches have severely rubbed into the trunk stem.

The picture above, taken at time of inspection, shows the base of the Eastern White pine. The red arrow points at the included bark between the trunks. This part of the trunk is likely to fail within the 5-year assessment time frame. The yellow arrow points at the dead stem which indicates root crown problems near the base of the tree. Severe branch rubbing is highlighted in yellow. The imbedded, rubbing branch has compromised the stem's structural strength and is likely to fail within the assessment period.

Tall stems add to the leverage load on the included bark and rubbing stress. A lot of over-lapping (girdling) phloem cells around the trunk base may be the reason for the stem dieback.

- The Eastern White Pine warrants removal because of structural defects that will require extensive pruning and cabling to lower risk without the guarantee of recovery. The total DBH of the tree is 38.0” which requires the planting of six (6) new trees under MICC 19.10.070. Conifer (evergreen) trees must be at least 6-feet tall when planted. Deciduous trees need to have a trunk caliper (base measurement) of 1.5 inches.
