March 22, 2022
Project No. 22-026

**Subject: Infiltration Test Report
4124 83rd Avenue Southeast
Mercer Island, Washington**

**INFILTRATION TEST REPORT
4124 83RD AVENUE SOUTHEAST
MERCER ISLAND, WASHINGTON**

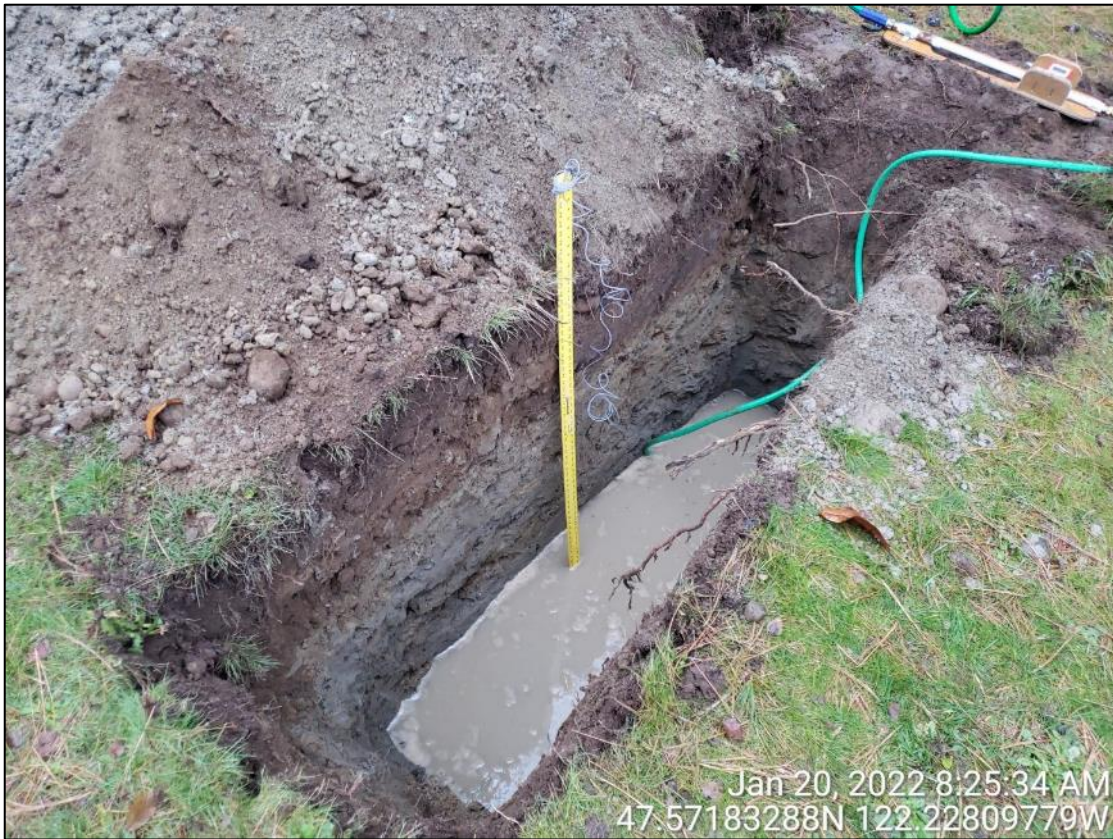
Test Pit No. PIT-1

During our initial test pitting procedures at the target depth of the proposed infiltration facility at test pit PIT-1, we observed light groundwater seepage at about 5 feet below the existing grade. During the pre-soak period of the infiltration test, water at the source was turned off and the level of water in the test pit continued to rise, resultant of exfiltration of groundwater into the PIT-1. At test pit PIT-2 location, groundwater seepage was encountered at about 3 to 4 feet below the existing grade, which is above the bottom of proposed infiltration facility. Therefore, based on the subsurface conditions, it is our opinion that infiltration of surface water is not feasible at this site and other stormwater BMPs should be considered for this project.

<u>Depth (ft)</u>	<u>Material Description</u>
0 – 1½	Approximate 6-inch topsoil above loose, brown to dark brown, silty SAND; trace gravel and cobble, roots and rootlets; disrupted texture, non-plastic, moist [Fill]
1½ – 3½	Medium dense, orange-brown to gray-brown, silty SAND; trace gravel and cobble; slightly diamict texture; non-plastic, moist <ul style="list-style-type: none">• <i>Increasing moisture and sand content with depth</i>
3½ – 5	Dense, gray, silty SAND; trace gravel, iron-oxide staining; non-plastic, very moist [Qvt – Vashon Till]

Photo PIT-1 : Shows PIT-1 at approximately 5 feet in depth during infiltration testing

Light groundwater seepage was encountered at approximately 5 feet below grade during explorations.

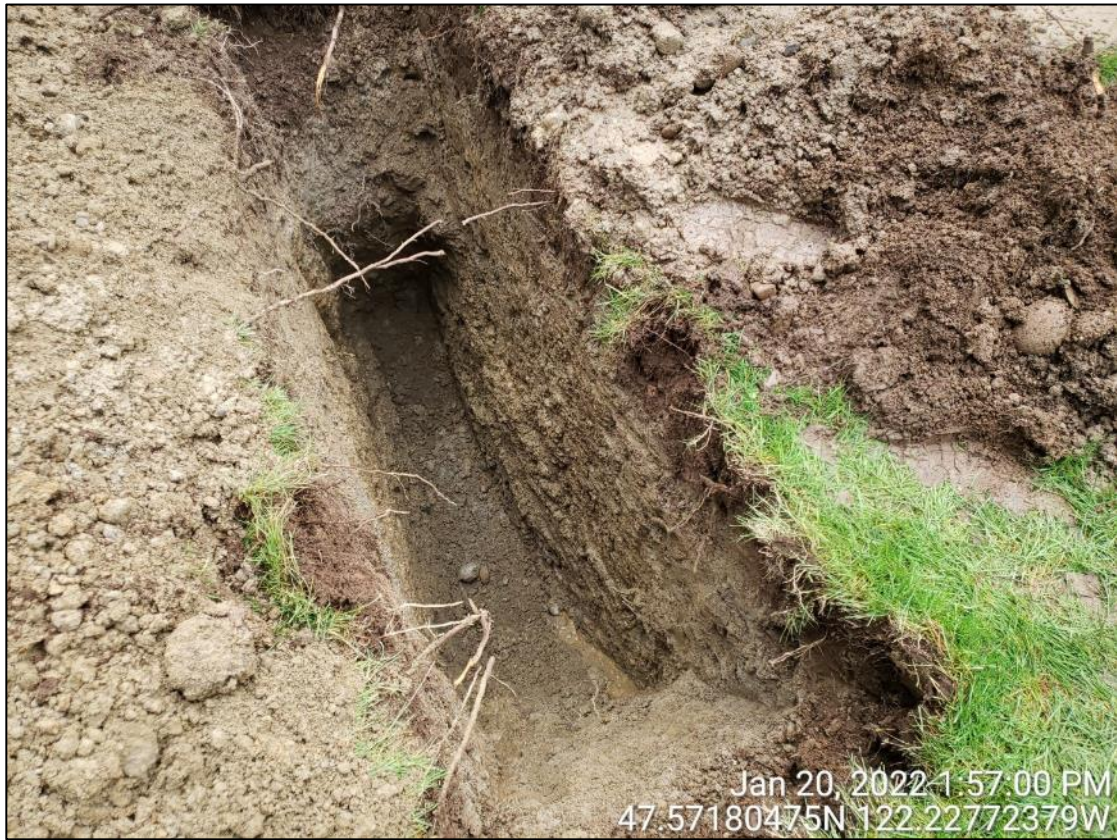
Test Pit No. TP-2

Groundwater was encountered in both test pits during excavation. Test pit PIT-1 encountered light groundwater seepage at the infiltration test depth of about 5 feet below the existing grade. Test pit PIT-2 encountered moderate perched groundwater seepage at about 3 to 4 feet below the existing grade within the surficial fill.

<u>Depth (ft)</u>	<u>Material Description</u>
0 – 2	Approximate 12-inch topsoil above loose to medium dense, brown to dark brown, silty SAND; trace gravel and cobble, roots and rootlets; disrupted, till-like texture, non-plastic, moist
2 – 5½	Medium dense, orange-brown, silty SAND; trace gravel and cobble, trace rootlets; slightly diamict texture; heavily reworked; non-plastic, moist to wet <ul style="list-style-type: none">• Moderate groundwater seepage from 3 to 4 feet below grade <p style="text-align: right;">[Fill]</p>
5½ – 7	Dense, gray-brown, silty SAND; trace gravel, iron-oxide staining; slightly diamict texture; non-plastic, very moist <p style="text-align: right;">[Qvt – Vashon Till]</p>

Photo TP-2 : Shows TP-2 at approximately 7 feet in depth

Moderate perched groundwater seepage was encountered at approximately 3 to 4 feet below grade during explorations.
