Gilles Consulting

ARBORIST REPORT FOR THE NGUYEN PROPERTY AT 8937 SE 56th Street Mercer Island, WA 98040

June 8, 2022

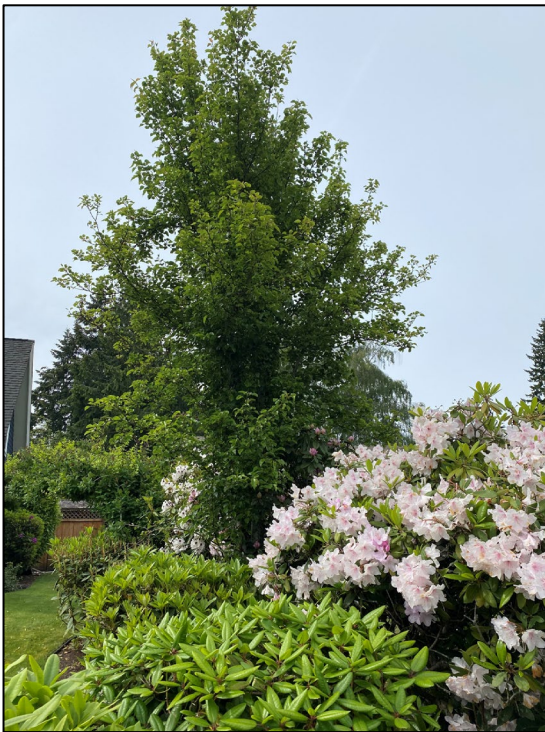
- Tree # 247:
 - Is a Bradford Pear on the adjacent property to the east at 8945 SE 56th Street.
 - It is estimated to measure 4.5 inches in diameter.
 - It is in Very Good Condition.
 - It is Viable.
 - Recommendation:
 - *Potential to retain with tree protection measures.*

Photo # 1: Tree # 247 the Bradford Pear on the adjacent property to the east at 8945 SE 56th Street.

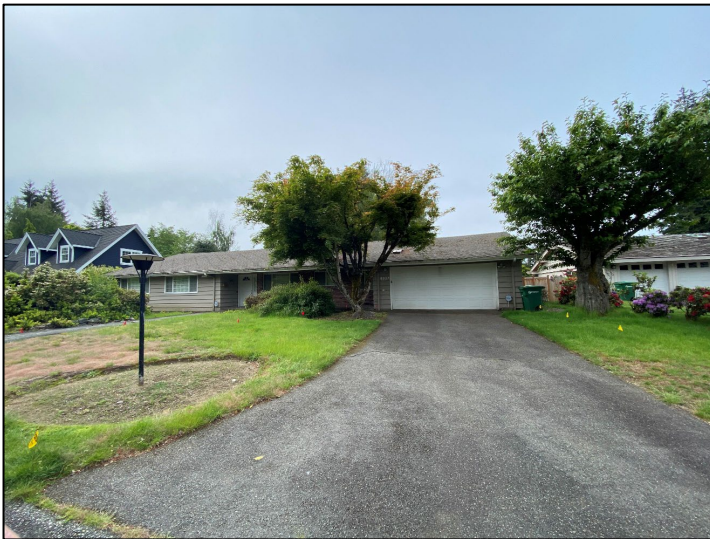
- Tree # 244 is a 35.7-inch diameter Flowering Cherry.
 - It is located at the top of the driveway on the west side near the northwest corner of the garage.

- The tree is a combination of three different species of Cherry trees grafted together at the top and bottom of the trunk.
 - There are the early stages of decay in the center of the trunk.

- The tree was topped at approximately 14 feet.
 - The roots are uplifting and damaging the driveway and adjacent sidewalk.
 - The species is subject to two major disease elements:

- The roots are uplifting and damaging the driveway and adjacent sidewalk.
 - The trunk is forked at the base and two feet with included bark.
 - This means that the root collar is structurally weak.

- The tree was previously topped at approximately 16 feet.
 - Scaffold branches extend over the driveway and over the sidewalk leading to the front door.

Photo # 2: Looking south from SE 56th Street at trees # 244, Cherry, and # 245 Japanese Maple.

- Recommendation:
 - *Consider removing this tree.*
- Tree # 245 is a multi-trunked Japanese Maple.
 - It is located at the top of the driveway on the east side near the northeast corner of the garage.

- These branches will need to be severely pruned back to allow for the demolition of the existing house and the construction of the new house.
- The tree is in Poor Condition but will not likely survive the severe pruning needed nor the stresses of demolition and construction.
- Recommendation:
 - *Consider removing this tree.*

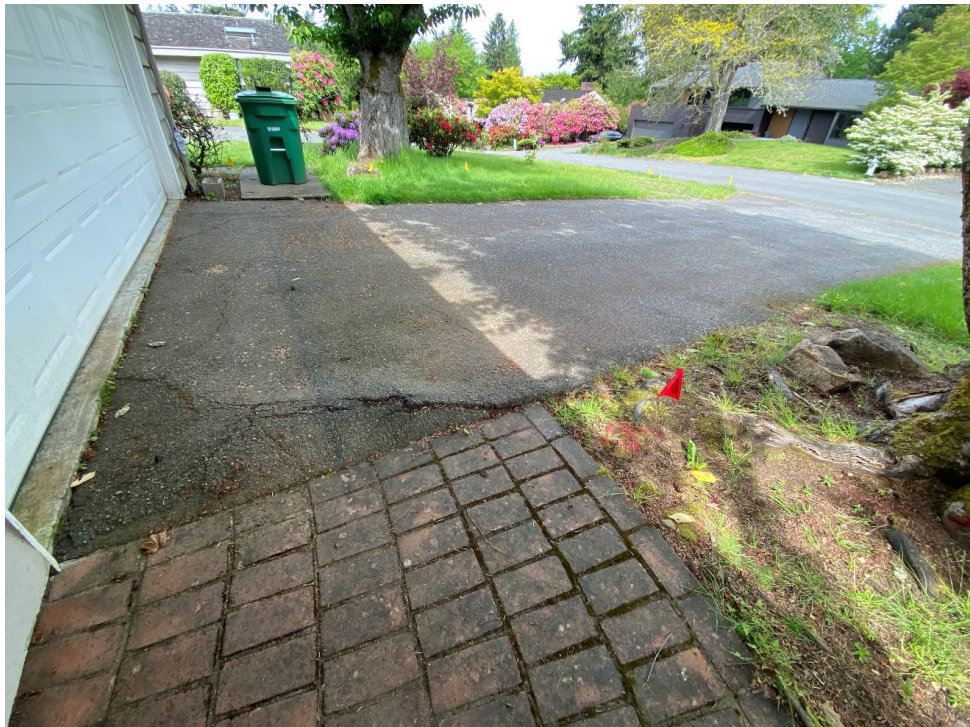
Photo # 3:
Looking at the base of tree # 244 on the far side of the driveway and the damage being done to the driveway and sidewalks.

Note also the surface roots of the Maple tree and the advanced decay in the buttress roots.

Both trees are recommended for removal.

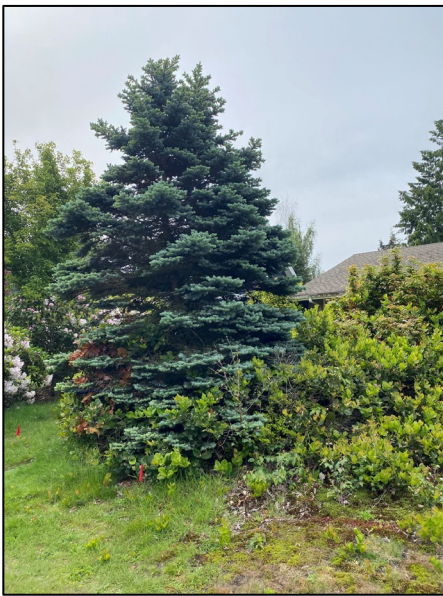
- Tree # 246 is a 5.5-inch diameter Colorado Blue Spruce located in the front yard.
 - The foliage of the tree is infested with a Spider Mite infestation.
 - In spite of this infestation, the tree is in Good Condition.
 - The tree is below the 6-inch threshold but is worthy of retention and provides great aesthetic and environmental benefits.
 - Recommendation:
 - *Potential to retain with tree protection measures.*
 - *Consider treating for Spider Mites and fertilization.*

Photo # 4: Tree # 246 the Colorado Blue Spruce in the front yard.
