AMENDED ARBORIST REPORT FOR THE NGUYEN PROPERTY AT

8937 SE 56th Street
Mercer Island, WA 98040

Amended September 11, 2022

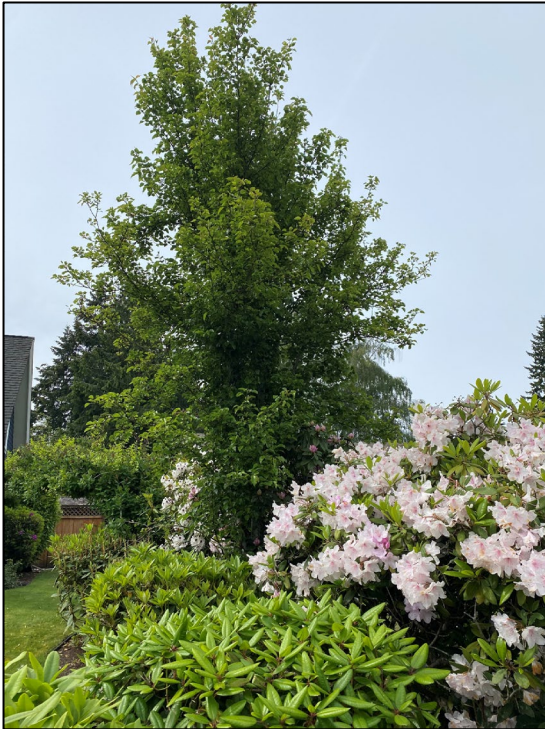
- Tree # 247:
 - Is a Bradford Pear on the adjacent property to the east at 8945 SE 56th Street.
 - It is estimated to measure 4.5 inches in diameter.
 - It is in Very Good Condition.
 - It is Viable.
 - Recommendation:
 - *Potential to retain with tree protection measures.*

Photo # 1: Tree # 247 the Bradford Pear on the adjacent property to the east at 8945 SE 56th Street.

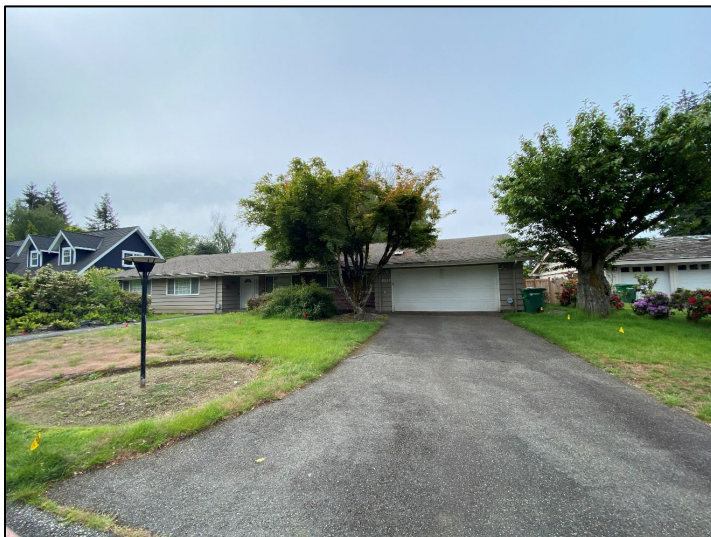
- The tree is a combination of three different species of Cherry trees grafted together at the top and bottom of the trunk.
 - There are the early stages of decay in the center of the trunk.

- The tree was topped at approximately 14 feet.
 - The roots are uplifting and damaging the driveway and adjacent sidewalk.
 - Removal of the roots under the hard surfaces will negatively impact the long-term survivability of the tree.

- This is a multi-trunked Japanese Maple.
 - It is located at the top of the driveway on the east side near the northeast corner of the garage.
 - While the canopy is generally symmetrical the tree has been previously topped at multiple heights. The result is a tree with poor structure with weakly attached regenerated crowns.

- The lower trunk is forked with unusually large amounts of included bark.
 - The root collar is characterized by an internal structural weakness prone to failure in storms.

- *The tree is in Poor Condition and will not likely survive the severe pruning needed nor the stresses of demolition and construction.*

Photo # 2: Looking south from SE 56th Street at trees # 244 the Cherry on the right, and # 245 the Japanese Maple on the left.

- Recommendation:
 - *Consider removing this tree.*
 - *If the City requires the tree to be retained, Tree Protection Measures below will be adequate.*
- *Amended Tree # 245:*

- Recommendation:
 - *Consider removing this tree.*
 - *If the City requires the tree to be retained, Tree Protection Measures below will be adequate.*

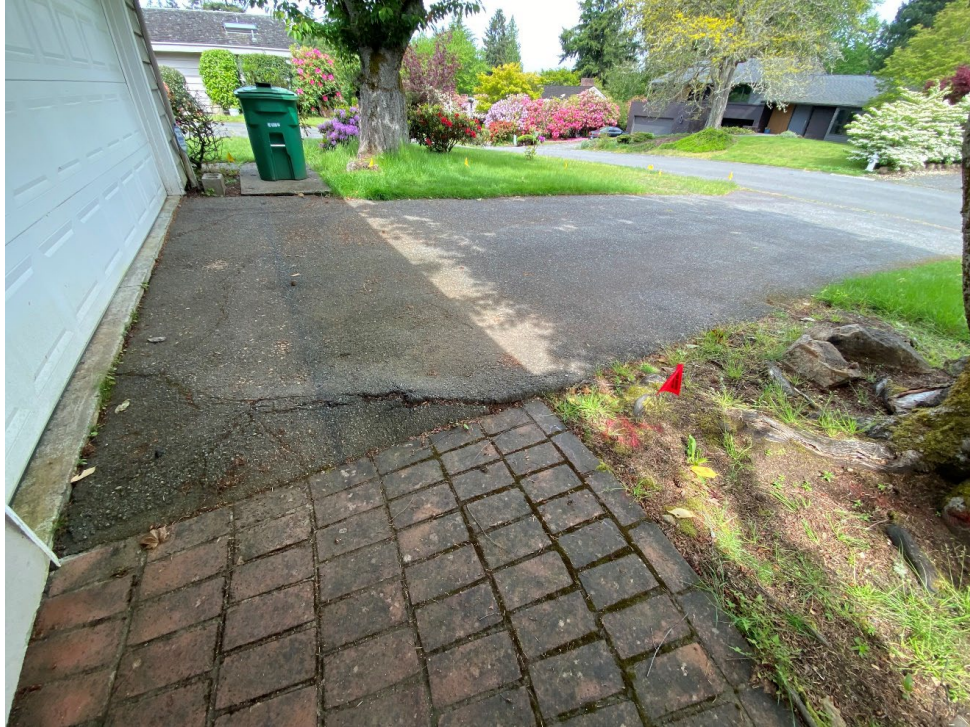
Photo # 3:
Looking at the base of tree # 244 on the far side of the driveway and the damage being done to the driveway and sidewalks.

Note also the surface roots of the Japanese Maple tree, at the right edge of the photo, and the advanced decay in the buttress roots.

Both trees are recommended for removal.

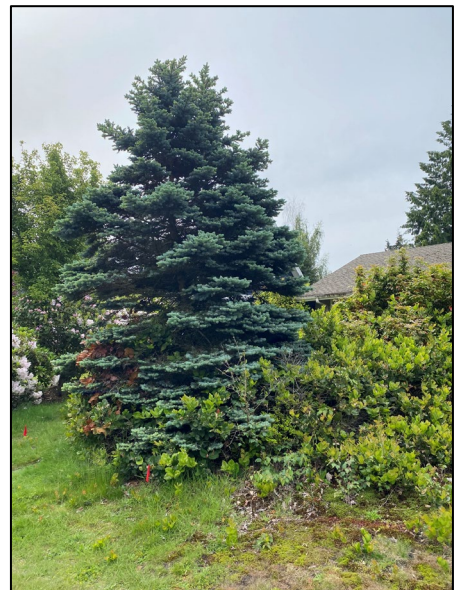
- Tree # 246 is a 5.5-inch diameter Colorado Blue Spruce located in the front yard.
 - The foliage of the tree is infested with a Spider Mite infestation.
 - In spite of this infestation, the tree is in Good Condition.
 - The tree is below the 6-inch threshold but is worthy of retention and provides great aesthetic and environmental benefits.
 - Recommendation:
 - *Potential to retain with tree protection measures.*
 - *Consider treating for Spider Mites and fertilization.*

Photo # 4: Tree # 246 the Colorado Blue Spruce in the front yard.
