## AMENDED ARBORIST REPORT FOR THE NGUYEN PROPERTY AT

8937 SE 56<sup>th</sup> Street  
Mercer Island, WA 98040

**Re-Revised October 18, 2022,  
Revised/Amended October 13, 2022**

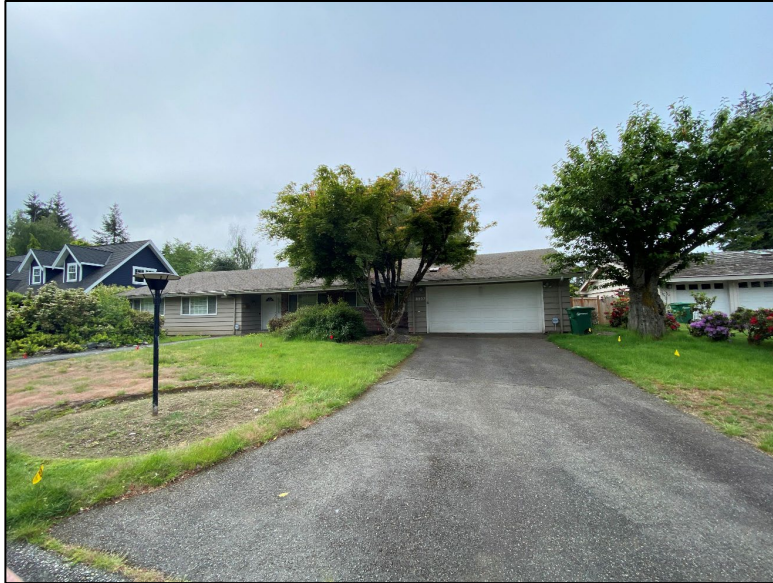
- Tree # 244 is a 35.7-inch diameter Flowering Cherry.
  - It is located at the top of the driveway on the west side near the northwest corner of the garage.
  - The tree is a combination of three different species of Cherry trees grafted together at the top and bottom of the trunk.
  - There are the early stages of decay in the center of the trunk.
  - The tree was topped at approximately 14 feet.
  - The roots are uplifting and damaging the driveway and adjacent sidewalk.
    - Removal of the roots under the hard surfaces will negatively impact the long-term survivability of the tree.
  - The species is subject to two major disease elements:
    - The foliage is attacked by an infection from a pathogen that causes the disease known as “Brown Rot.” The pathogen is *Monilinia fructicola*.

- The lower trunk is forked with unusually large amounts of included bark.
    - The root collar is characterized by an internal structural weakness prone to failure in storms.

- Scaffold branches extend over the driveway to the west and over the sidewalk leading to the front door to the east.
    - These branches will need to be severely pruned back to allow for the demolition of the existing house and the construction of the new house.

- *The tree is in Poor Condition and will not likely survive the severe pruning needed nor the stresses of demolition and construction.*

Photo # 2: Looking south from SE 56<sup>th</sup> Street at trees # 244 the Cherry on the right, and # 245 the Japanese Maple on the left.

- Recommendation:
  - Consider removing this tree.
  - If the City requires the tree to be retained, Tree Protection Measures below will be adequate.

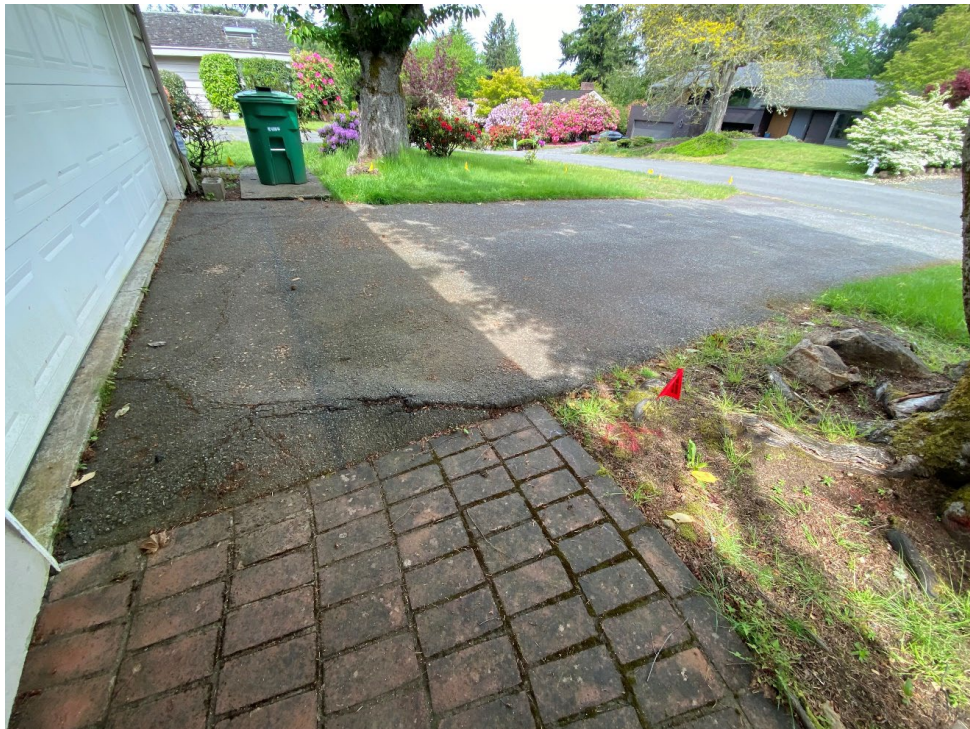
Photo # 3:  
Looking at the base of tree # 244 on the far side of the driveway and the damage being done to the driveway and sidewalks.

Note also the surface roots of the Japanese Maple tree, at the right edge of the photo, and the advanced decay in the buttress roots.

Both trees are recommended for removal.

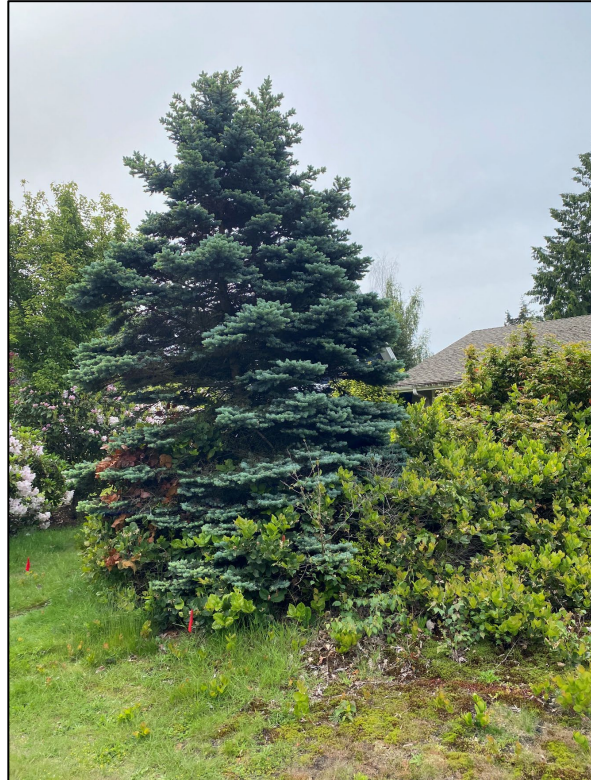
- Tree # 246 is a 5.5-inch diameter Colorado Blue Spruce located in the front yard.
  - The foliage of the tree is infested with a Spider Mite infestation.
  - In spite of this infestation, the tree is in Good Condition.
  - The tree is below the 6-inch threshold but is worthy of retention and provides great aesthetic and environmental benefits.
  - Recommendation: Because the tree is below the 10-inch threshold of a *Managed Tree*, this tree is not required to be retained.
    - However, the tree is healthy and vigorous and is worthy of retention. If it can be saved it will contribute to the finished new home and be a benefit to the property and the community.
    - *Potential to retain with tree protection measures.*
    - *Consider treating for Spider Mites and fertilization.*

Photo # 4: Tree # 246 the Colorado Blue Spruce in the front yard.

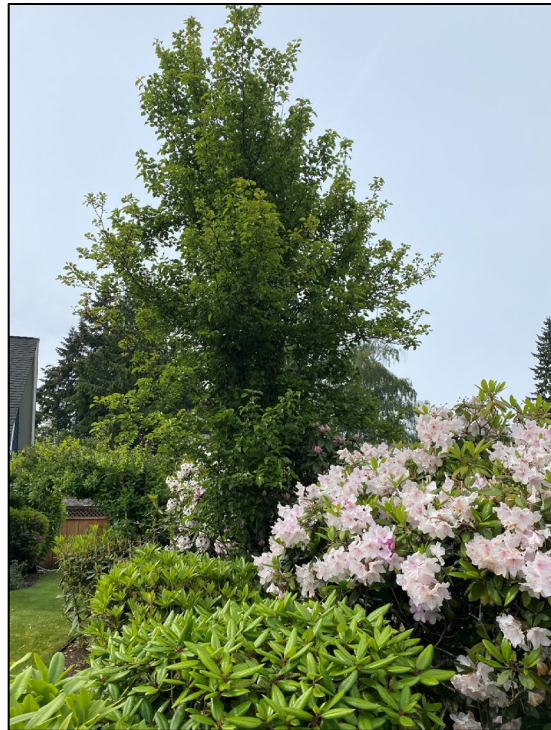
- Tree # 247:
  - Is a Bradford Pear near the east property line.
    - It is estimated to measure 4.5 inches in diameter at 4.5’.
    - It is in Very Good Condition.
    - It is Viable.
  - It is below the threshold of *Managed Trees*.
  - Recommendation: Because the tree is below the 10-inch threshold of a *Managed Tree*, this tree is not required to be retained.
    - However, the tree is healthy and vigorous and is worthy of retention. If it can be saved it will contribute to the finished new home and be a benefit to the property and the community.

Photo # 1: Tree # 247 the Bradford Pear near the east property line. While not required to be retained, the tree is in good health and vigor and is worthy of retention. It contributes value to the property and the neighborhood.

- *Potential to retain with tree protection measures.*
