AMENDED ARBORIST REPORT FOR THE NGUYEN PROPERTY AT 8937 SE 56th Street Mercer Island, WA 98040

Re-Re Revised: November 1, 2022

**Dmitry Lebed
Emerald City Build
P.O. Box 1925
Bellevue, WA 98009**

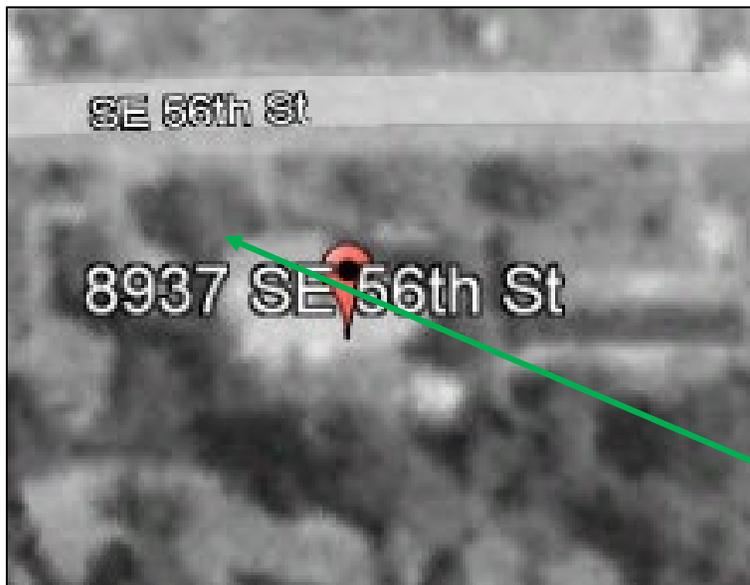
Photo # 1: a July 9, 1990 Google Earth image of the immediate area of the Nguyen house.

While blurry, one can discern that tree # 244 was present and fully grown on July 9, 1990. It is reasonable to conclude that the tree has been growing there for at least 40 years and has adapted to the growing conditions. Given this, there is no need to redesign the house to pull it away from the tree.

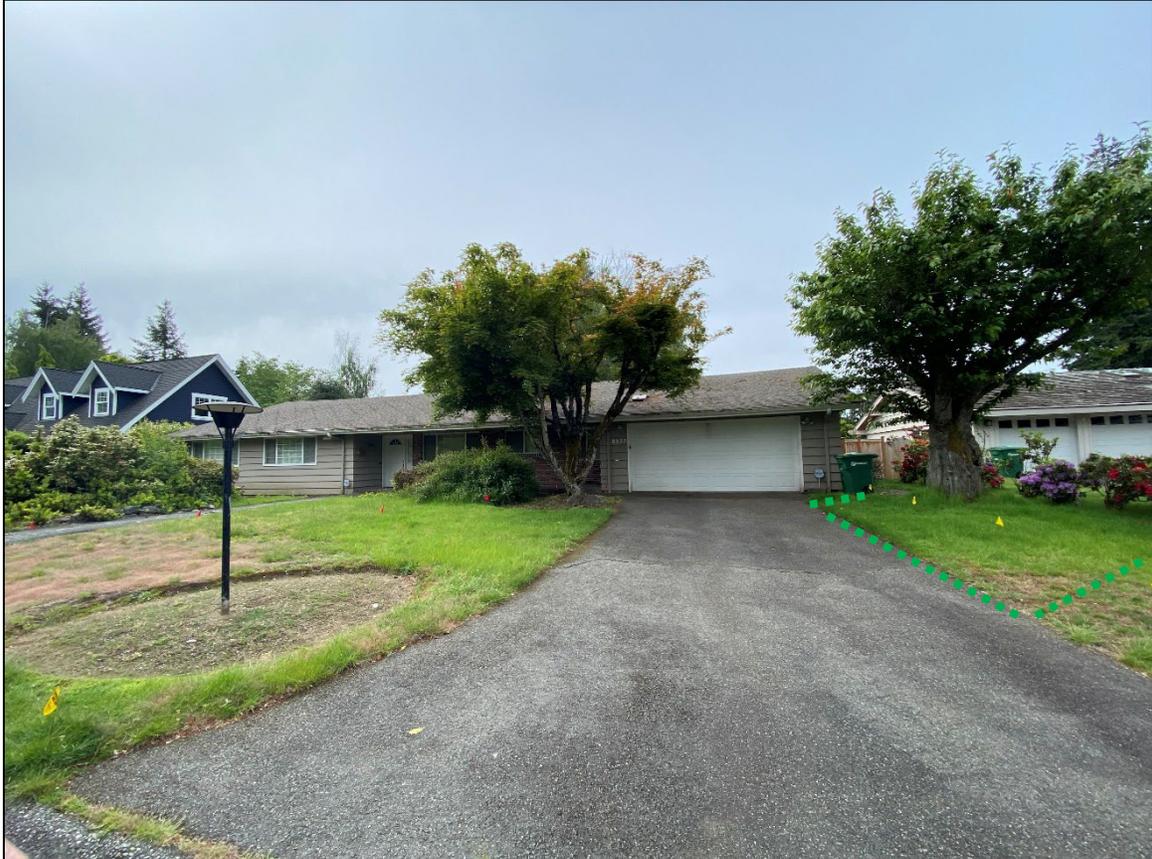
- Photo # 1: Looking south from SE 56th Street at trees # 244 the Cherry on the right, and # 245 the Japanese Maple on the left. Tree Protection Fence Locations.
