# LAYTON TREE CONSULTING, LLC

## ARBORIST REPORT

6922 SE 33<sup>rd</sup> Street  
Mercer Island, WA

**February 11, 2022**

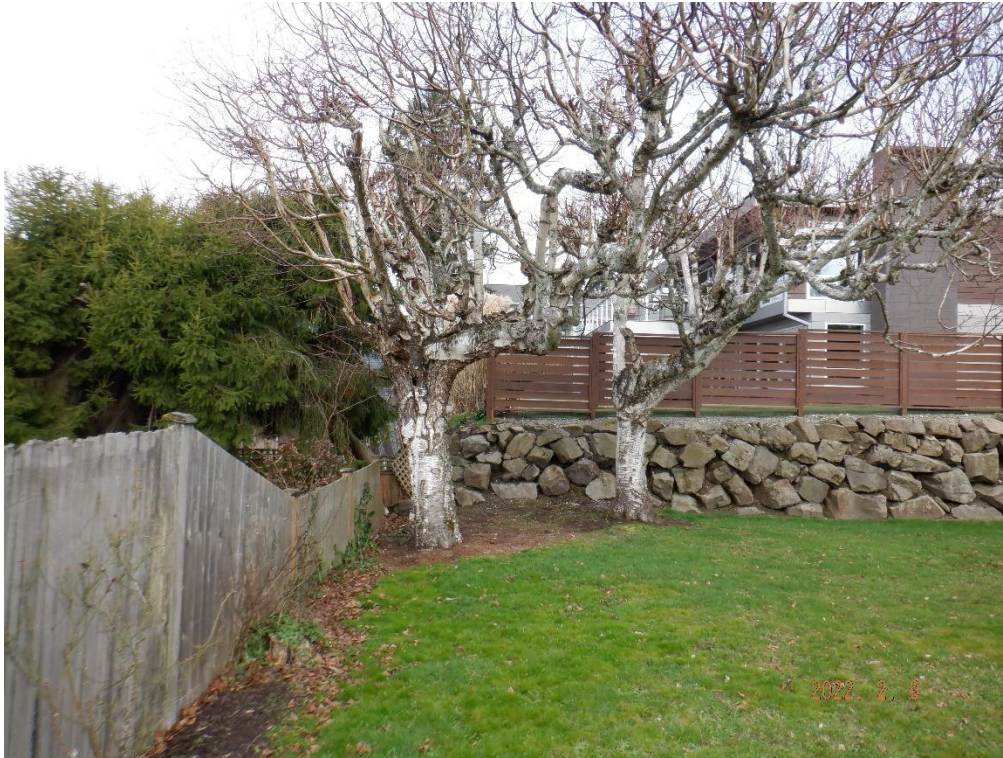
Trees #1 and #2 in northwest corner of property, neighboring Tree #101 on left

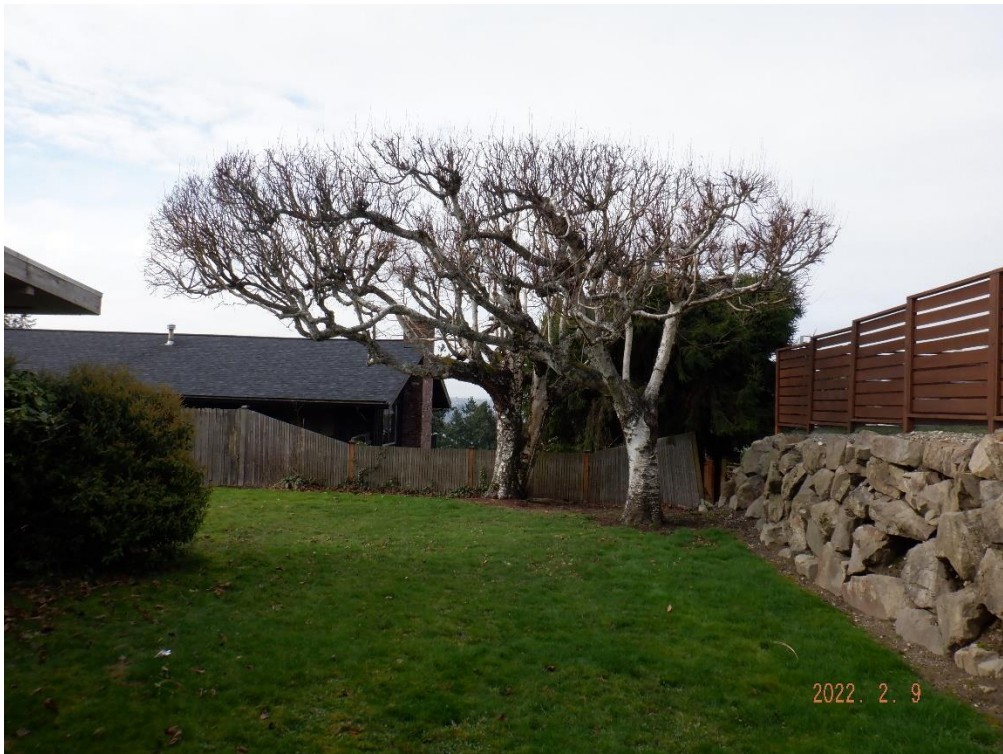
Trees #1 and #2 are mature European white birch, located in the northwest corner of the property. These have been topped and sheared, and maintained at a height of roughly 18-feet for many years now. See pictures below. Both appear to be of fairly good vigor. Tree #1 has significant internal decay within the lower trunk. This is evident by a cavity on the southwest side of the lower trunk. The lower trunk of #2 appears sound. These are in ‘fair’ condition.

Trees #1 and #2 in northwest corner of property

Trees #1 and #2 are well-positioned for successful retention. These should continue to be periodically trimmed or sheared to maintain their current height. Position tree protection fencing at the dripline for adequate protection. Care shall be taken when working near trees to protect soils and surface roots that likely extend beyond the dripline. Cover areas outside of the protection zone with a +/- 6-inch layer of wood chips or hog fuel to protect soils from compaction and damage to surface roots. Tree #2 can be pruned back if desired to provide more clearance. Remove no more than 15% of the total live branches.

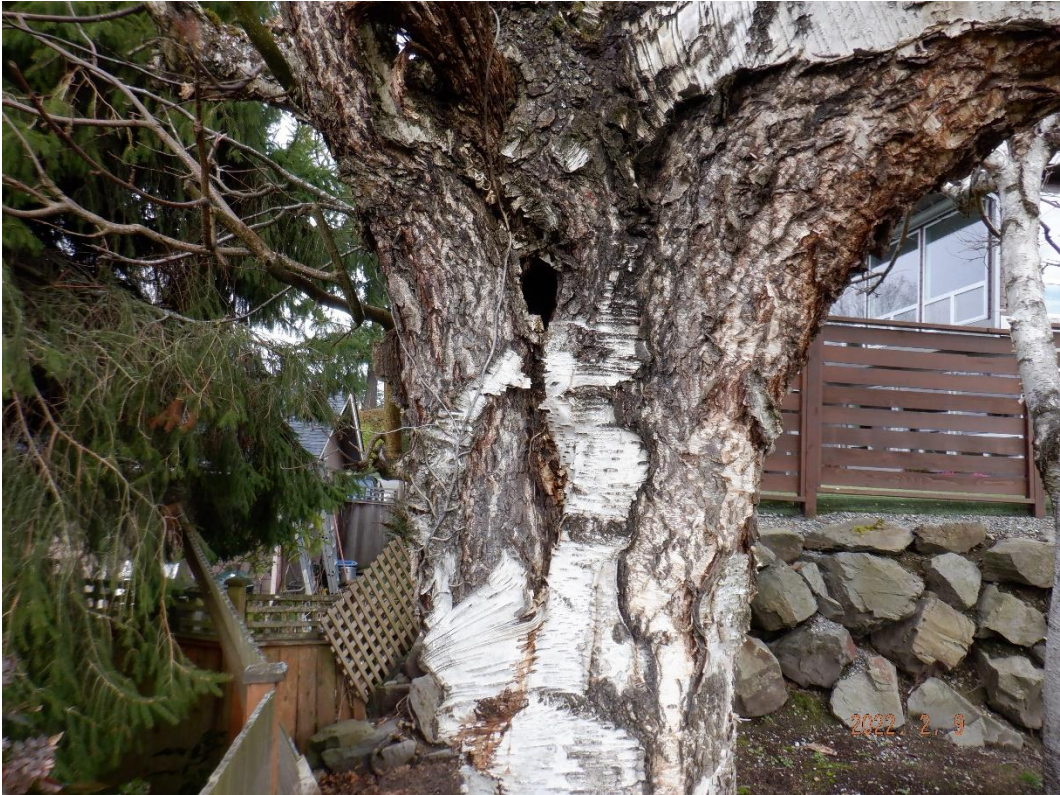
Tree #1, noteworthy trunk decay, cavity

| Tree/<br>Tag # | Species<br>Common Name | Species<br>Scientific Name | DBH<br>(inches) | Height<br>(feet) | Drip-Line / Limits of Disturbance<br>(feet) | | | | Condition | Regulated<br>Yes/No | Exceptional<br>Yes/No | Comments | Proposal |
|---|---|---|---|---|---|---|---|---|---|---|---|---|---|
| 1 | European white birch | <i>Betula pendula</i> | *22 | 18 | 10 | 16/14 | 10/12 | 10 | Fair | Yes | No | routinely topped, extensive trunk decay | Remove |

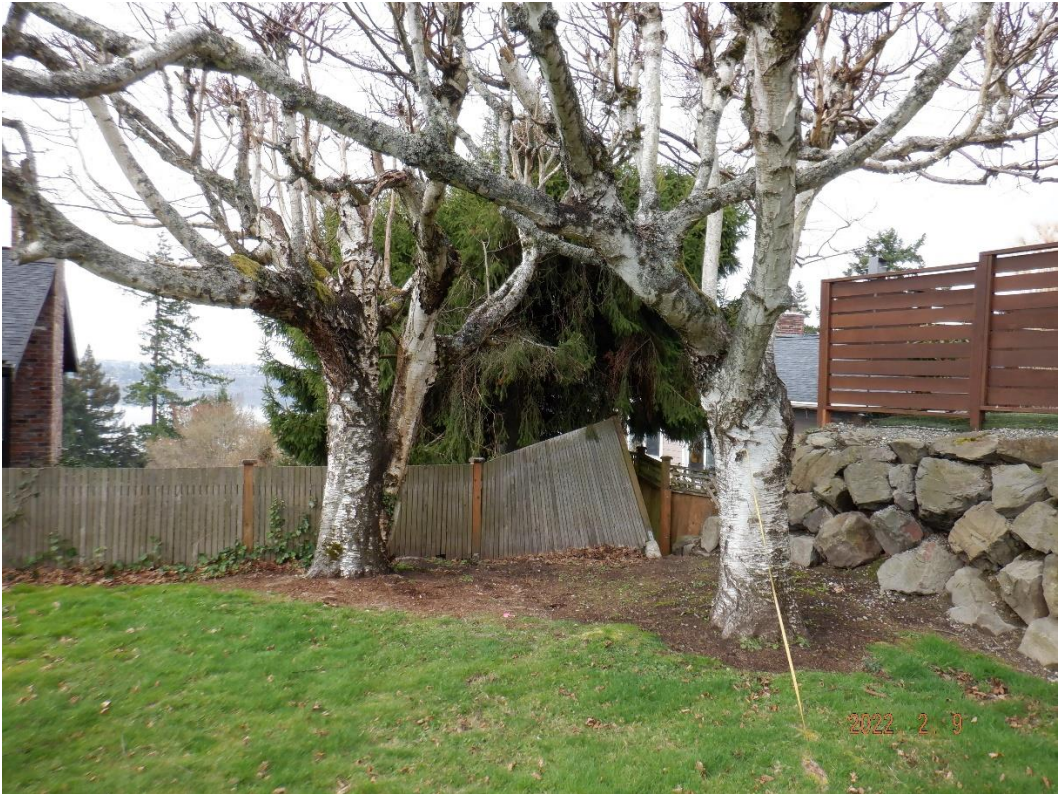
Trees #1 and #2, neighboring Tree #101 in background

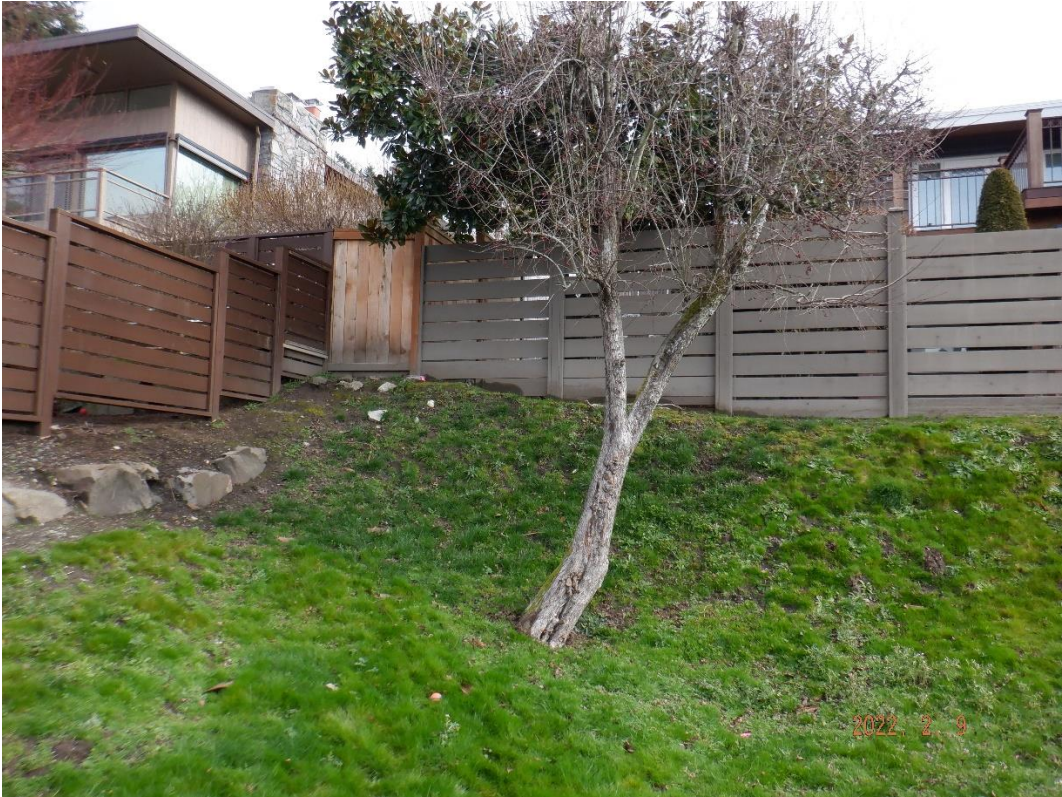
Tree #3 is a young to semi-mature English hawthorn in the northeast corner of the property. It has also been topped in the past. It is in ‘fair’ condition.

Tree #3, neighboring Tree #102 in background

Tree #3, the small non-regulated tree can be removed if desired. If removed, one replacement tree would be required.

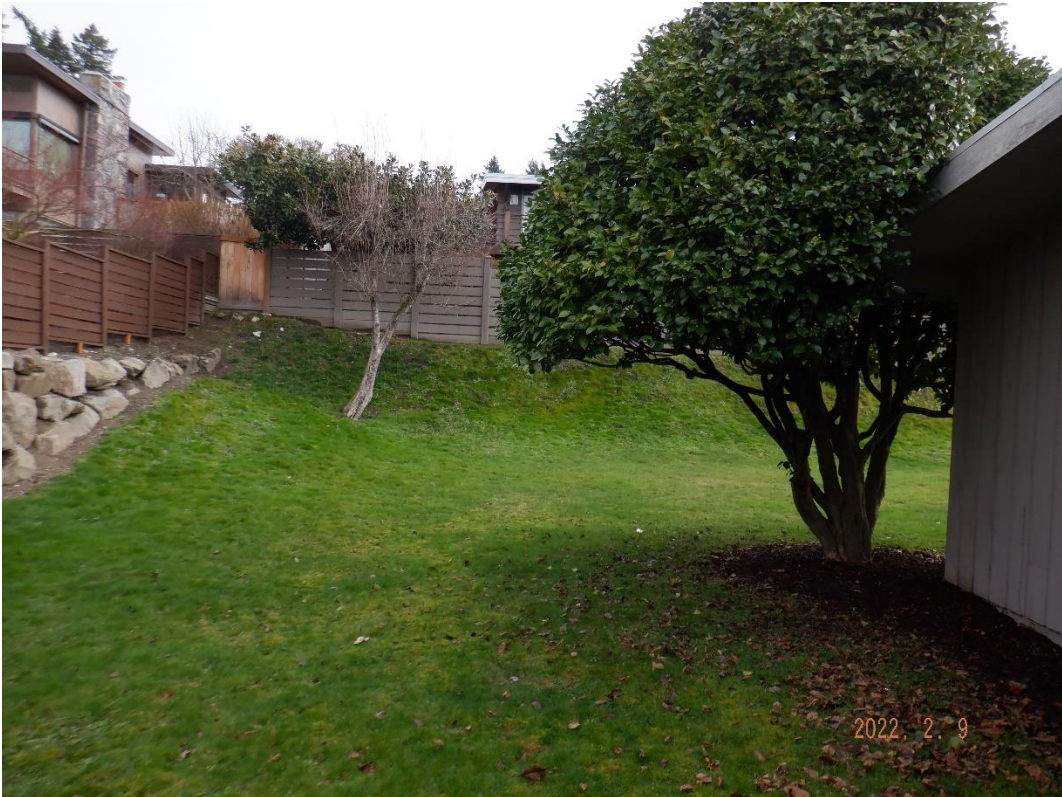
Back of property looking eat to Tree #3, large Camellia shrub at corner of house

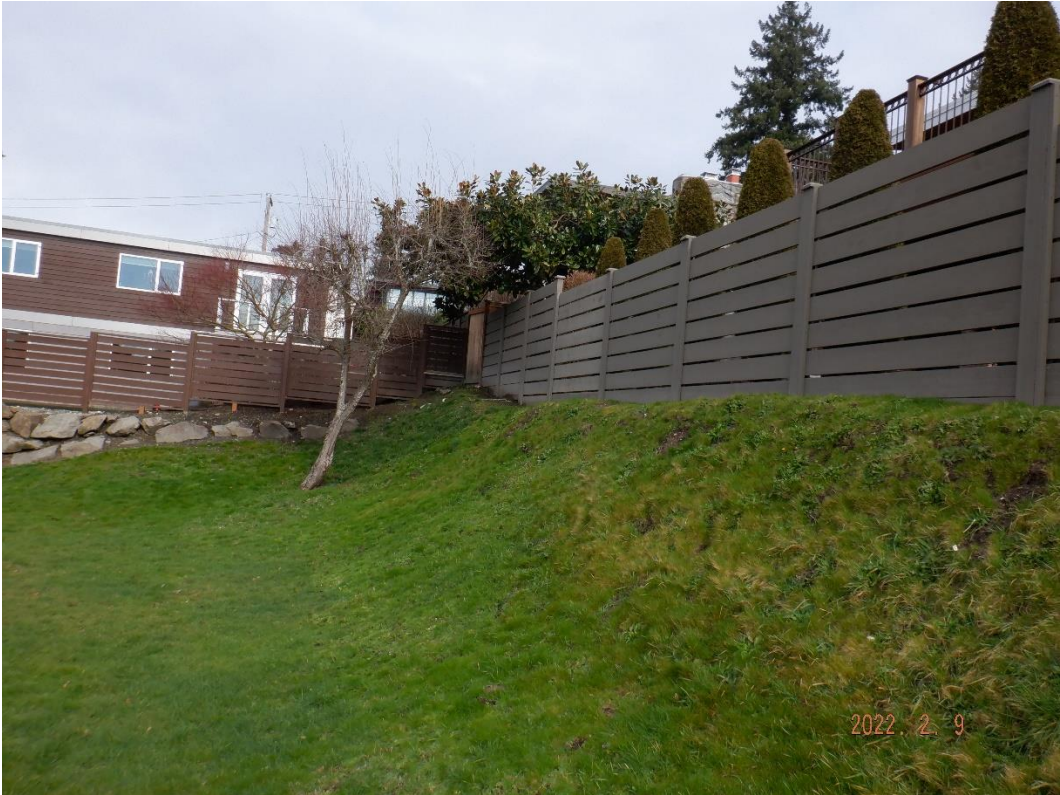
Looking north to northeast property corner

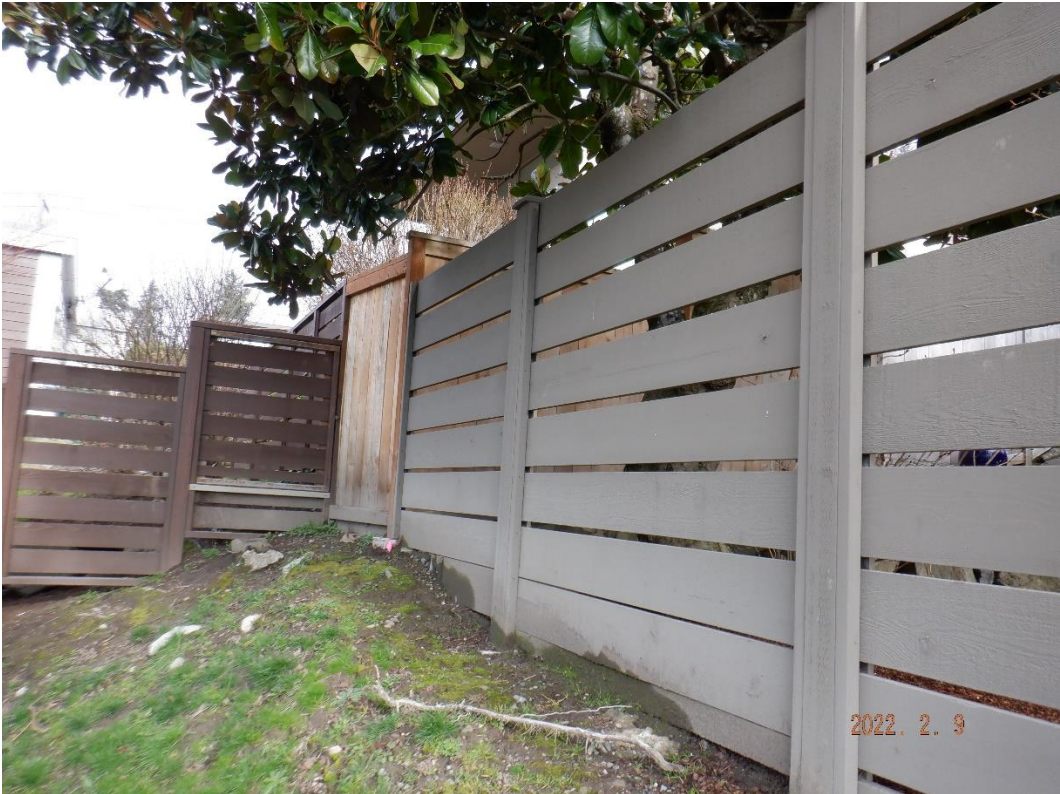
Tree #102 is a semi-mature southern magnolia located close to the east property line off of the northeast corner. It has also been topped in the past. It is situated on a grade or elevation approximately 5-feet above that of the property. There is a steep slope or bank on the east perimeter of the property. It is of good vigor and appears to have developed good structural form when viewed from the subject property. Condition is rated as 'fair' due to the topping.

Neighboring Tree #102, protect soils within dripline

Neighboring Tree #101 will not be impacted by re-development of the property. To adequately protect neighboring Tree #102, maintain the existing grade within the dripline. Position a protection barrier a few feet beyond the dripline.
