June 1, 2020

Project: Tree review and assessment at 3633 90th Avenue SE, Mercer Island, WA.
Parcel number 5021900400.

Objectives: Addendum to MacCoy report dated 2/21/2020 correcting tree species, conditions, and sizes as necessary.

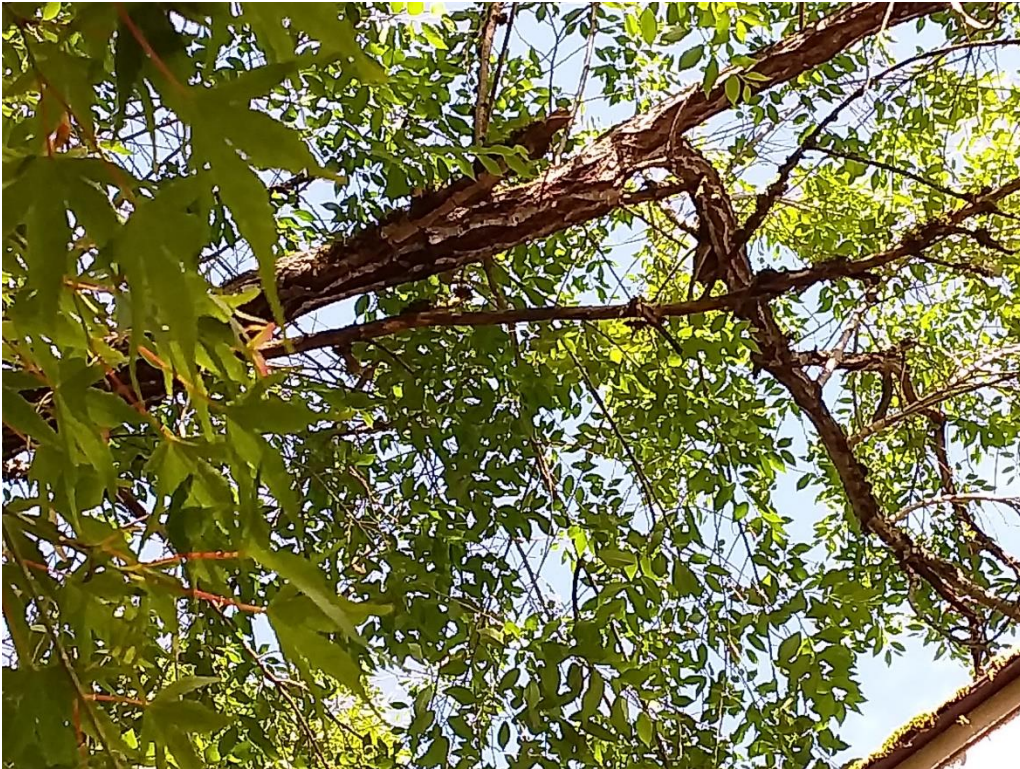
- 3) Weeping Cherry (*Prunus sp*) 8” DSH, 7’ tall, 4’ radial spread. Fair condition.
- 4) Siberian Elm (*Ulmus pumila*) 27” DSH, 45’ tall in highest reaches but has been breaking down in the 30’ range and then resprouting. It spreads unevenly 18-24’ radially and has breakage along the limbs of most of its scaffolds (Figure 5 and 6). It is heavy coated in ivy from the base to at least the mid canopy. This elm is in weak condition with limited new growth, elongation, and poor color.

Figure 5. Photo of breakage in the crown of the elm.

Recommendations: Based solely on their conditions and suitability for retention the author would advise that the #2, #4, and #7 trees be removed.

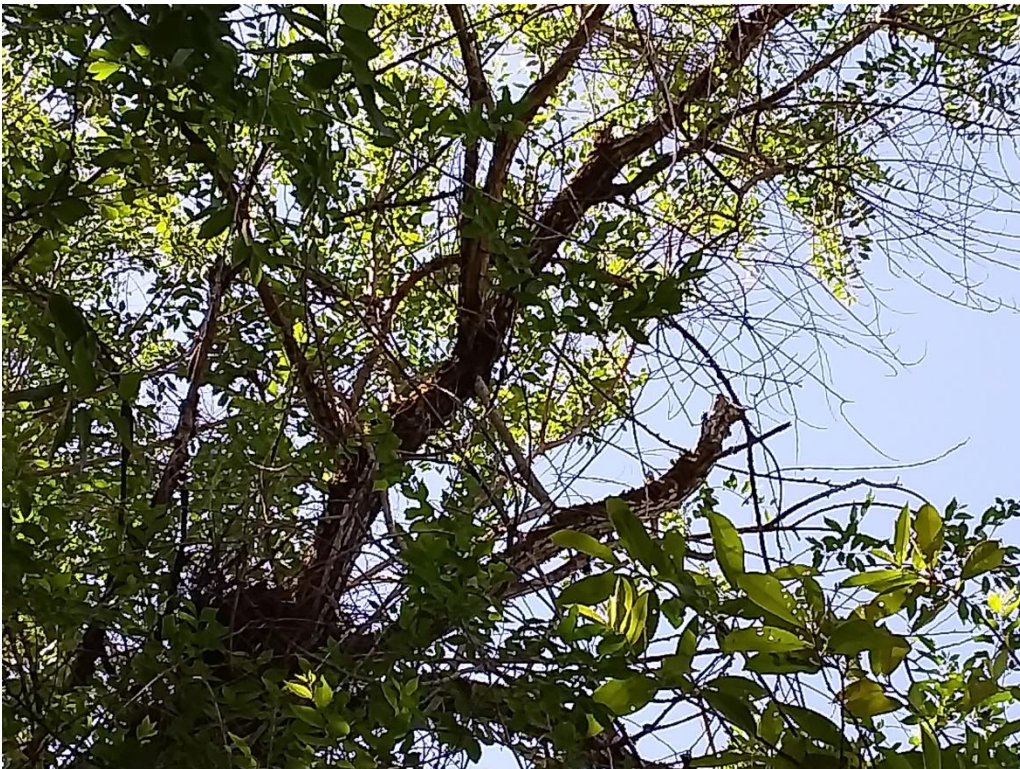
Figure 6. Another breakage area in the canopy of the elm.
