## Arborist Report

To: Sturman Architects c/o Logan Gaylan  
Site: 6454 E Mercer Way, Mercer Island, WA  
Re: Tree Inventory and Assessment  
Date: March 14, 2022  
Project Arborist: George White,  
ISA Certified Arborist #PN-8908A  
ISA Qualified Tree Risk Assessor  
Reviewed By: Connor McDermott,  
ISA Certified Arborist #PN- 8704A  
ISA Qualified Tree Risk Assessor  
Referenced Documents: Site Plan (Sturman Architects, 1/20/2022)  
Attached: Table of Trees  
Tree Site Map

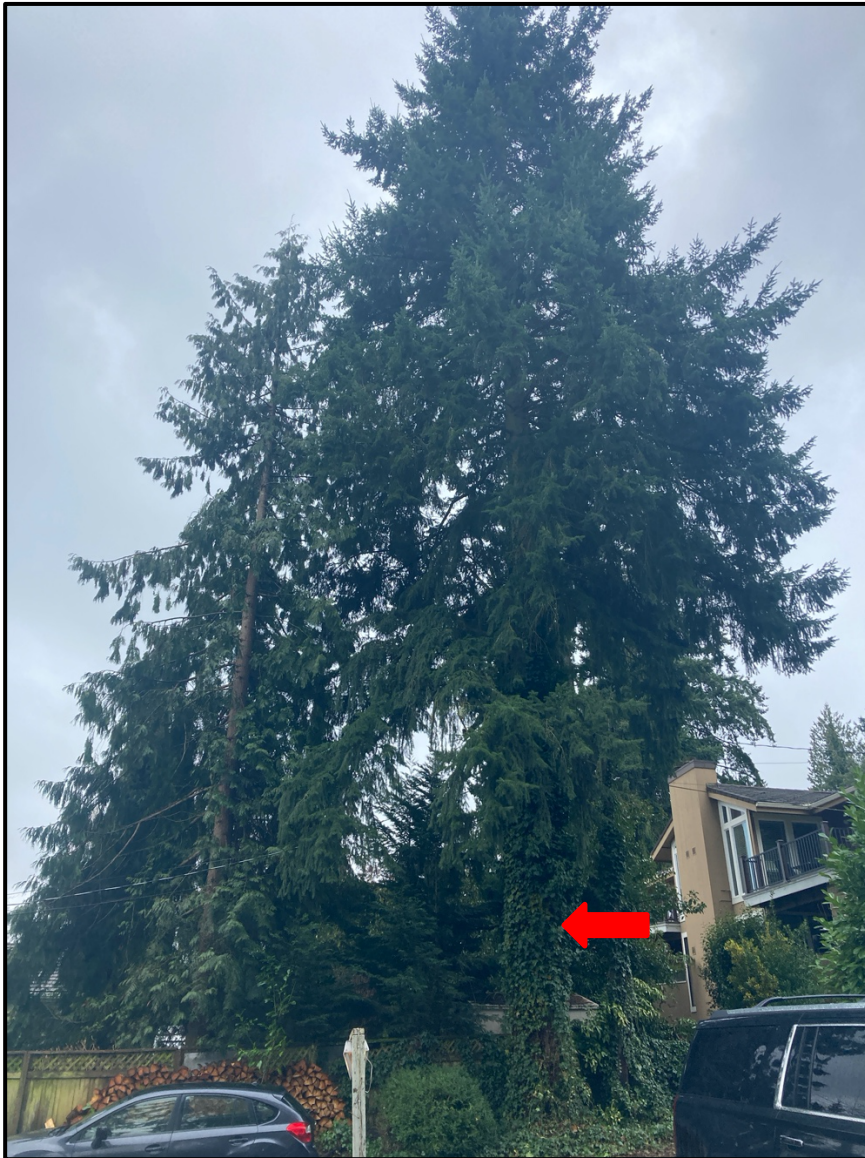
Tree 72 is an exceptional Douglas-fir the southwest corner of the lot that is currently proposed for retention (see photograph 1). A significant portion of the root zone of this tree lies beneath the existing driveway. This tree can be protected at the edge of the existing hardscape provided that the existing driveway is resurfaced without demolishing the existing surface.

**Photograph 1.** Tree 72, an exceptional Douglas-fir (Indicated with red arrow) in the southwest corner of the lot. This tree can be protected at the edge of the existing hardscapes. The English ivy should be removed from the trunk.

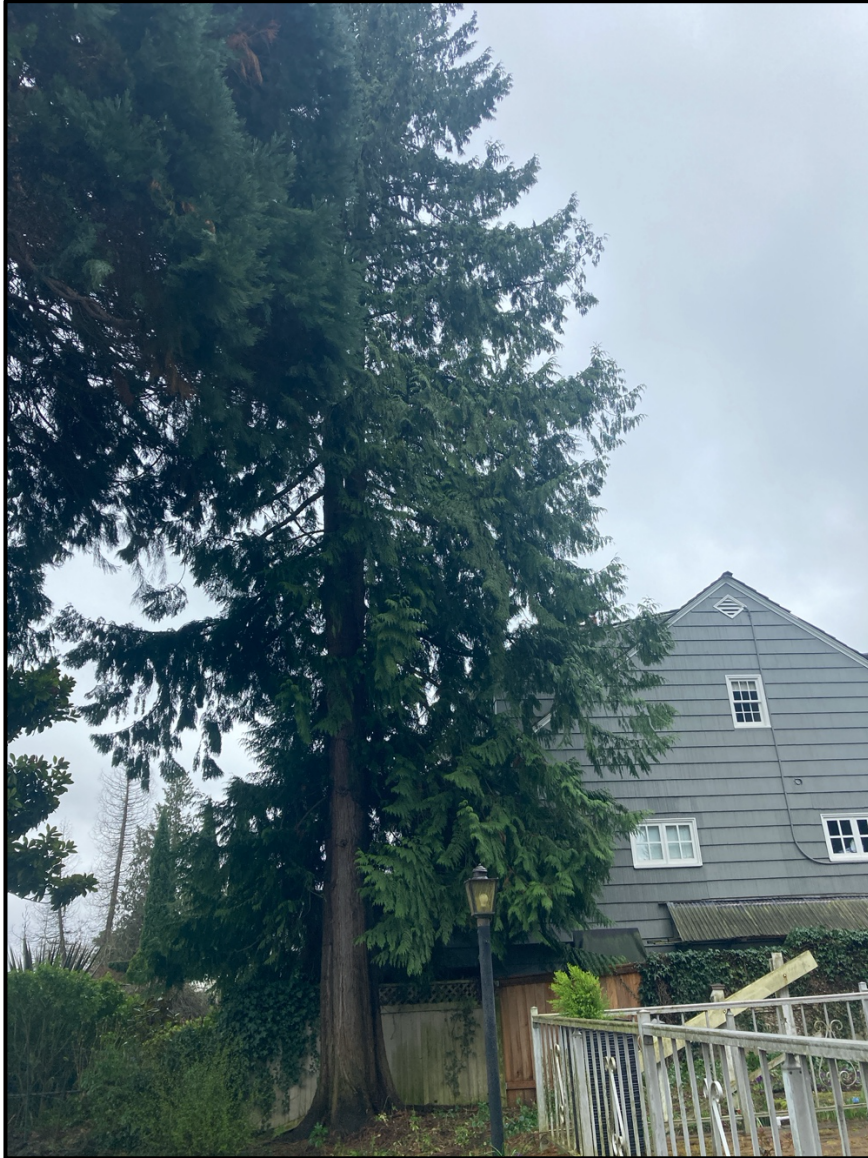
Tree 73 is an exceptional western redcedar located just southeast of the existing house (see photograph 2). Plans show that the corner of the proposed addition will encroach slightly on the recommended limits of disturbance (RLOD) for this tree. Based on the provided plans the impacts in this area should be minimal because the addition sits on two post footings. Any excavation within the RLOD must be conducted carefully using a flat-fronted bucket and must be monitored by the project arborist. Any exposed roots must be cut cleanly and immediately backfilled to avoid desiccation. Tree protection

**Photograph 2.** Tree 73, an exceptional western redcedar southeast of the existing house.

fencing to the specifications outlined in Appendix F must remain in place for the duration of the project. No materials storage or machine access shall be permitted within the RLOD.

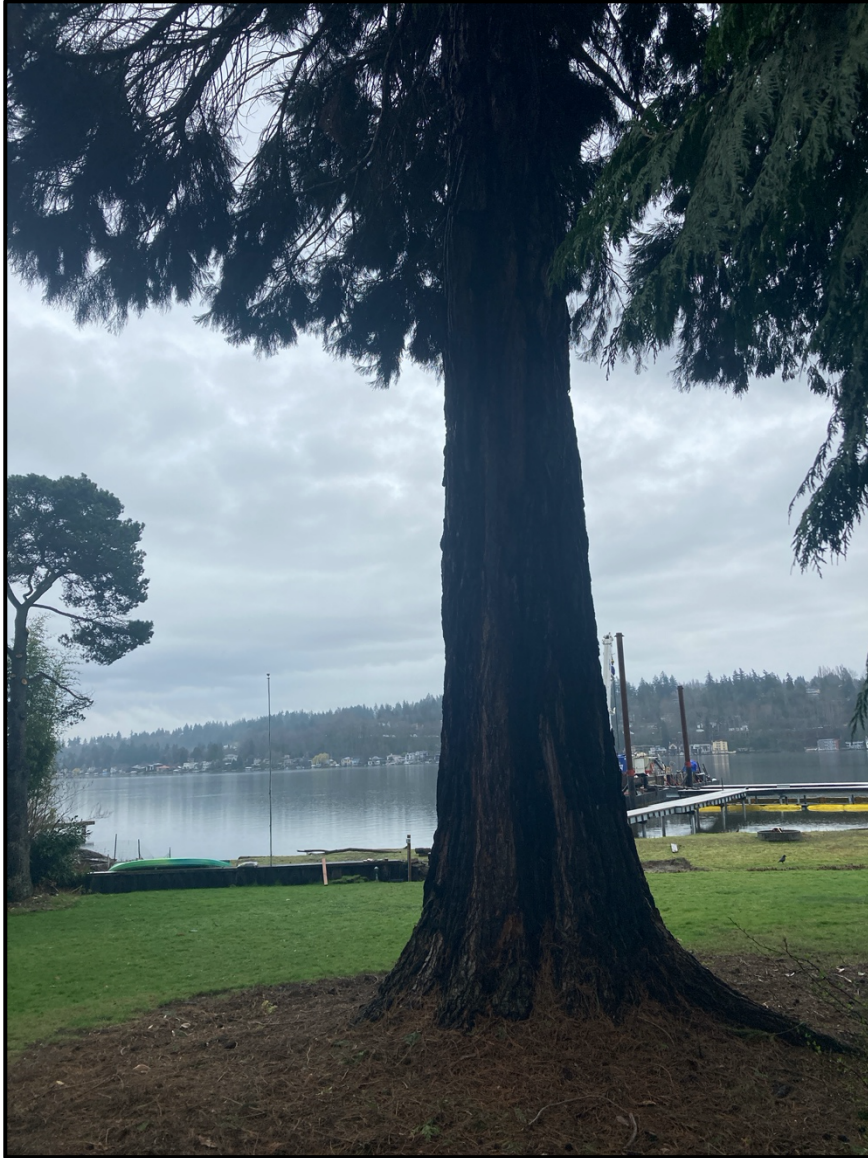
Tree 74 is an exceptional giant sequoia due east of the existing house this tree must be protected at the RLOD listed in the attached Table of Trees with tree protection fencing to the specifications outlined in Appendix F for the duration of the project (see photograph 3).

**Photograph 3.** Tree 74, an exceptional giant sequoia due east of the existing house.

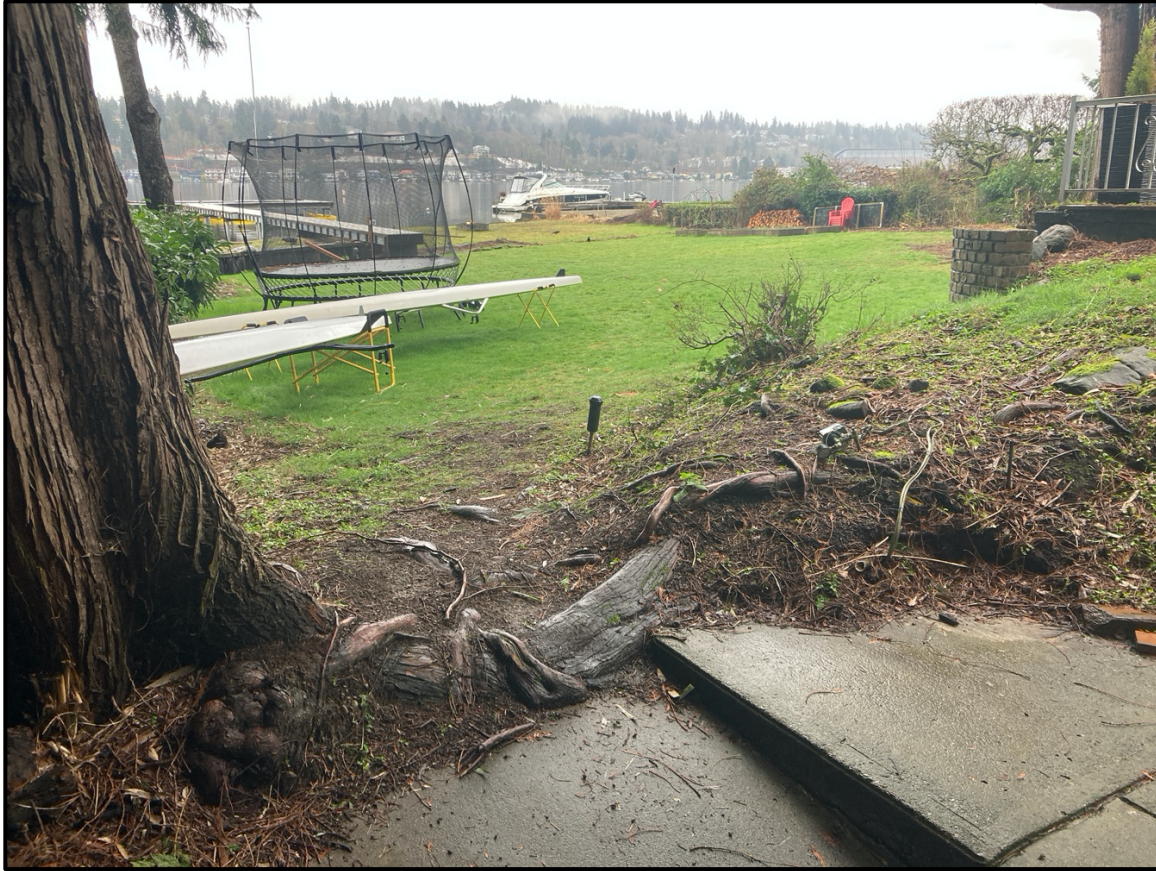
Tree 79 is a western redcedar that has significant conflicts with the existing patio and concrete path and is proposed for removal. (See photograph 4). The stump of this tree should be ground in place and not ripped out to avoid root damage to adjacent trees. Three replacement trees will be required to mitigate this tree, in accordance with the specifications outlined in MMC 19.10.070.

**Photograph 4.** Tree 79, a 29-inch western redcedar with significant root conflicts with the patio and concrete path. This is the only large tree currently proposed for removal.

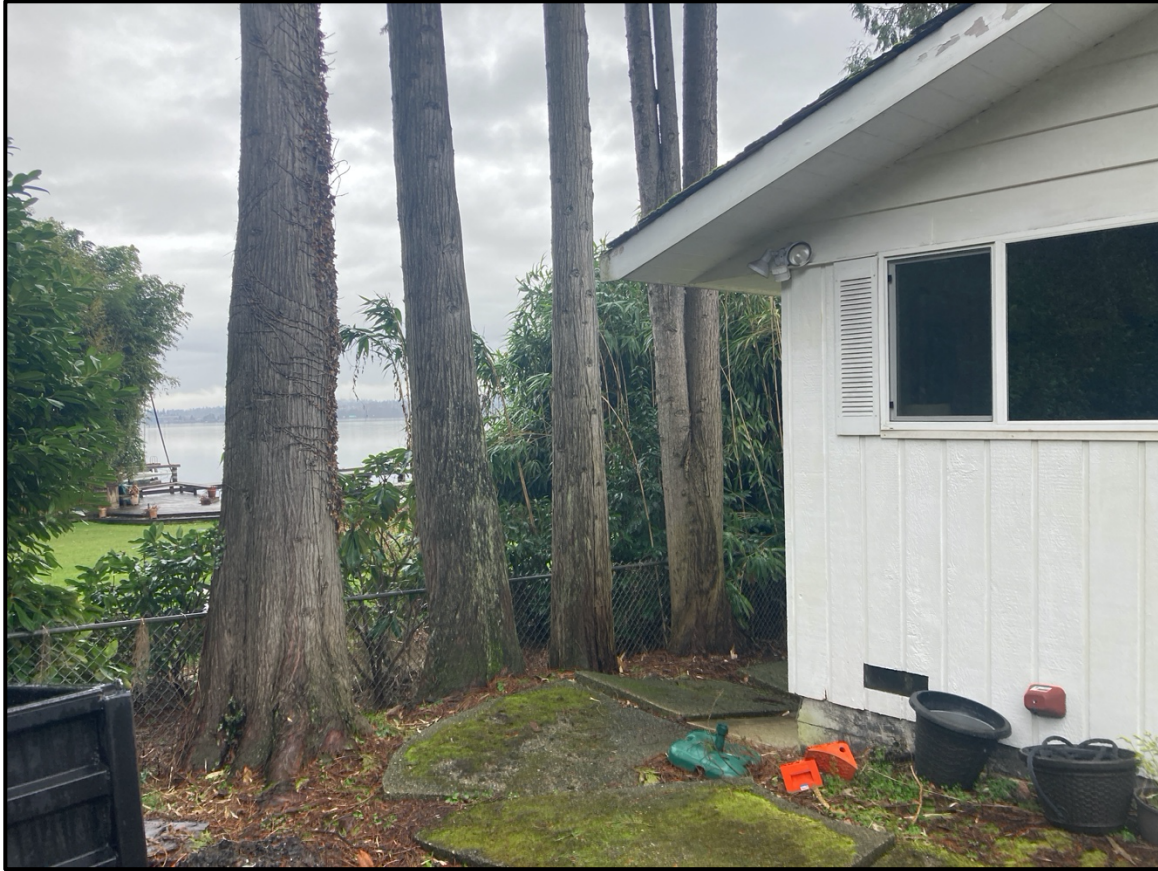
Trees 80-83 are a row of western redcedars north of the house. These trees must be protected at the RLOD of at the edge of the existing hardscapes. Any necessary clearance pruning must be completed by an ISA certified arborist in accordance with ANSI A300 pruning standards. If the concrete path along the north side of the house is to be re-leveled it should be leveled using fill only. No roots should be cut or shaved in this process (see photograph 5).

**Photograph 5.** Trees 80 through 83, four western redcedars immediately north of the house. These trees must be protected at the edge of the existing hardscapes for the duration of the project. Any leveling of the concrete pavers must be achieved through fill only.
