Arborist Report

Site: Matthew Wiley Property
6838 96th Ave SE, Mercer Island

Re: Tree Inventory

Date: May 13, 2022

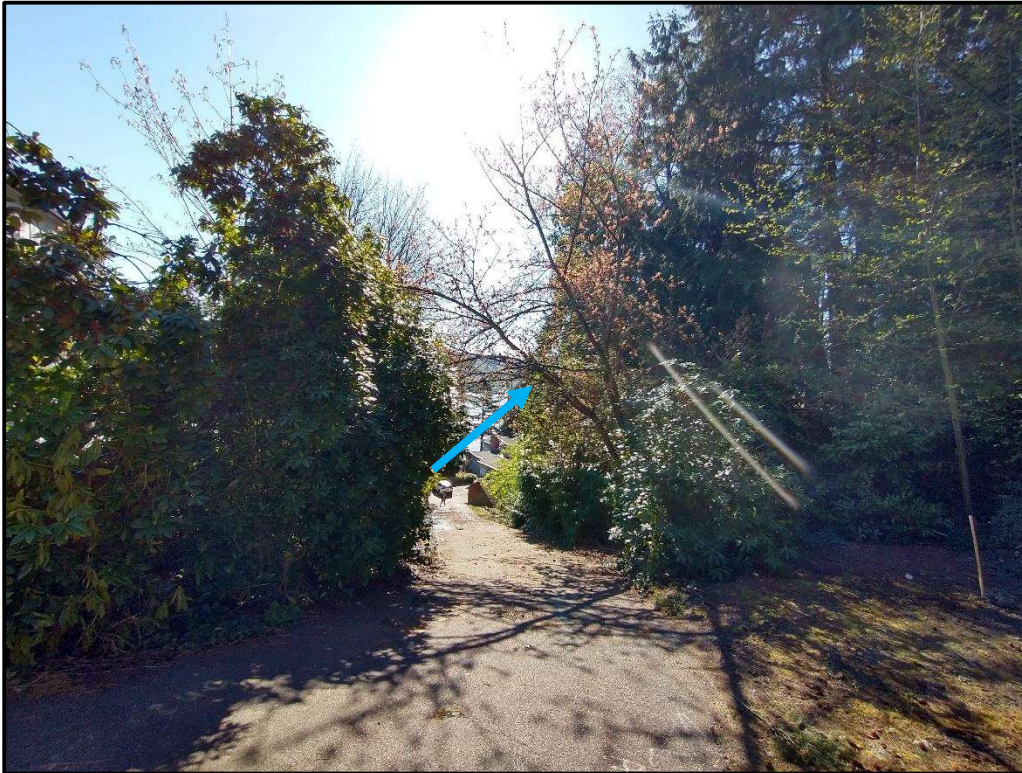
Photo 1. Looking to the southeast from the top of the driveway. Tree 331, a bitter cherry, will likely require some clearance pruning to accommodate construction access.

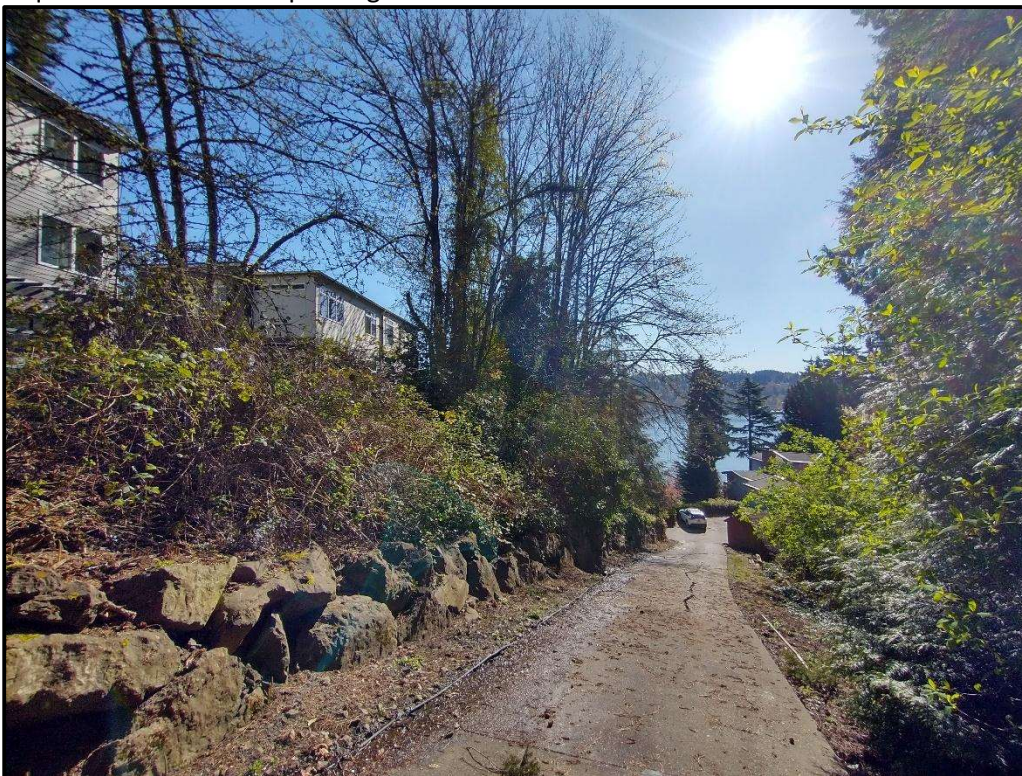
Photo 2. Looking east from near the top of the driveway. Rockery to the north is planned for retention.

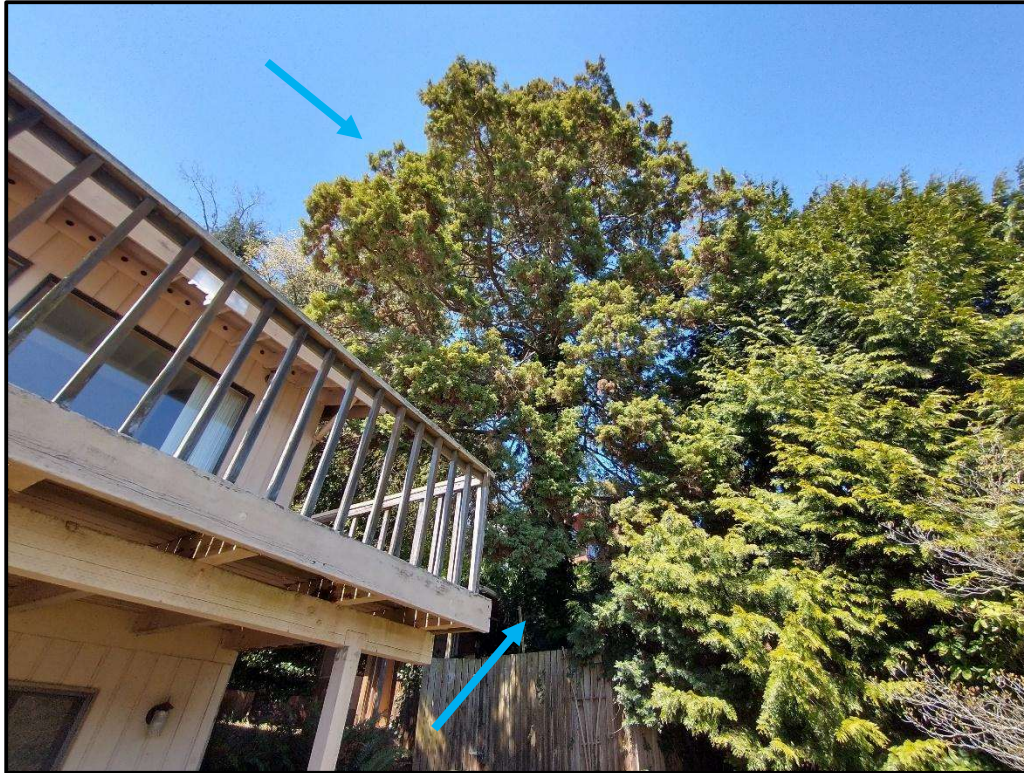
Tree 362 is a 31-inch DSH Sawara cypress (*Chamaecyparis pisifera*) in good health and structural condition located within a small, fenced area near the garden shed just north of the house.

Photo 3. Tree 362, a Sawara cypress, directly adjacent to the shed proposed for removal. Demolition and construction activities adjacent to this tree should be monitored by an ISA certified arborist. Some clearance pruning may be required to accommodate site work.

The RLOD for tree 362 is 21 feet. Because of existing site conditions, most of the work proposed near tree 362, including demolition of the existing home, falls within the RLOD. Note on the plan set that required work in this area is all within the RLOD. All work within the tree protection area is subject to arborist monitoring and tree protection specifications outlined in Appendix F. Alternative methods may be required.

To preserve the root system of tree 362 and the adjacent off-site trees, the shed should be demolished carefully with equipment staged outside the tree protection area. The project arborist should be on site to monitor this work and document any root impacts. The soil area exposed by the removal should be backfilled with native soil from the site or sandy-loam mixture prepped for new landscaping.

When installing the proposed prefabricated shed, install the foundation on a platform with concrete-forming-tube footings. Exact footing locations should be finalized in the field and oriented to avoid impacting any structural roots of tree 362. Any excavation for footings must use excavation methods and specifications as indicated in the tree protection specifications provided in Appendix F.

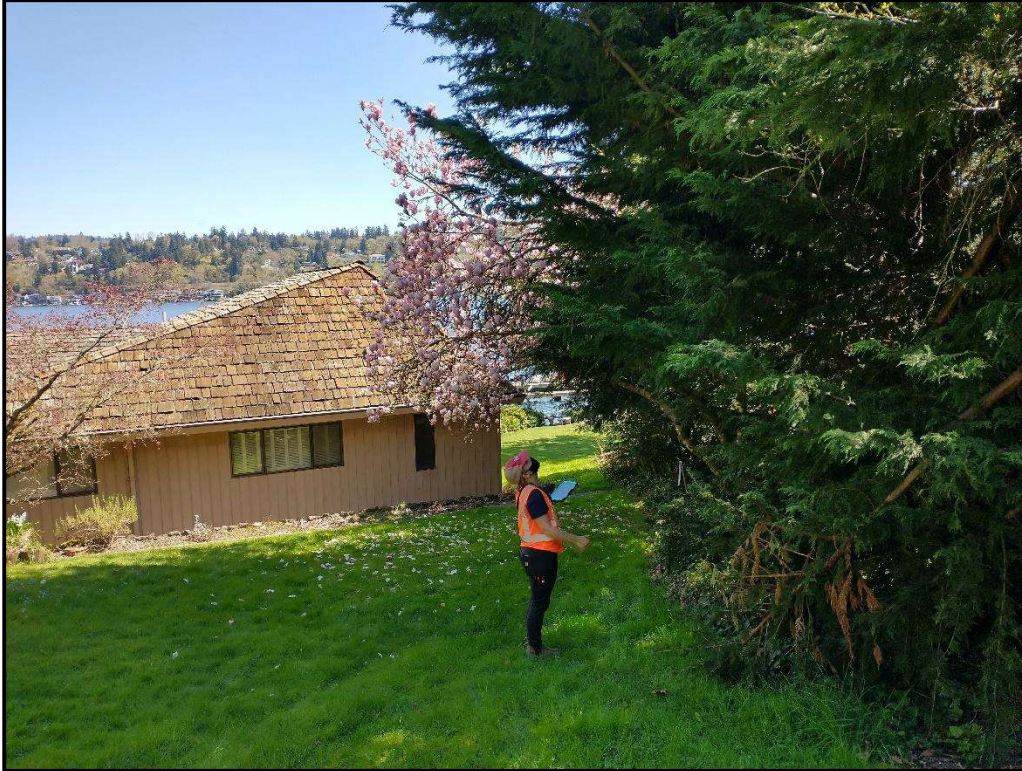
Photo 4. Off-site trees on southern property line and tree 363, a phototropic saucer magnolia. Depending on clearance requirements, the magnolia is not suitable for retention as clearance pruning would remove a significant portion of the canopy.

Two non-regulated trees (Tree 363 and ACPA-NR) are proposed for removal due to construction impacts. Per 19.10.030.A both trees are exempt from the replacement requirements as they are under 10-inches DSH.

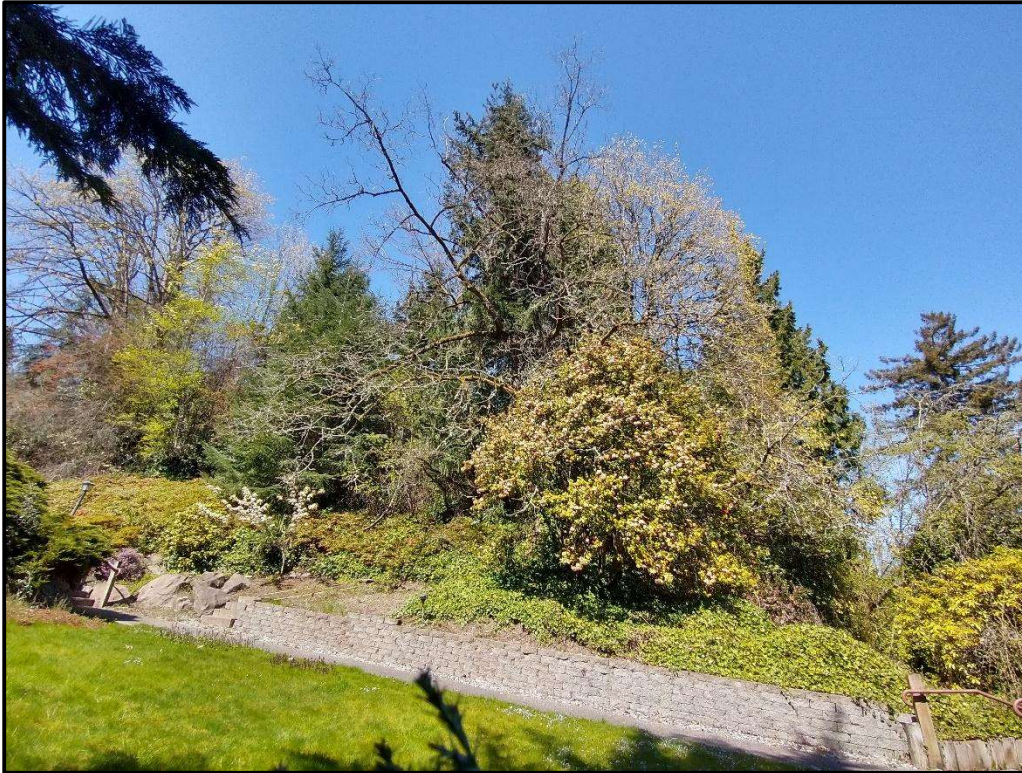
The understory is primarily invasive ivy (*Hedera helix*) with some areas vegetated with native sword fern (*Polystichum munitum*). The amount and density of the ivy will affect the tree and vegetation management. We recommend managing ivy on the site.

Photo 5. Trees north of the driveway. Stacked block retaining wall is proposed for replacement. Note extensive ivy understory.

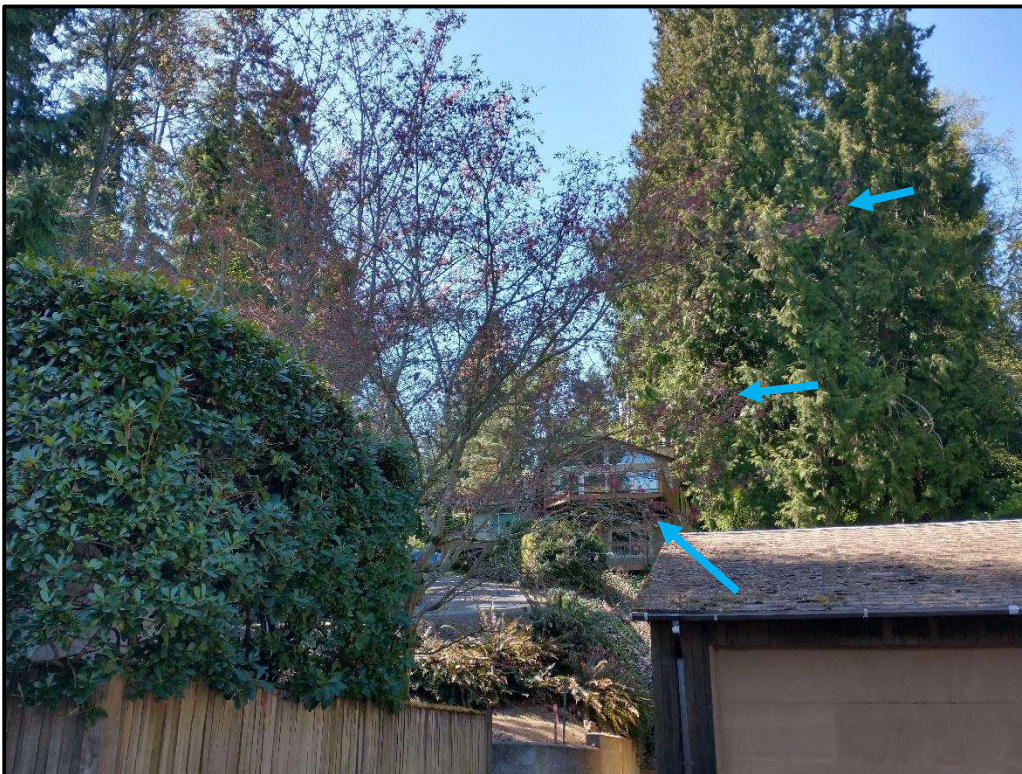
Photo 6. Off-site Japanese maple may require some clearance pruning to accommodate demolition and construction activities. Blue arrows identify overhanging branches that may need pruning management.

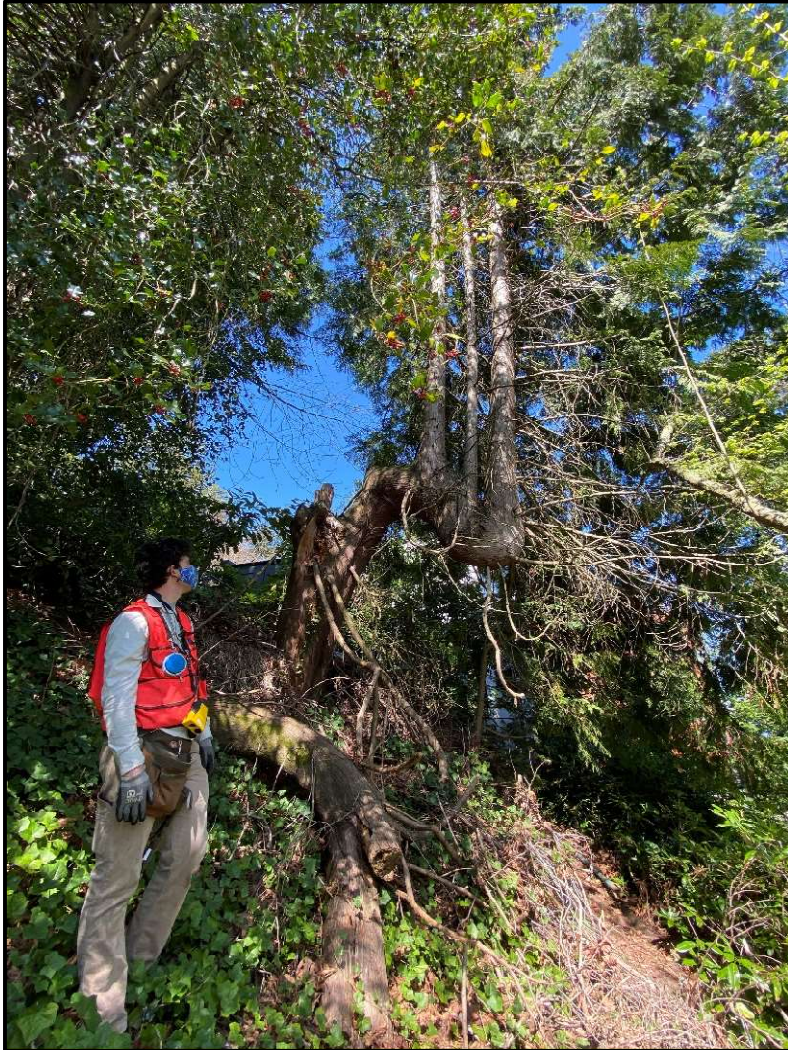
Off-site tree C is a large western redcedar that has a broken top and three codominant reiterations growing asymmetrically to the east. We recommend a follow-up assessment of this tree, in coordination with the adjacent property owner, to assess structural stability and provide recommendations for long-term management.

Photo 6. Off-site tree C, a western redcedar with a broken primary leader and three reiterations. We recommend further assessment of this tree in coordination with the adjacent property owner.
