Re: Tree Protection – Malone 4214 – 86<sup>th</sup> Ave SE, Mercer Island, WA

NeilKelly – Malone storm drain

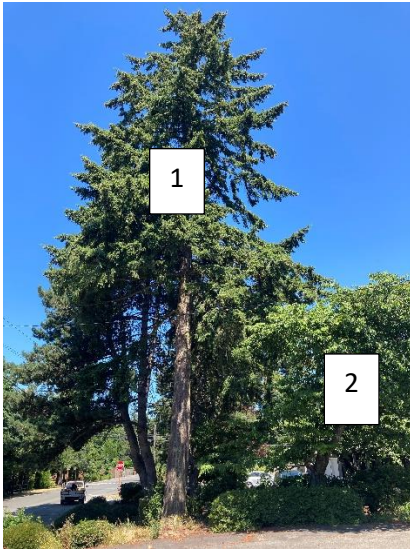
The plan calls for a storm drain to be installed about three to four feet south of the trees and two feet deep. Tree data is provided below. Both trees are in fair to good condition and should be retained.

<u>Tree No</u>	<u>Species</u>	<u>~Diameter (inches)</u>	<u>~Height (feet)</u>	<u>Live Crown (%)</u>	<u>Dripline Live limb extent (feet)</u>	<u>Comments</u>
1(offsite)	Douglas-fir ( <i>Psuedotsuga menziesii</i> )	31	85	70	22	Minor pitching, slight butt swell
2(On site)	Cherry ( <i>Prunus sp</i> )	18	22	80	16	Decay pockets at pruning wounds

Subject Trees

Traditional open line excavation will sever up to 30-percent of the root systems of each tree, thus destabilizing and creating decay causing fungal entry points. A better solution is to air excavate (vacuum) the route and insert the pipe under and through the root system.

Damaged roots, if any should be cut cleanly if broken or covered with damp burlap if scraped until the native soil is replaced. In the event that roots over 2-inches in diameter are severed inadvertently then a certified arborist should inspect those and make a determination of remedial actions.

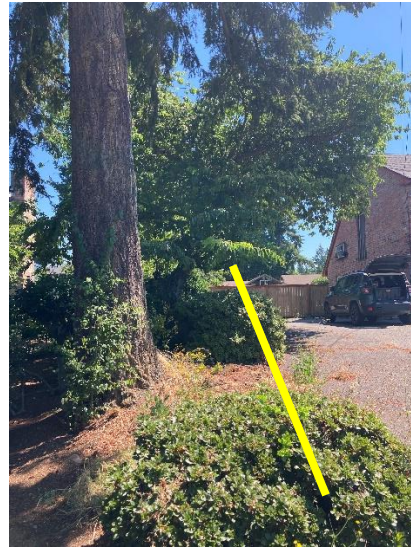
Approximate Drain Location

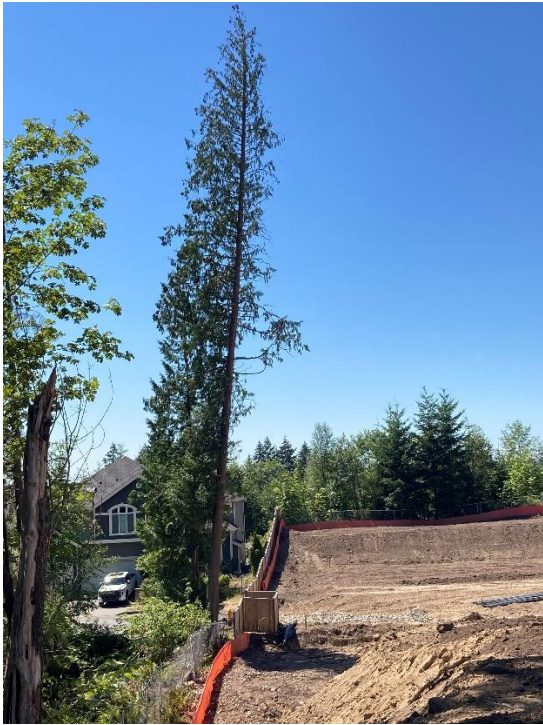
Tree No. 1, showing lean

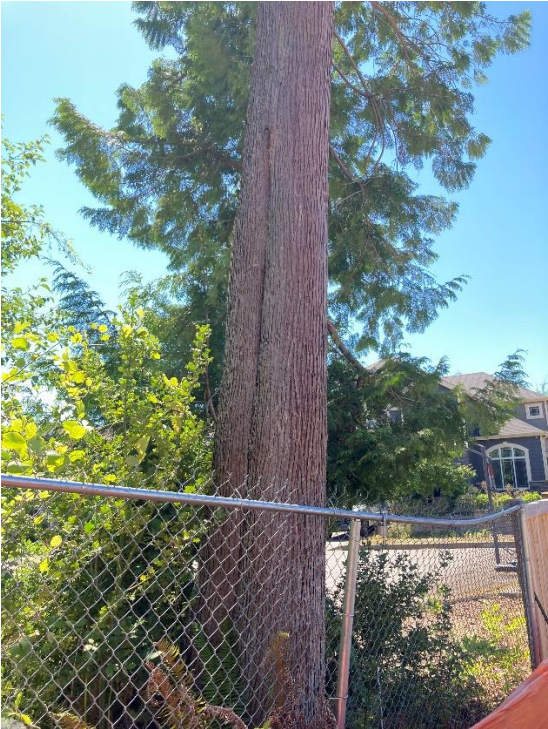
Tree No. 1 with seam and decay

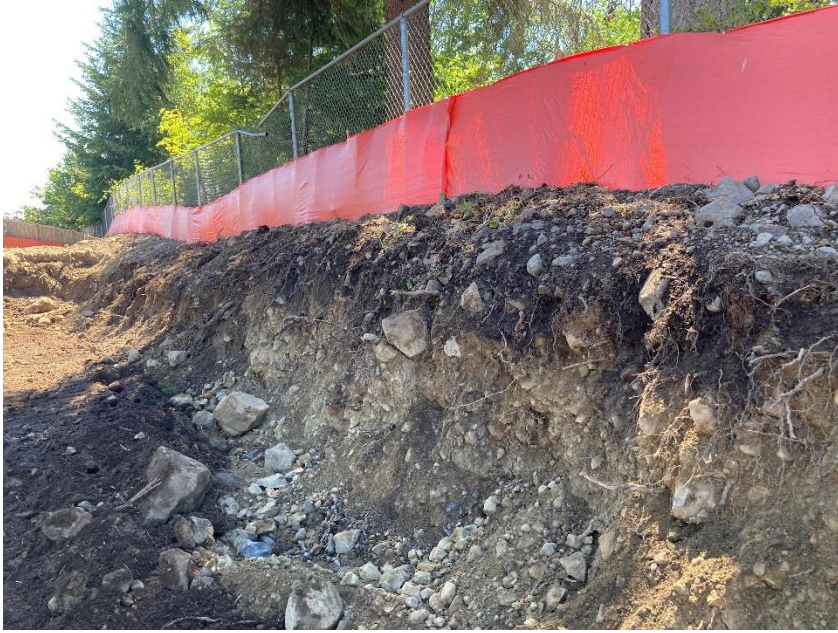
Excavation limit under trees 2,3,4
