**Arborist Report
DRAFT**

To: Sarah Lee
Site: 9772 SE 41st St Mercer Island, WA 98040
Re: Tree Inventory
Date: October 19, 2021
Project Arborist: Andrea Starbird
ISA Certified Arborist #PN-9084A
ISA Qualified Tree Risk Assessor
Reviewed By: Josh Petter
ISA Board Certified Master Arborist #PN- 8406B
ISA Qualified Tree Risk Assessor
Attached: Table of Trees
Tree Site Map

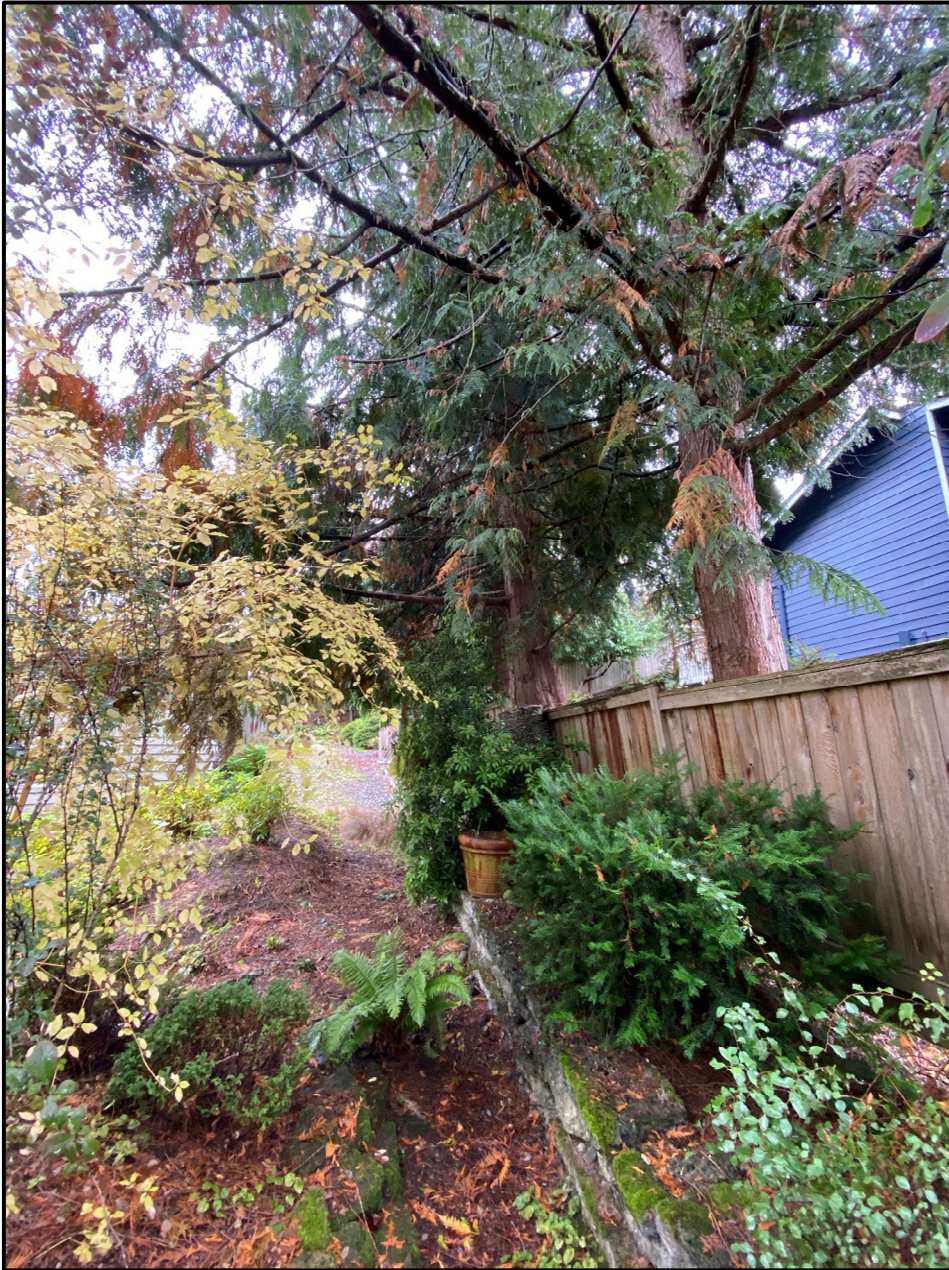
Trees B, C, and D were western redcedars (*Thuja plicata*) growing in a row along the western property line. There is a short rockery on site that crosses through the root zone of these three trees (Photo 1).

Photo 1. Trees B, C, and D. Off-site western redcedars growing near the fence. Note the rockery at the base on the subject site.

Trees B, C, and D should be protected as a group. Their root zone extends below the existing fence and rockery near the property line. No ground disturbance should occur within the recommended limits of disturbance for these trees without arborist coordination; arborist monitoring may be required.

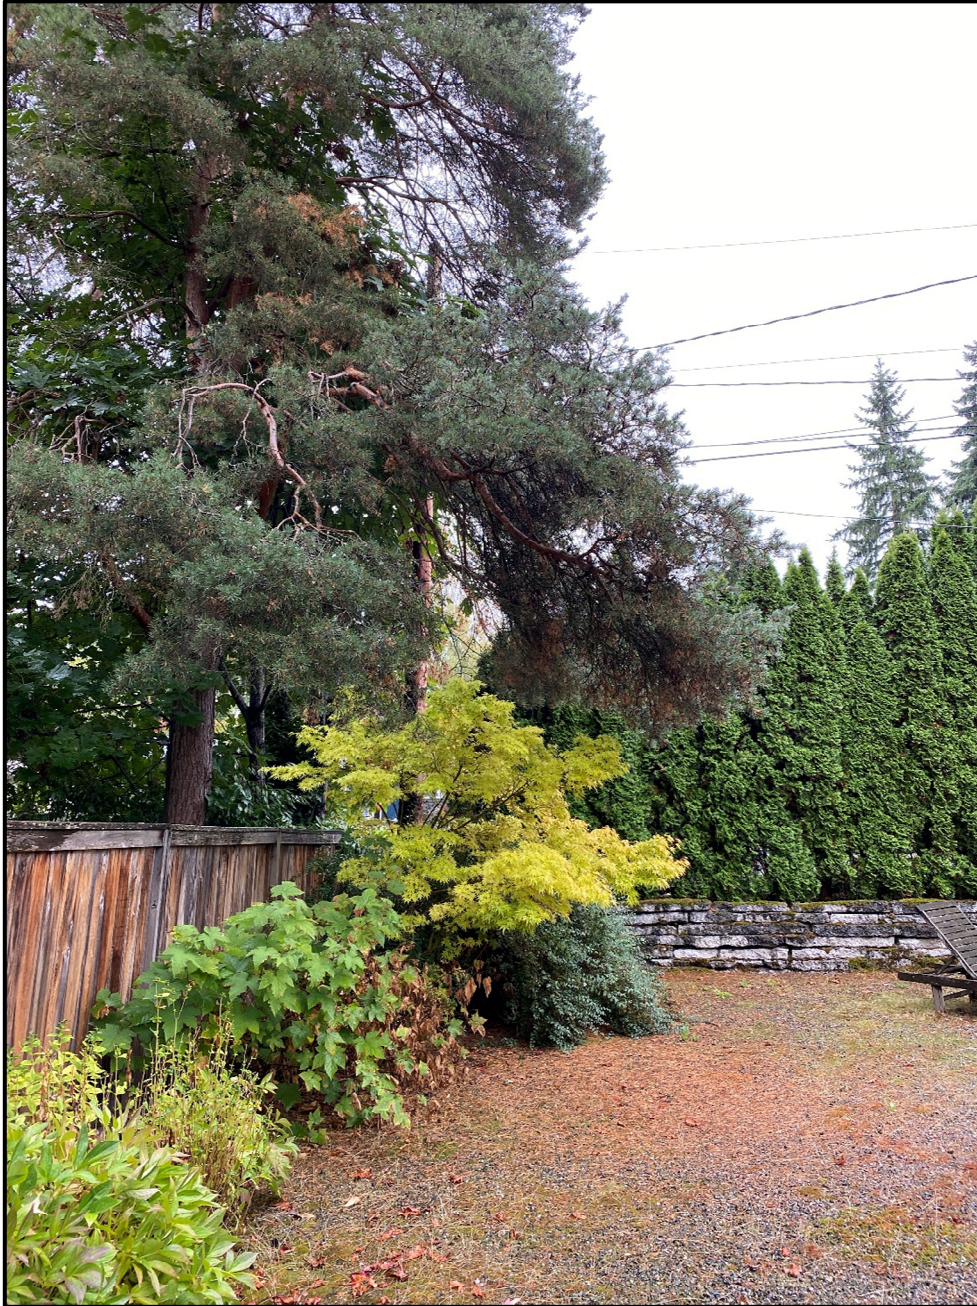
Tree F was a 14-inch DSH Scot's pine (*Pinus sylvestris*) in good health and structural condition. The canopy was asymmetrical and the portion overhanging the subject site was low hanging.

Photo 2. Tree F, an off-site Scot's pine with low-hanging canopy. If clearance pruning is necessary, perform minor canopy reduction, removing no more than 10% of the live crown in any 3 year period. Use the smallest pruning cuts (2 inch-diameter and smaller) possible to achieve clearance.

Trees F and G may require pruning to raise the canopy and provide access clearance for site demolition and new building construction. If clearance pruning is required, remove the minimum canopy necessary using 2-inch diameter cuts and smaller. Remove no more than 10% of the live canopy for either tree in a 3-year period. (Photos 2, 3)

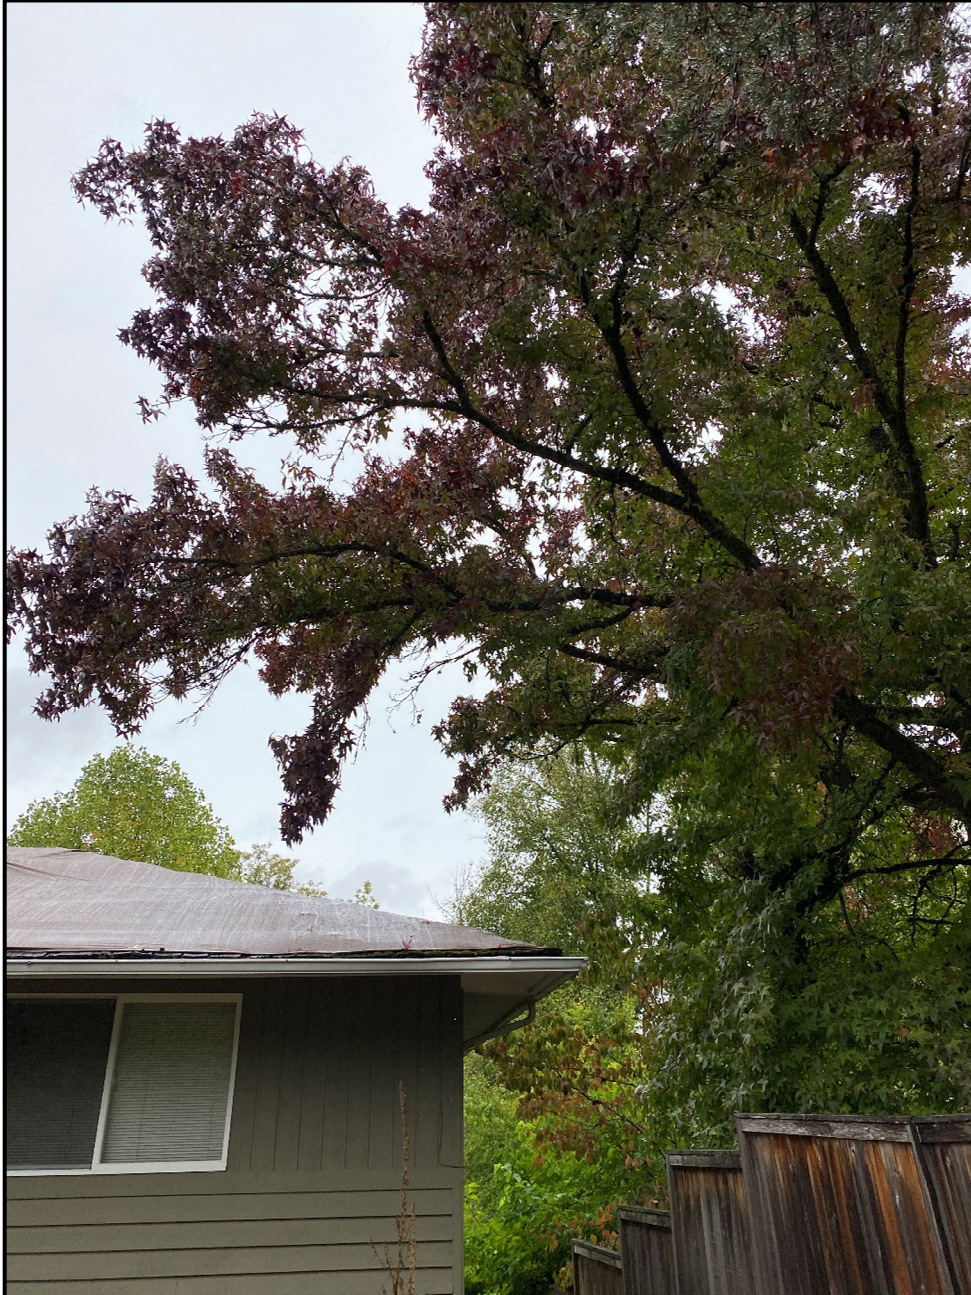
Tree G was a 12-inch DSH sweetgum (*Liquidambar styraciflua*) with an open-grown, spreading canopy form. This tree overhangs the roof of the existing house.

Photo 3. Tree G, an open grown sweetgum with overhanging canopy. An experienced ISA certified arborist should reduce the crown using the small diameter cuts to achieve any clearance required. Do not remove any more than 10% of the live canopy within a 3 year period.
