Arborist Report

To: Sturman Architects, City of Mercer Island
Site: 4603 89th Ave SE, Mercer Island, WA 98040
Re: Tree Inventory for Development
Date: Nov 29, 2022
Project Arborist: Joseph Sutton-Holcomb
ISA Board Certified Master Arborist #PN- 8397BM
Municipal Specialist; Qualified Tree Risk Assessor
Referenced Documents: Lanctot Residence: Permit Set (Sturman Architects, dated 11/29/2022)
Attached: Table of Trees
Tree Site Map
Tree Retention Worksheet

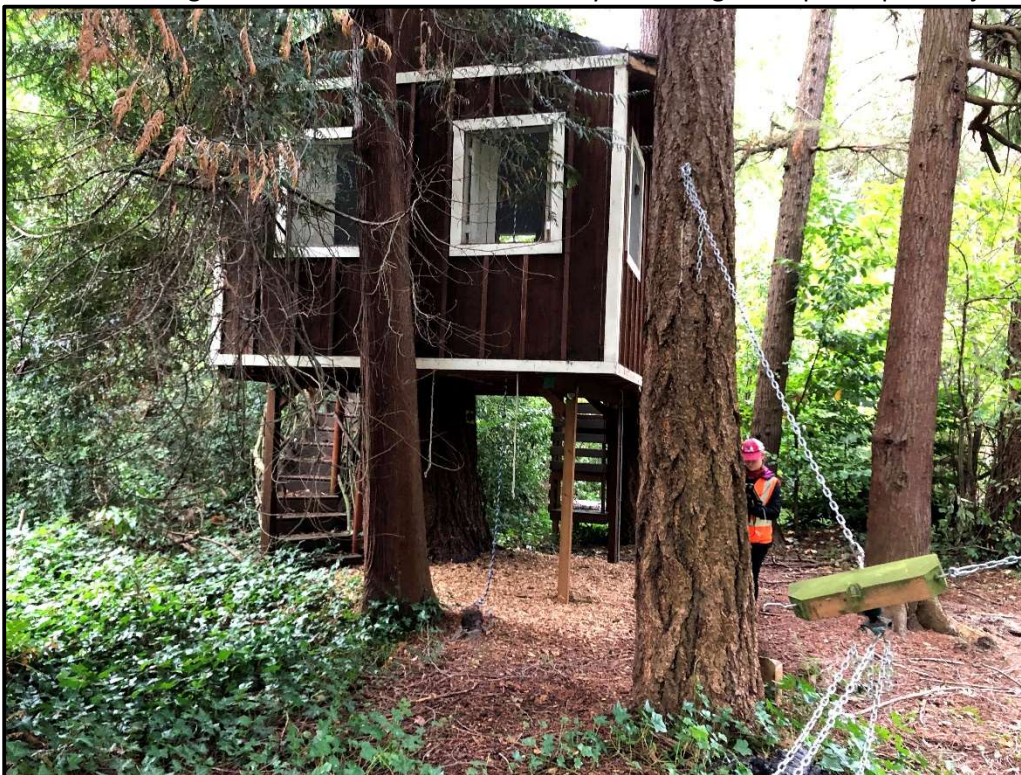
Several trees are used as attachment points and supports for a tree house and adjacent zipline. These trees are 1806, 1810 and 1813.

Photo 2. There is a treehouse and associated recreation apparatuses attached to trees near the center of the site.

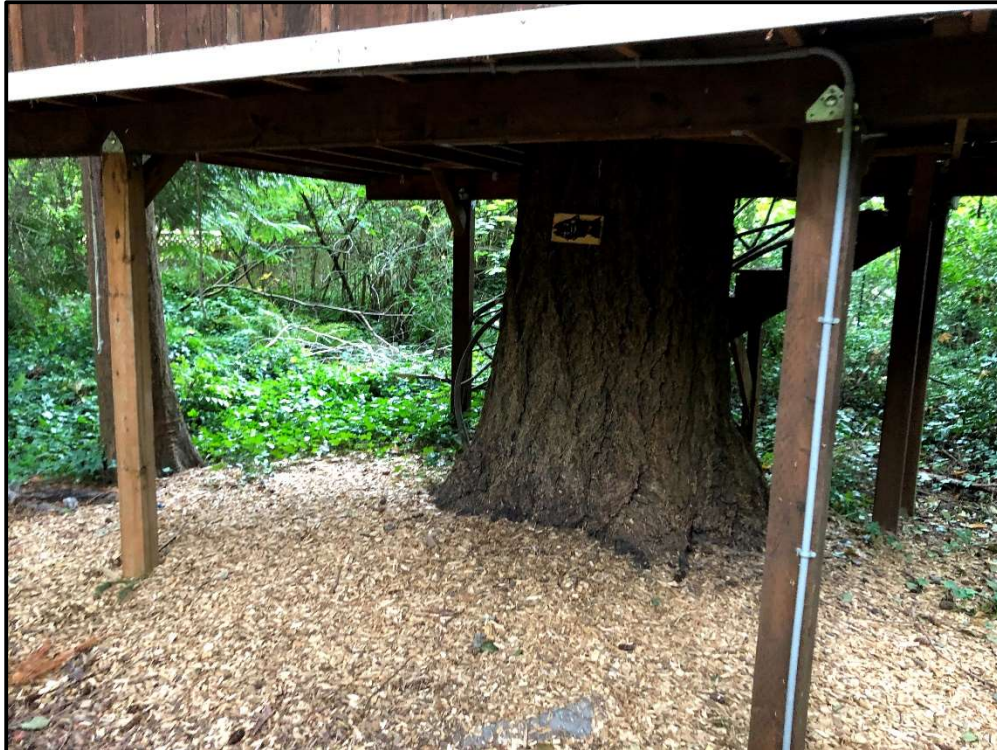
Photo 3. Tree 1806 is not serving as a primary support but is in the center of the treehouse with small attachment hardware. Large diameter surface roots are just below landscape fabric and mulch layer.

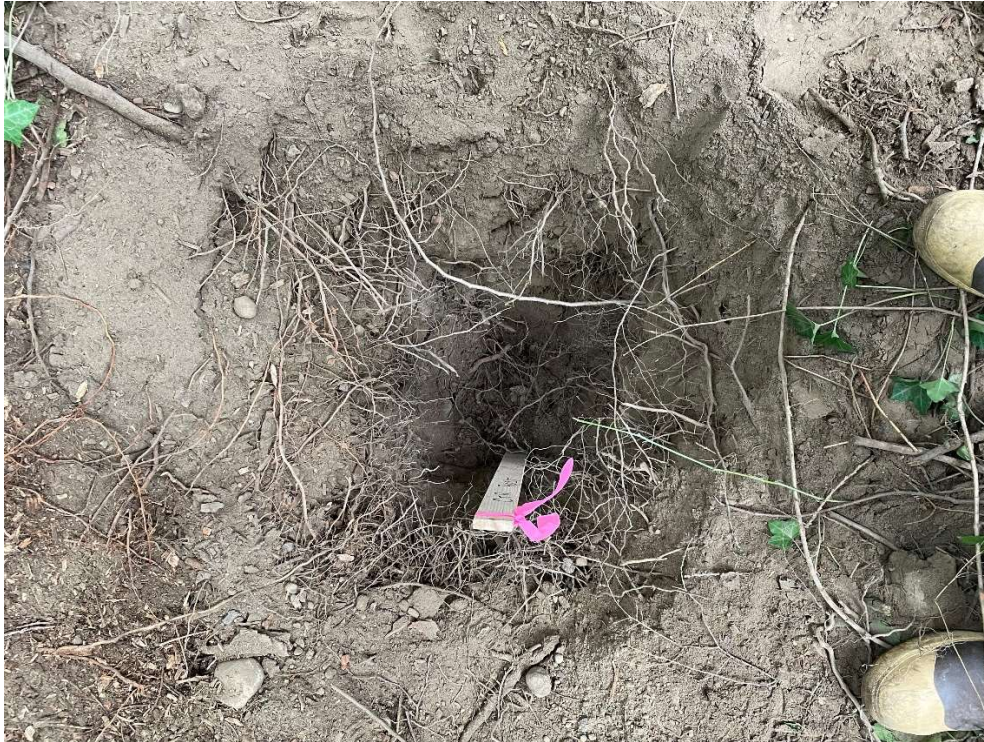
We found no structural roots from tree 1813 at the locations of either deck footing.

Photo 6. A view of the air excavation at deck footing 1, which is 11 feet to the east of tree 1813. No structural roots were found.

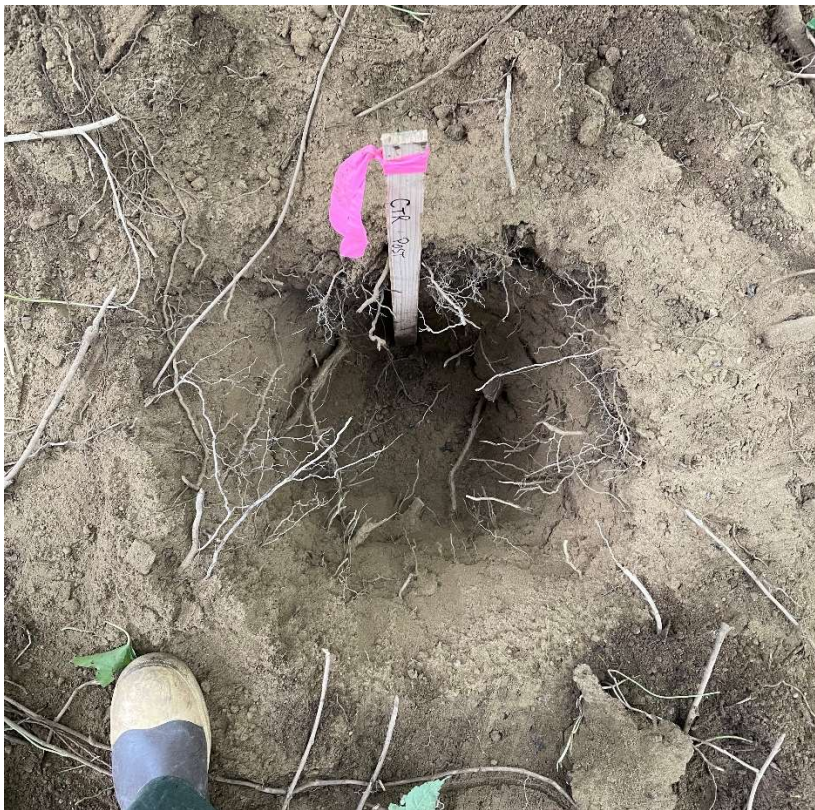
Photo 6. A view of the air excavation at deck footing 2, which is 17 feet to the east of tree 1813. No structural roots were found.

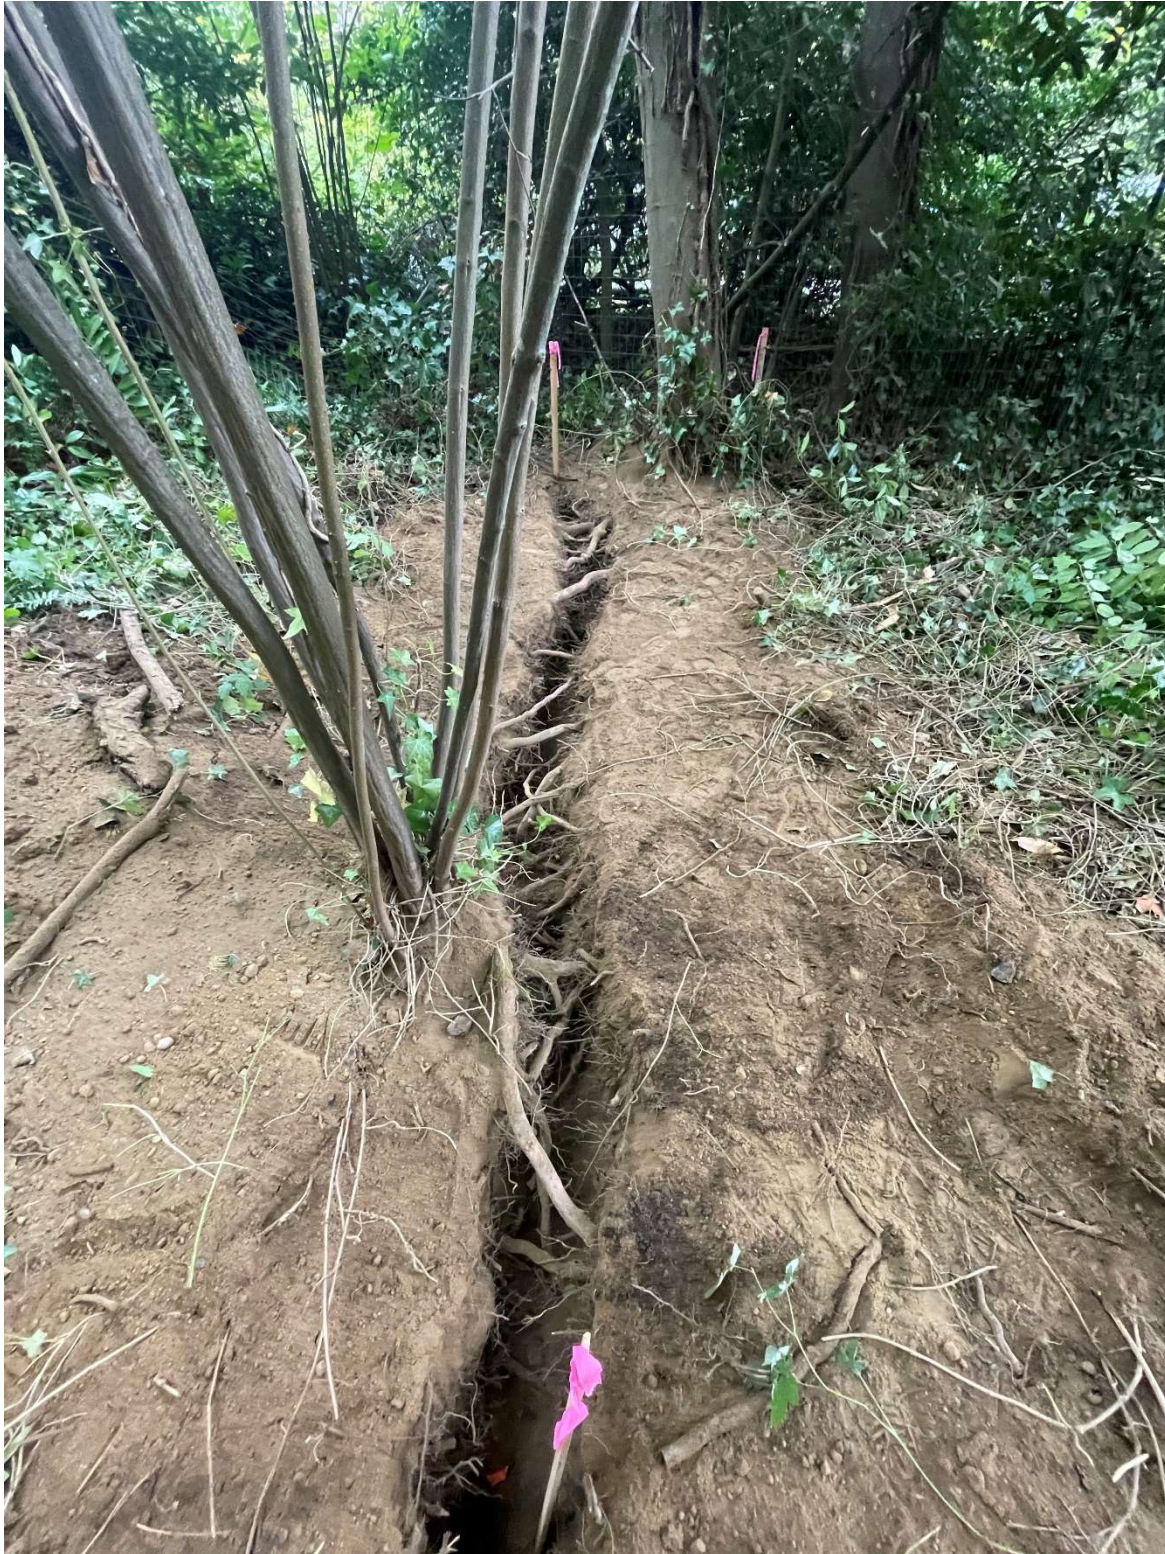
Photo 8. A closer view of roots encountered during air excavation at the edge of the proposed walkway. All visible roots are associated with the non-regulated beaked hazelnut or red alder tree 1814, which is proposed for removal.

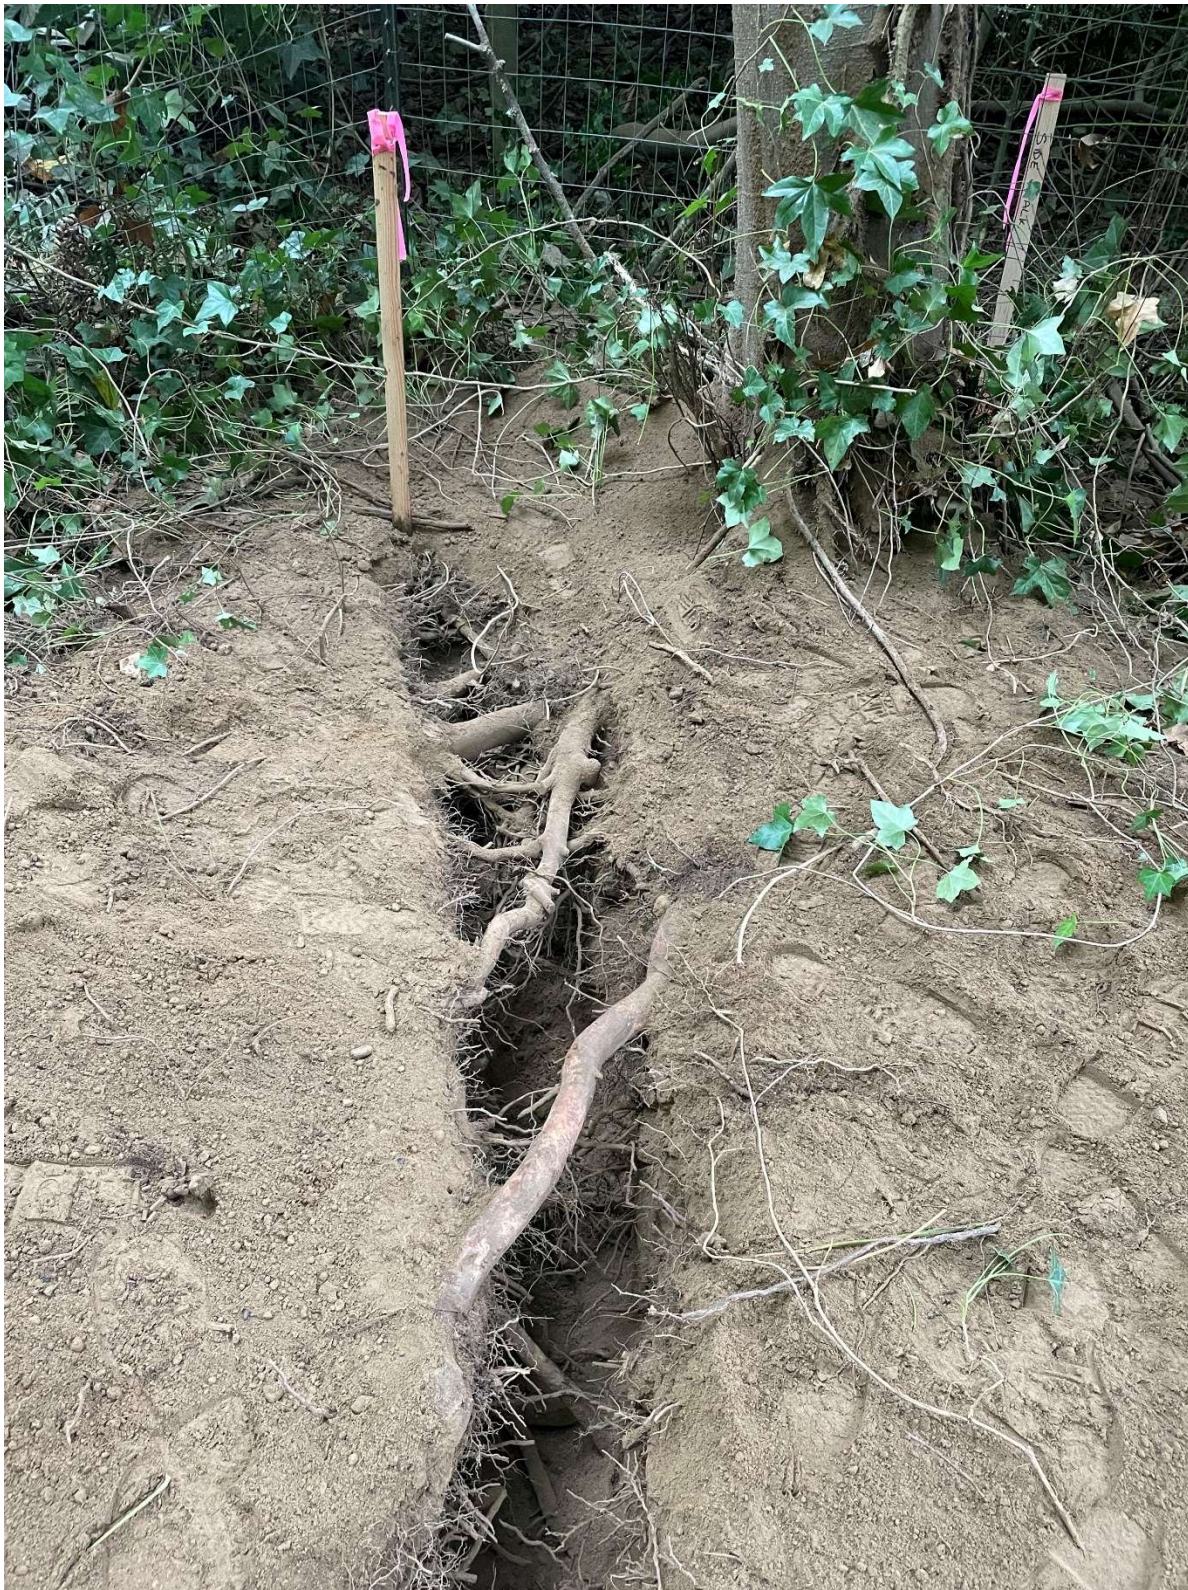
Photo 9. A closeup of the structural roots from tree 1814 found during air excavation of the proposed walkway. None of the roots visible are associated with tree 1813.
