Arborist Report

To: Sturman Architects, City of Mercer Island
Site: 4603 89th Ave SE, Mercer Island, WA 98040
Re: Tree Inventory for Development
Date: Feb. 10, 2023
Project Arborist: Joseph Sutton-Holcomb
ISA Board Certified Master Arborist #PN- 8397BM
Municipal Specialist; Qualified Tree Risk Assessor
Referenced Documents: Sheet A1.1 Excavation Plan / Tree Plan
(Sturman Architects, dated Feb. 6, 2023)
Attached: Table of Trees
Tree Site Map
Tree Retention Worksheet
Letter: Explanation and justification for removal of exceptional trees
(Sturman Architects, dated Feb. 6, 2023)
Sheet A1.X – Tree GFA Diagrams
(Sturman Architects, dated Jan. 4, 2023)

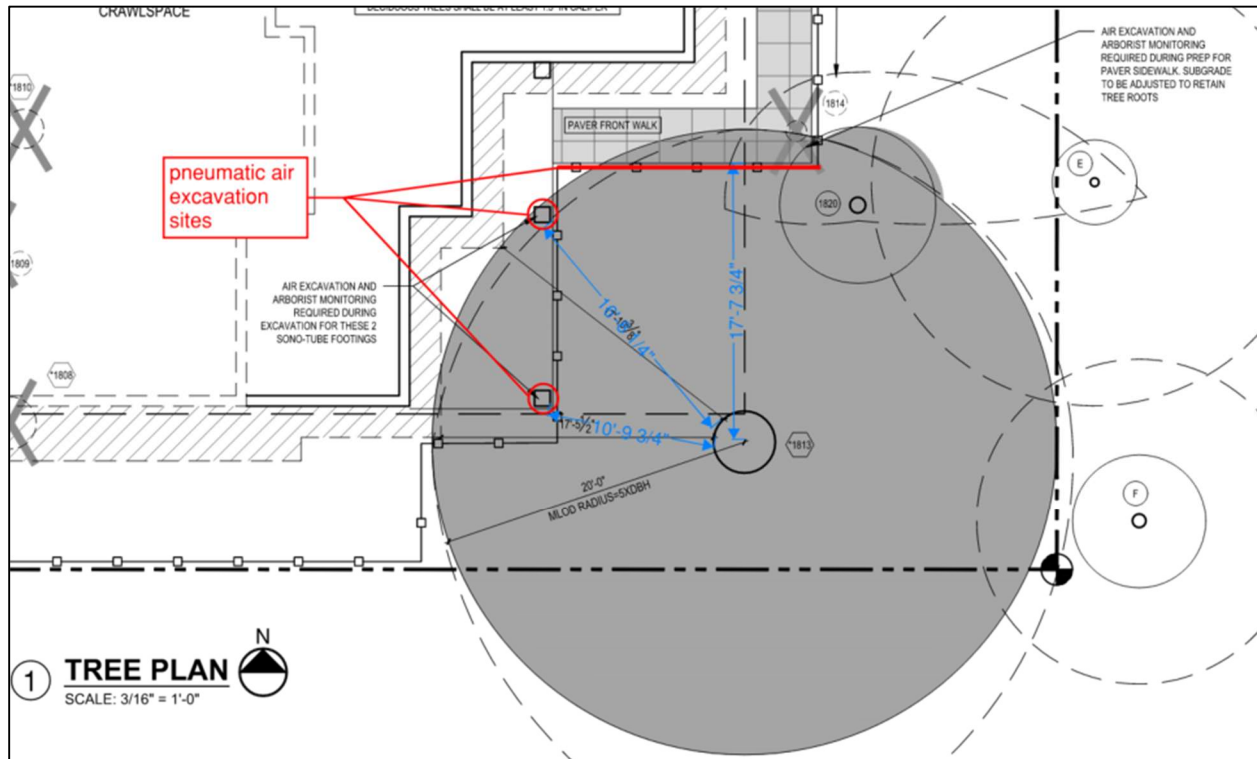
Figure 1. An excerpt from the tree plan showing the areas where air excavation occurred on Nov. 11, 2022. The objective of air excavation was to determine whether structural roots from tree 1813 were present at the deck footings and edge of the proposed front walkway.

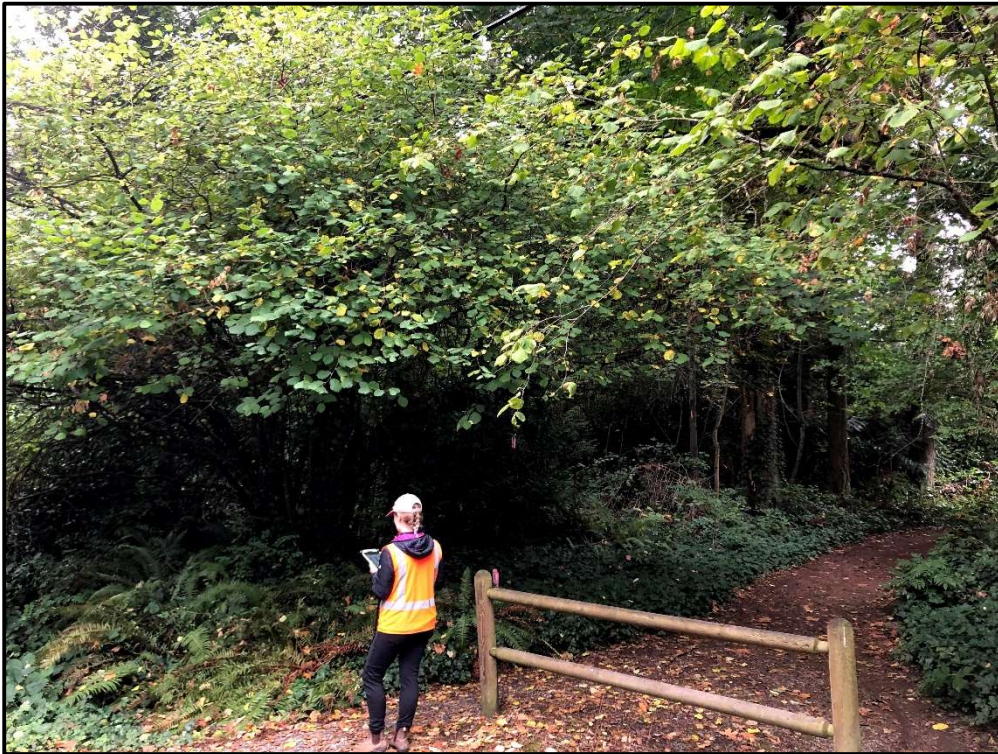
Photo 1. Looking southwest into the site. Walkway on the right is a public path adjacent to the site.

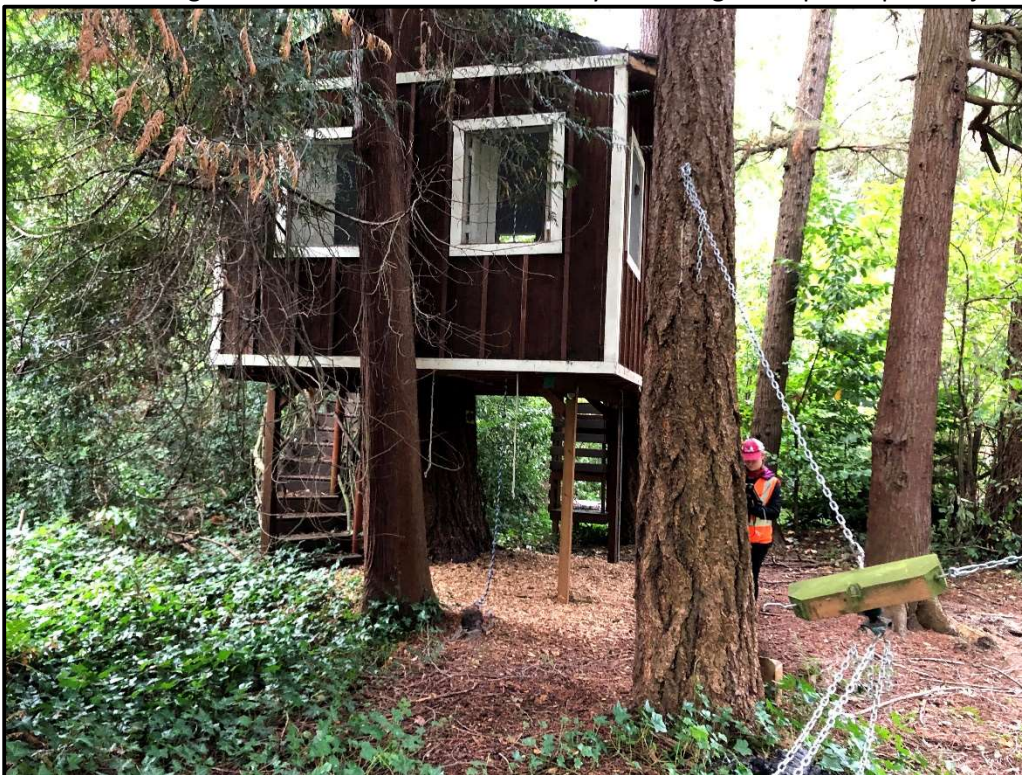
Several trees are used as attachment points and supports for a tree house and adjacent zipline. These trees are 1806, 1810 and 1813.

Photo 2. There is a treehouse and associated recreation apparatuses attached to trees near the center of the site.

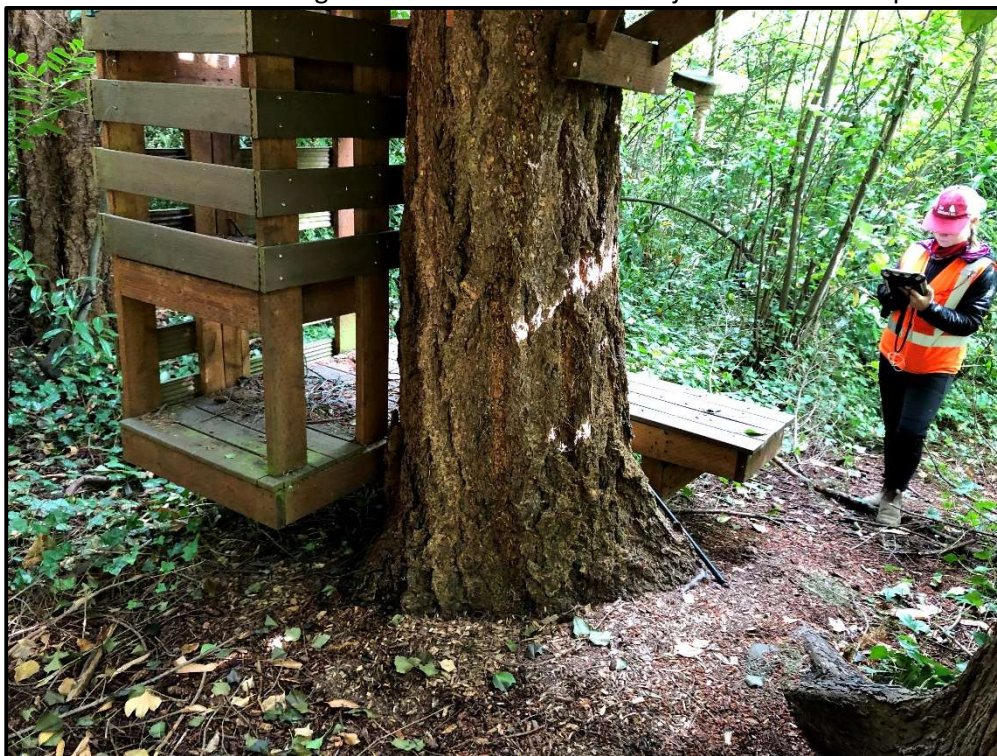
Photo 4. Tree 1810 has a platform and ladder with swing and zipline attachments; it is a primary support for the structures.

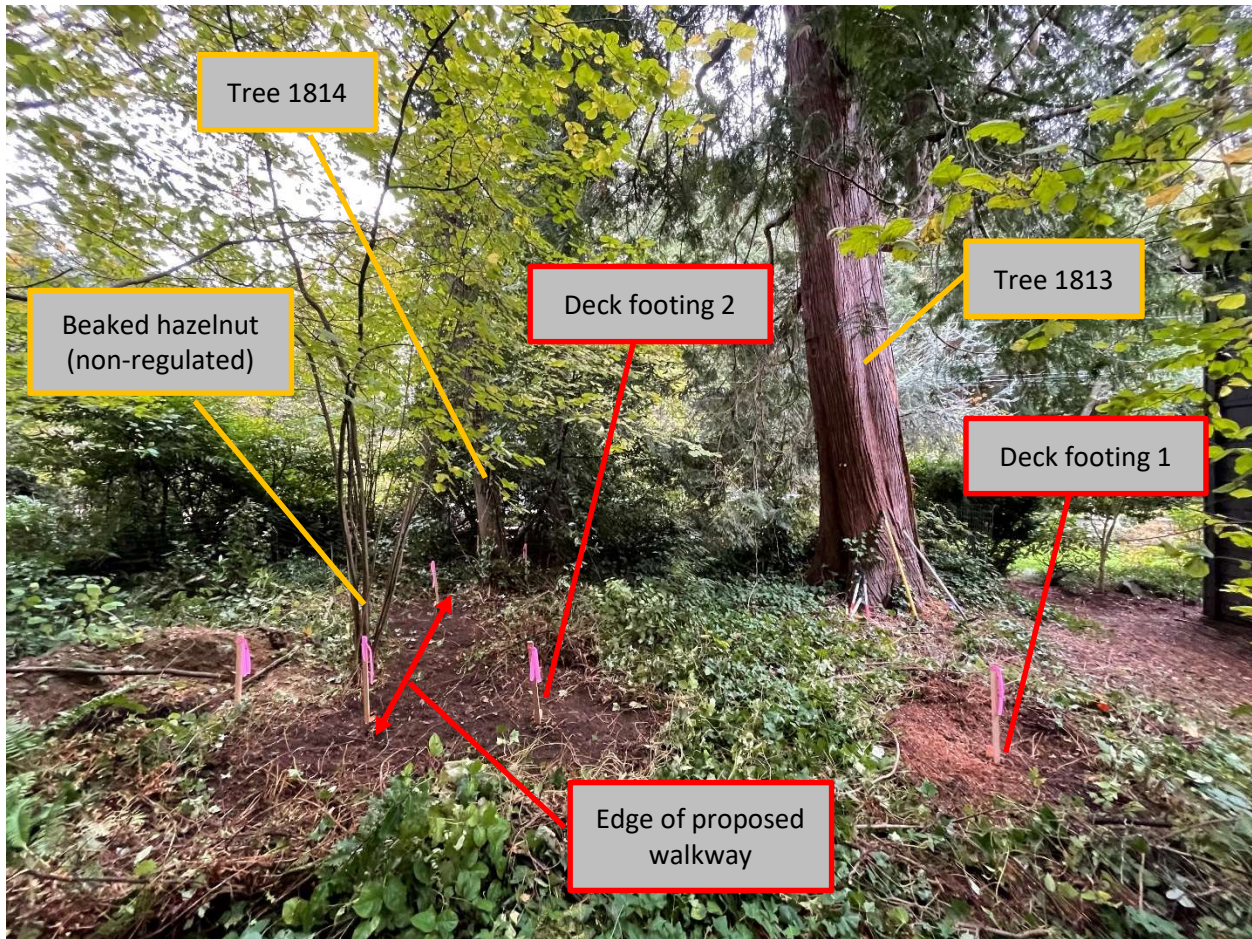
Photo 5. A view of the site prior to air excavation. Locations of impact areas to be assessed are indicated.

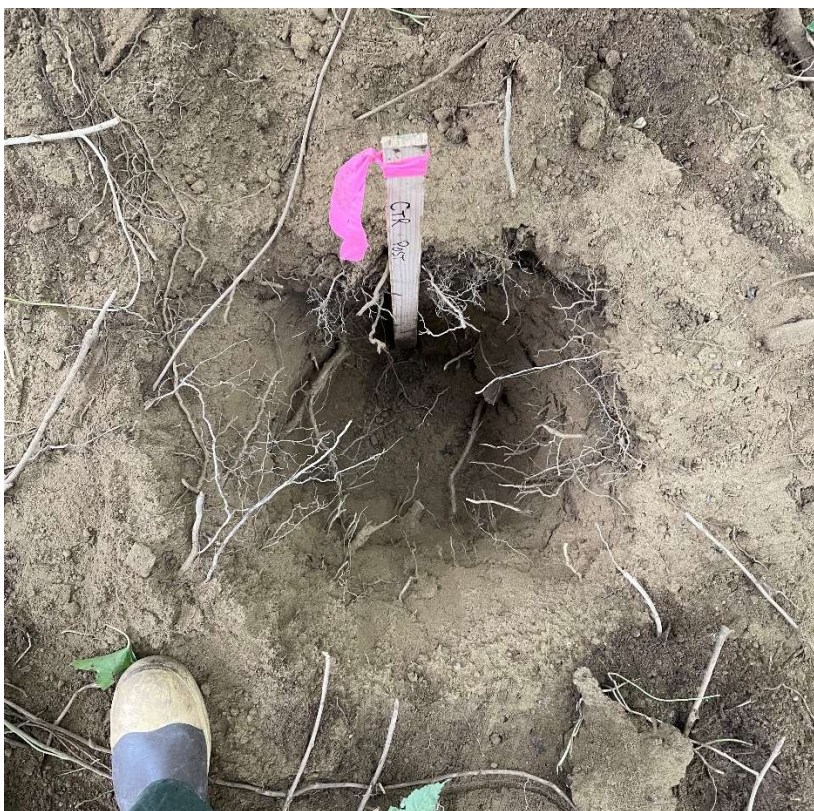
We found no structural roots from tree 1813 at the locations of either deck footing.

Photo 6. A view of the air excavation at deck footing 2, which is 17 feet to the east of tree 1813. No structural roots were found.

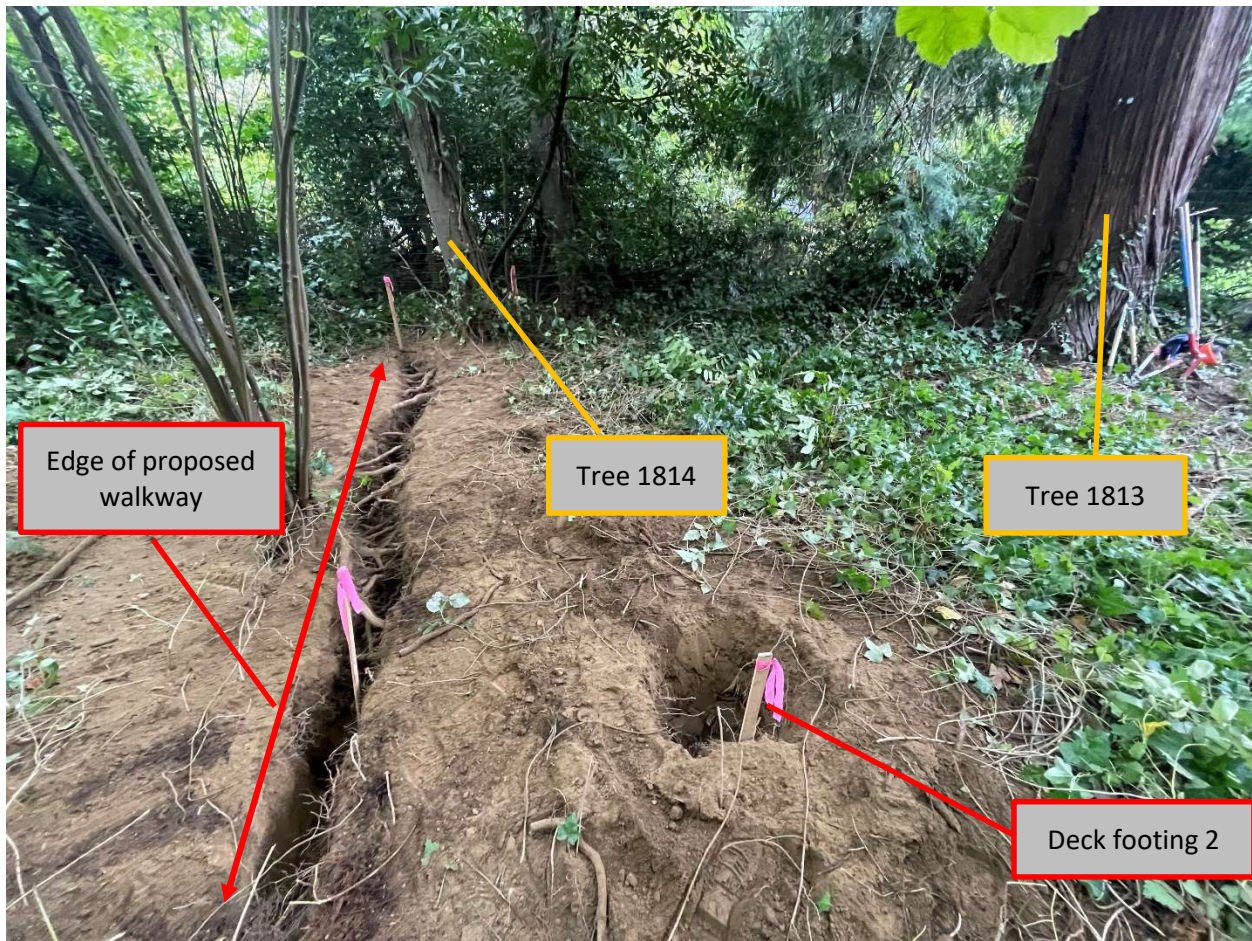
At the location of the proposed walkway, we found 3 roots 2 inches in diameter, and 15-20 roots ½ inch to 1 inch diameter. However, an analysis of root bark color and texture, as well as the orientation of root growth, strongly indicates these roots are associated with tree 1814 and a non-regulated beaked hazelnut which are both proposed for removal.

We identified 3-5 roots ½ inch diameter that were likely from tree 1813 based on an analysis of bark color and texture and orientation of root growth. In my opinion, these roots can be cut cleanly at the edge of the proposed walkway without negatively impacting the health and structural stability of tree 1813.

Photo 7. A view of the trench at the edge of the proposed walkway. All large structural roots found are associated with tree 1814 and an unregulated beaked hazelnut, both of which are proposed for removal. We found 3 to 5 roots ½ inch diameter that are associated with tree 1813 based on the bark color and texture.

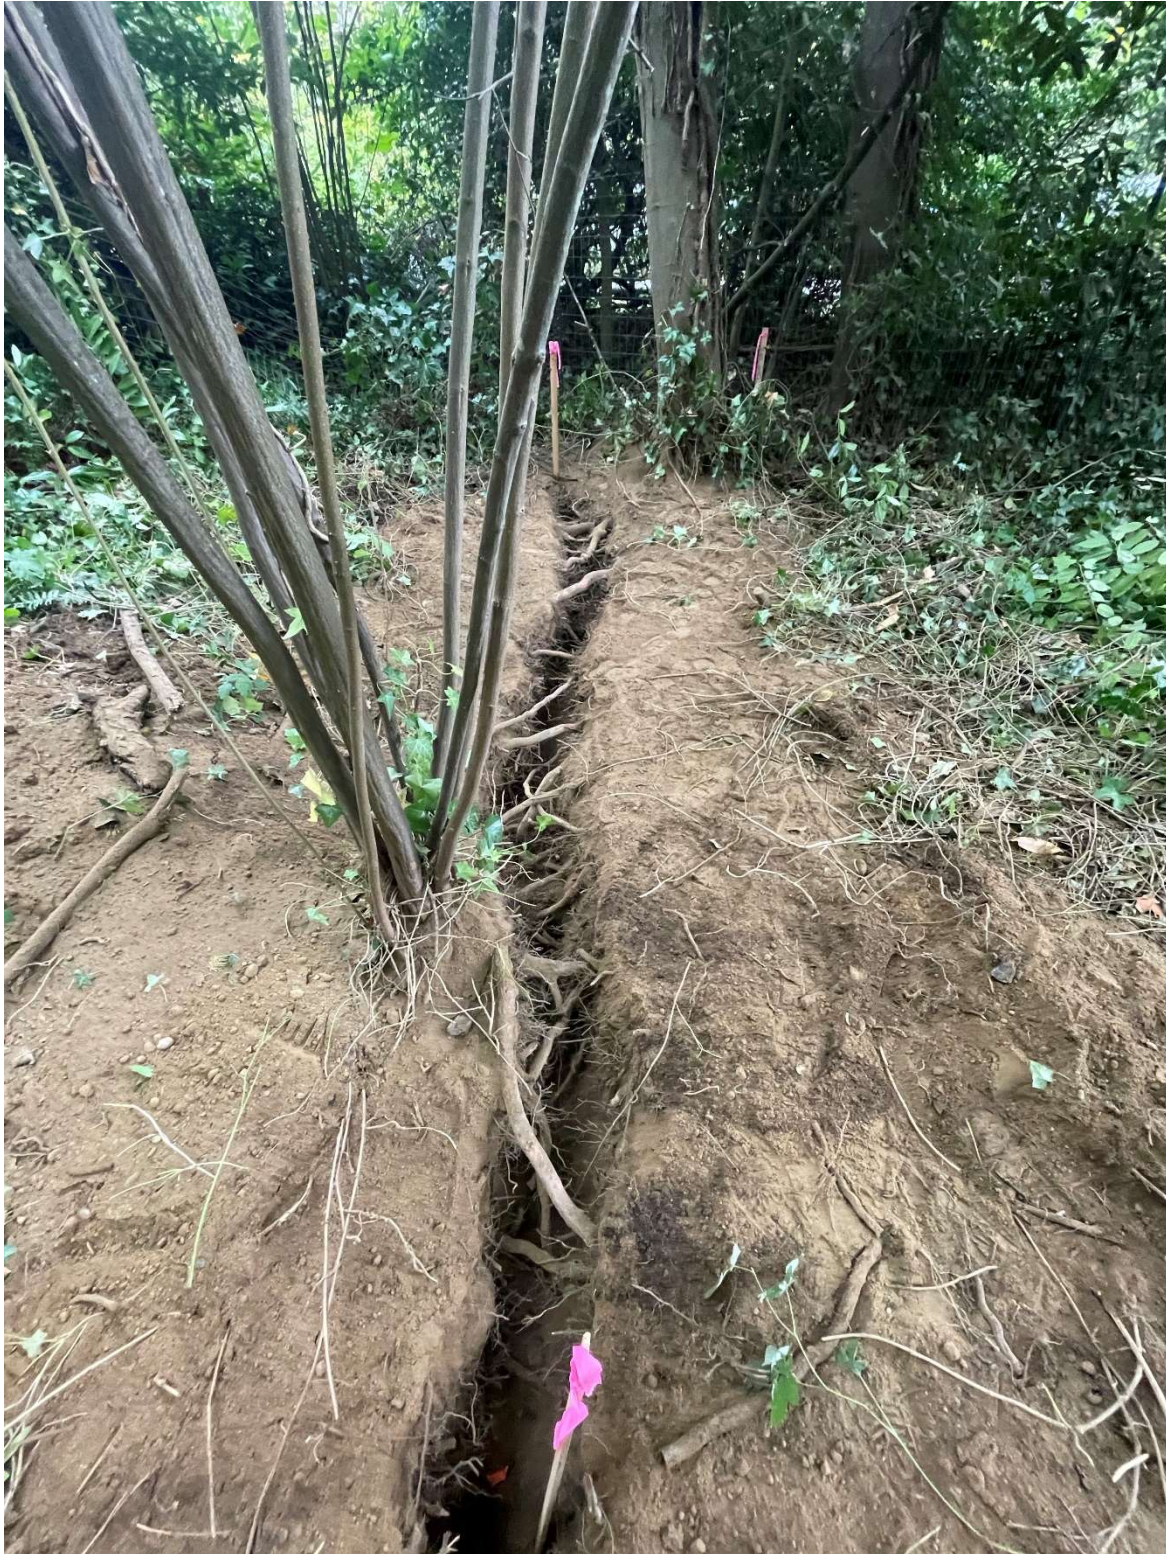
Photo 8. A closer view of roots encountered during air excavation at the edge of the proposed walkway. All visible roots are associated with the non-regulated beaked hazelnut or red alter tree 1814, which is proposed for removal.
