Tree Protection Plan

August 31, 2022

Laurie Yang
8456 SE 40th St
Mercer Island, WA 98040

Jordan Blonski
Certified Arborist PN-8610-A
Qualified Tree Risk Assessor (TRAQ)
Eastside Tree Works
253-358-6143
Jordan@eastsidetreeworks.com

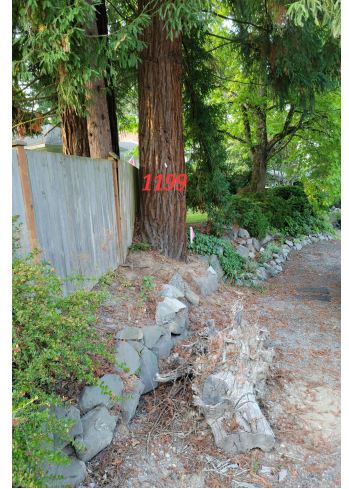
Tree #1199*, Redwood, (*Sequoia sempervirens*) The tree is perched on top of a small stone retaining wall at the northeast corner of the property. The tree has a DBH of 33" at a height of 95' and a crown spread of approximately 20'. There is a small fence that is growing against the trunk at the root flare. This tree is part of a cluster of 3 Redwood trees.

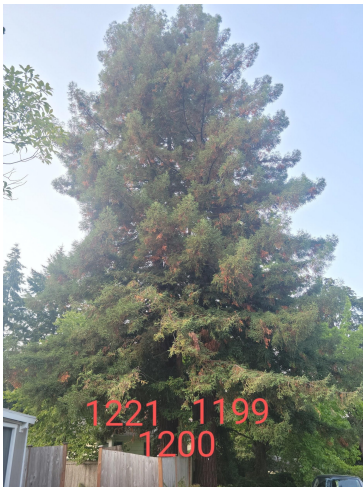
Tree #1200, Redwood, (*Sequoia sempervirens*) The tree is located at the northeast corner of the property. The tree has a DBH of 12" at a height of 35' and a crown spread of approximately 17'. This tree is growing subdominantly under 2 larger Redwood trees.
