August 16, 2022

**Project:** Pre-construction assessment for lot re-development at 6950 SE Maker Street, Mercer Island, WA. Parcel number 9350900620.

**Objectives:** Evaluate health of existing trees and establish criteria for the preservation of those to be retained.

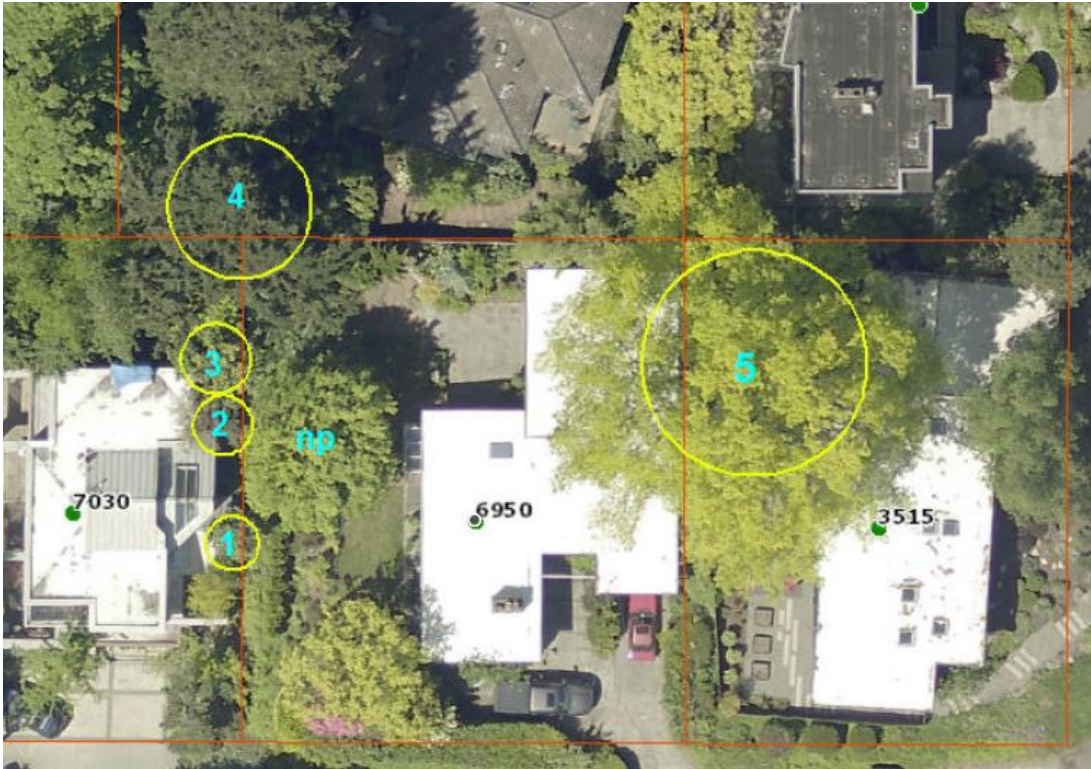
Figure 3. Aerial photo circa 2019 showing the approximate locations of the trees noted in the study (teal numerals). The yellow circles just help spot the numbers. The 'np' stands for 'not present' as this plant was not present at the time of the August 2022 site visit. It is presumed to have been removed by the previous owners in anticipation of selling the home.

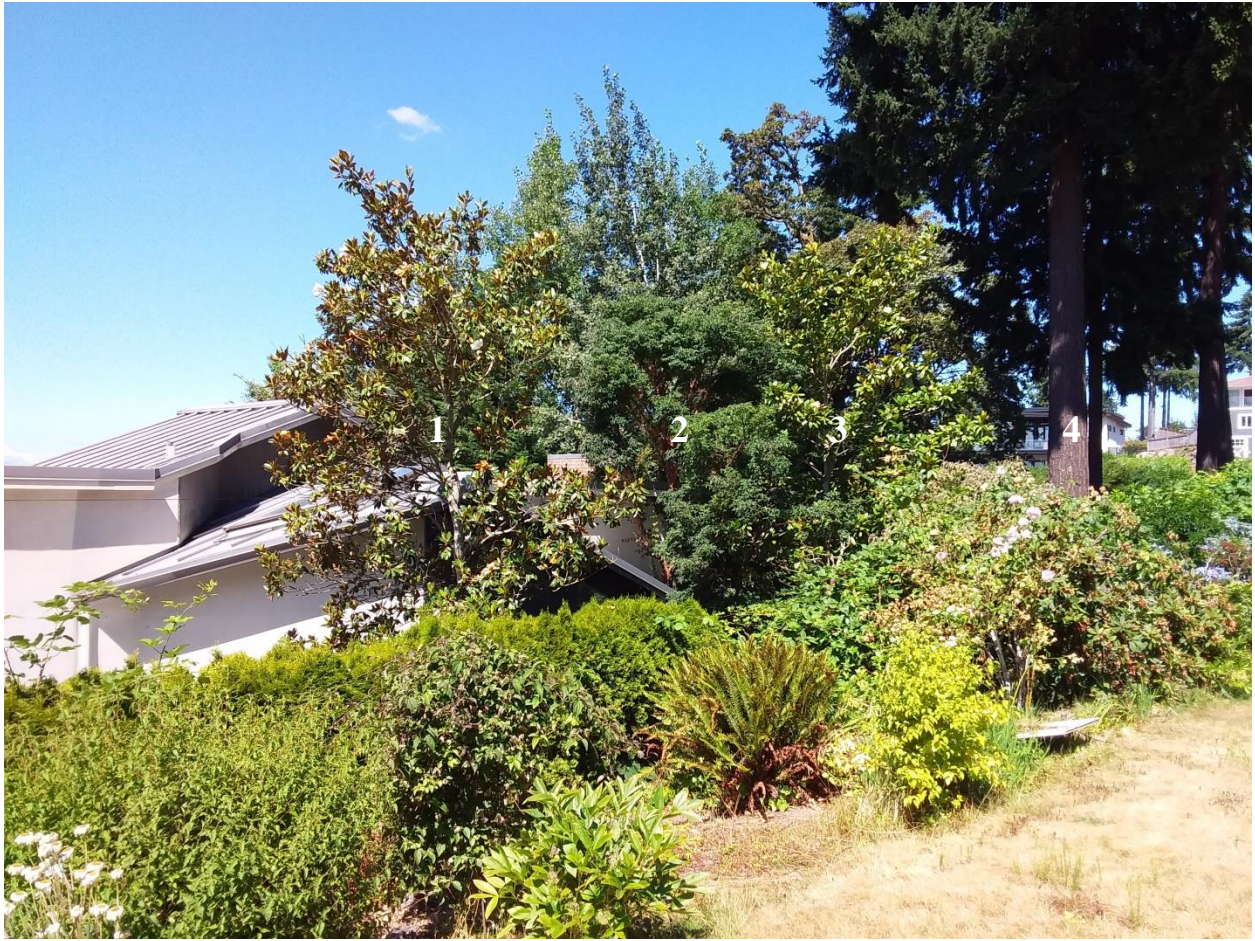
1. Likely a Teddy Bear Magnolia (*Magnolia grandiflora* 'Teddy Bear') about 8" DSH, 22' tall with a 6' radial spread. The tree stands 10' W of the west property line and close to 40 N of the SE corner (Figure 4). Fair condition with average new growth and color.

2. Paper Bark maple (*Acer griseum*) 10" DSH, 24' tall with an 8' radial spread. Tree stands close to 15' W of the west line and 25' N of the #1 magnolia. Good condition.

3. Southern Magnolia (*Magnolia grandiflora*) about 10" DSH, 28' tall with a 12' radial spread. The tree stands 12' W of the west line and about 20' S of the NW corner. Tree is in fair condition.

Figure 4. Looking NW at the #1-4 trees.

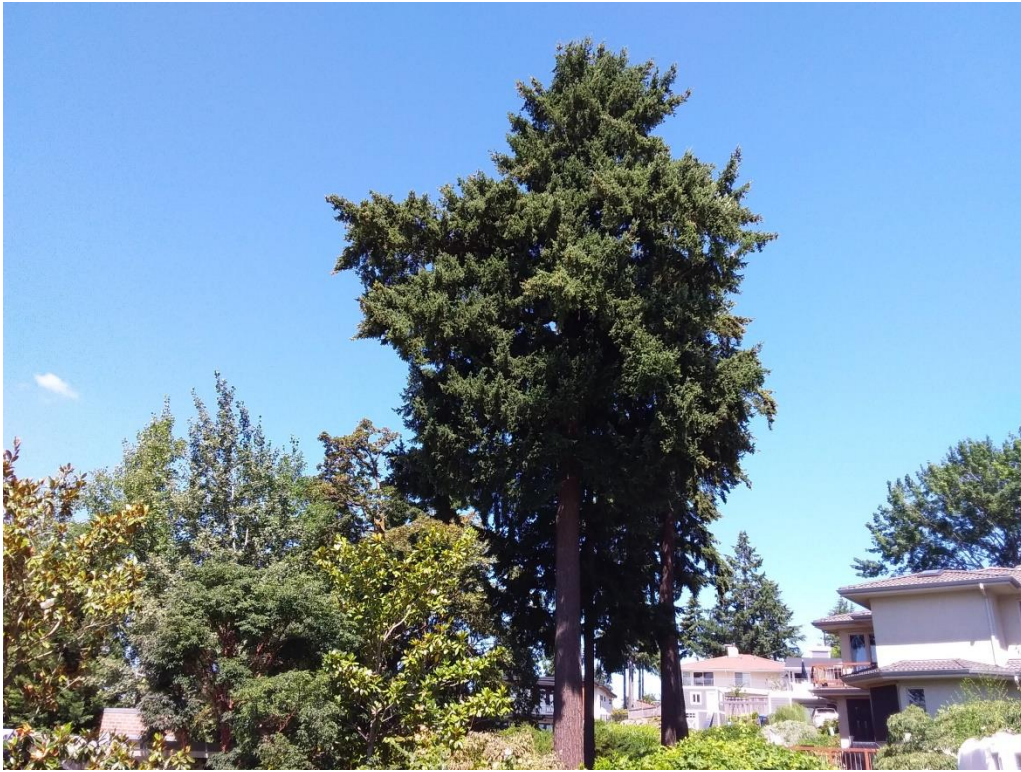
4. Douglas fir (*Pseudotsuga menziesii*) 36" DSH (may be less as it appears to have heavy bark), reaches in the neighborhood of 75' tall. It appears to have been topped multiple times and regrown (Figure 5). Exhibits good new growth and color with a full radial canopy down below the halfway point. Base of the tree is 9.5' N of the northwest corner of the subject property. There is a significant drop off in this area of the yard. The plan sheet indicates a negative 12' grade change.

The fir tree is also deemed to be under little to no risk of disturbance from the proposed construction project.

Figure 5. Looking NNW at the #4 fir and showing its conformation.

Ideally the protection fencing will be set up prior to the demolition. Along the east side it can just follow the top of the Keystone wall as there are no roots west of it. Technically a fence could be erected along the top of the west retaining wall but the trees to that side are not large enough to have penetrated into the subject property. Out of an abundance of caution a section of fence could be set between the north and west property lines at a radial distance of 25' out from the base of the #4 tree. This should ensure that no accidental impact will occur within the potential root zone of the Douglas fir.

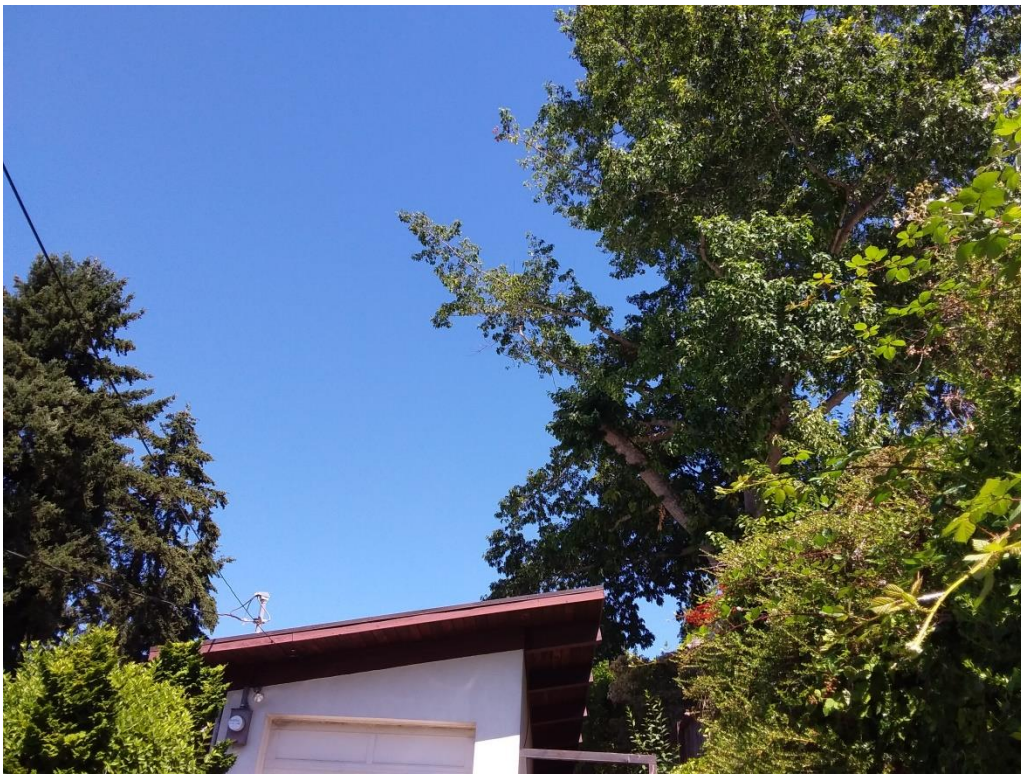
5. Red oak (*Quercus rubra*) easily 40" DSH, 50' tall in the highest reaches, spreads as much as 45' north and south, around 35' east, but was cut back quite hard on the west and extends no more than 18' to that side (Figure 6). The base of the tree is 25' S of the NE corner and 10' on center east of the east line. It sits on top of a large stone retaining wall that is near 5' tall and fully on the neighbor's lot (Figure 7). The stone wall sits above a Keystone block retaining wall that is 5.5' tall and runs along the whole east side of the existing house and 5' E of it (Figure 8). The roots from the oak have interwoven with the stones and likely have entered the soil beneath but primarily they have to have spread toward the east side neighbor's house. There are no indications that the oak's roots have disrupted the Keystone blocks. The oak appears to be fair condition overall but is exhibiting signs of stress in the upper canopy. Heavy epicormic response growth is present in the lower canopy.

Figure 6. Looking up and north at the west side of the #5 oak's canopy. It was pruned back as to not extend over the roofline of the existing house. This was likely done in anticipation of selling the home.

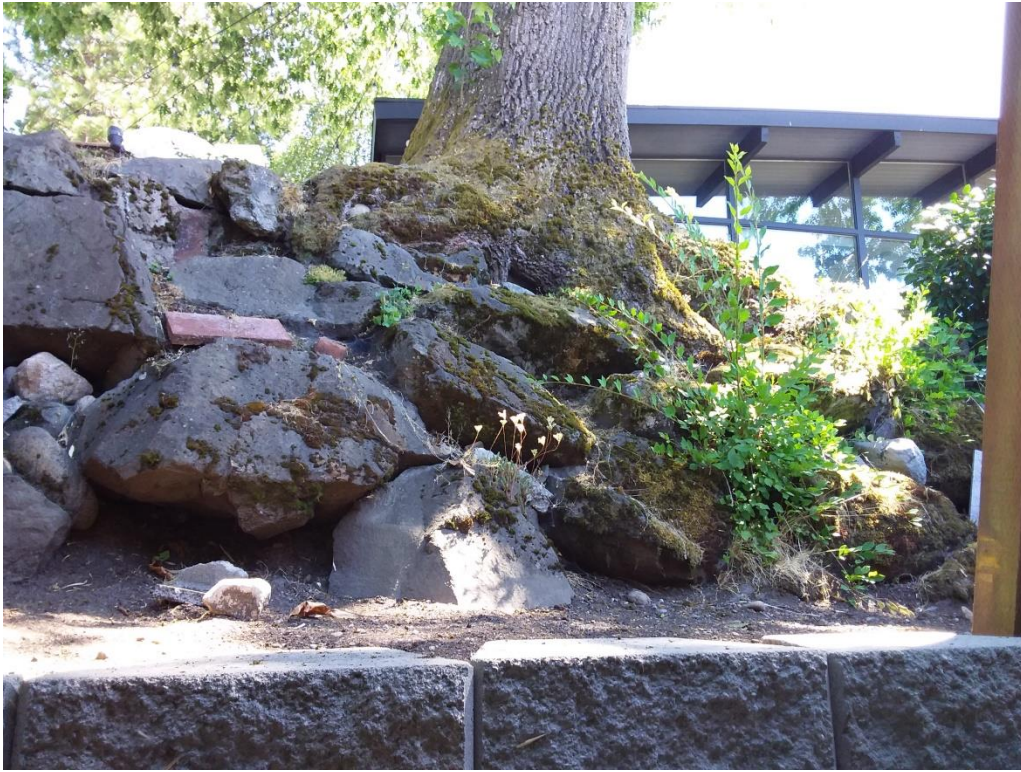
**Discussion:** The demolition of the existing home theoretically, based on the linear distances, has the potential to create root disturbance in the CRZ of the #5 oak. The Keystone block wall is to be retained though. As a rule of thumb it is rare to find roots from trees more than 4' below their bases in areas of sudden grade change. Roots have to have aerated soils to function properly. While oak trees are known to be rock breakers and large ones like the subject tree have the power to crack concrete and affect other types of hardscaping there are no indications that this tree has any roots on the 6950 property.

The oak tree is deemed to be under little to no risk of disturbance from the proposed construction project.

Figure 7. Looking up and east at the base of the #5 oak. The concrete blocks at the bottom of the photo are the top or the Keystone wall shown in Figure 8.

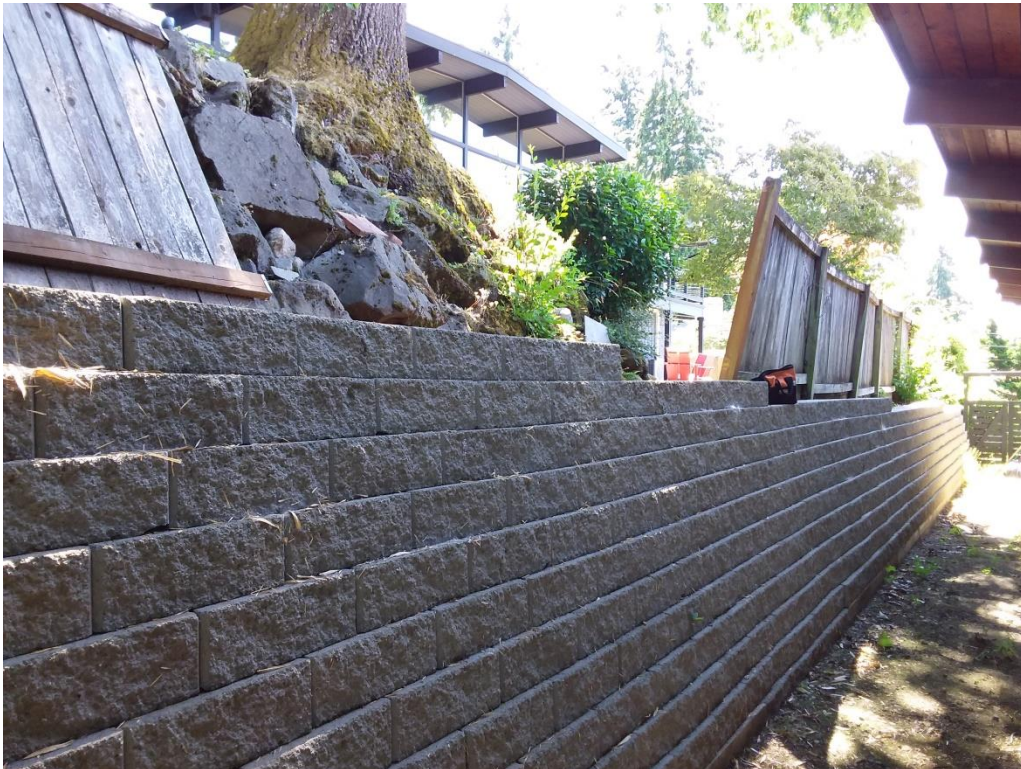
Figure 8. Looking SSE down the length of the Keystone block retaining wall running along the east side of the existing house. Note the base of the #5 oak at top center of the photo, The edge of the existing roof is visible in the top right corner of the image.
