Superior NW Enterprises

August 24, 2023

RE: Review of retaining wall plan for 6950 SE Maker, PN-9350900620

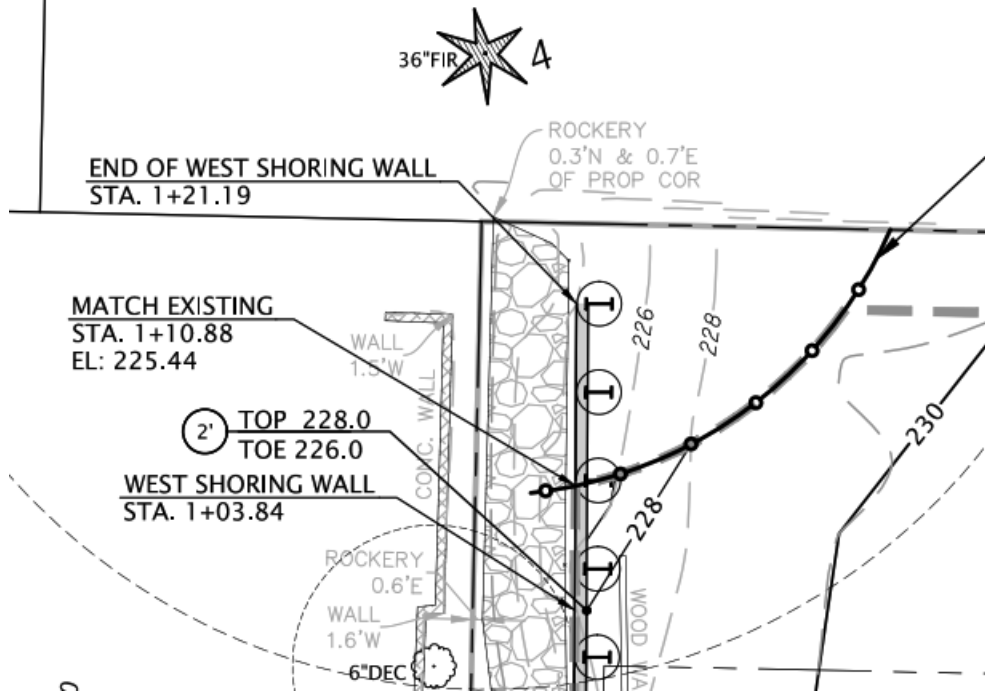
Based on the plan set drawing shown in Figure 1 the north end of the new wall will terminate 15' out from the base of the tree. This means there is no chance that the work will damage the Structural Root Plate of the tree.

The base of the #4 tree is close to 5' below the level of *the base* of the existing stone wall which ends right at the NW corner post. According to the architect and builder this wall will remain in place and not be disturbed. Only a secondary section of stone that is well outside the theoretical CRZ will be removed to facilitate the installation of the pile wall.

The work plan states that the machinery required for drilling the pile holes will be stationed outside the theoretical CRZ for the tree. This is not absolutely necessary as it is highly unlikely that the fir has any roots present east of the existing wall in the first place. Douglas fir rarely has roots present below 36" due to compaction and oxygenation constraints.

In this specific case the tree is unlikely to have pushed roots around the wall and upslope into the subject property as there is not a resource base present that would have drawn roots into the space. Drilling the line of five 24" diameter holes within the theoretical CRZ would realistically create little functional impact even if the tree did have roots present in the space. They move perpendicularly away from the tree and have exponentially lessor chances of intersecting with any roots that may present.

Installing another wall 4-5' E and nearly 5' higher on the grade will create no significant disturbance for the tree. No excavation will be done to the existing grade. There will be fill work done to level the grade but this will occur over only 6% of the tree's theoretical rooting space. Again, it is highly unlikely that the fir does have roots present in the area.

Figure 1. Excerpt from page C-2 of the submitted plan set. The base of the fir is roughly at the 214 grade level. Fir tree rarely if ever have roots deeper than 3' below grade. It is highly unlikely that this tree has any significant root density in the area east (right) of the existing rock wall.

Out of an abundance of caution an arborist should be onsite during the proposed work.
