RE: HU - 02 Arborist, 2448 72<sup>nd</sup> AVE SE Mercer Island, WA.

I inspected the lot for significant trees and found two. A Japanese Maple with a 8.8" DBH and a Douglas Fir with a 32" DBH.

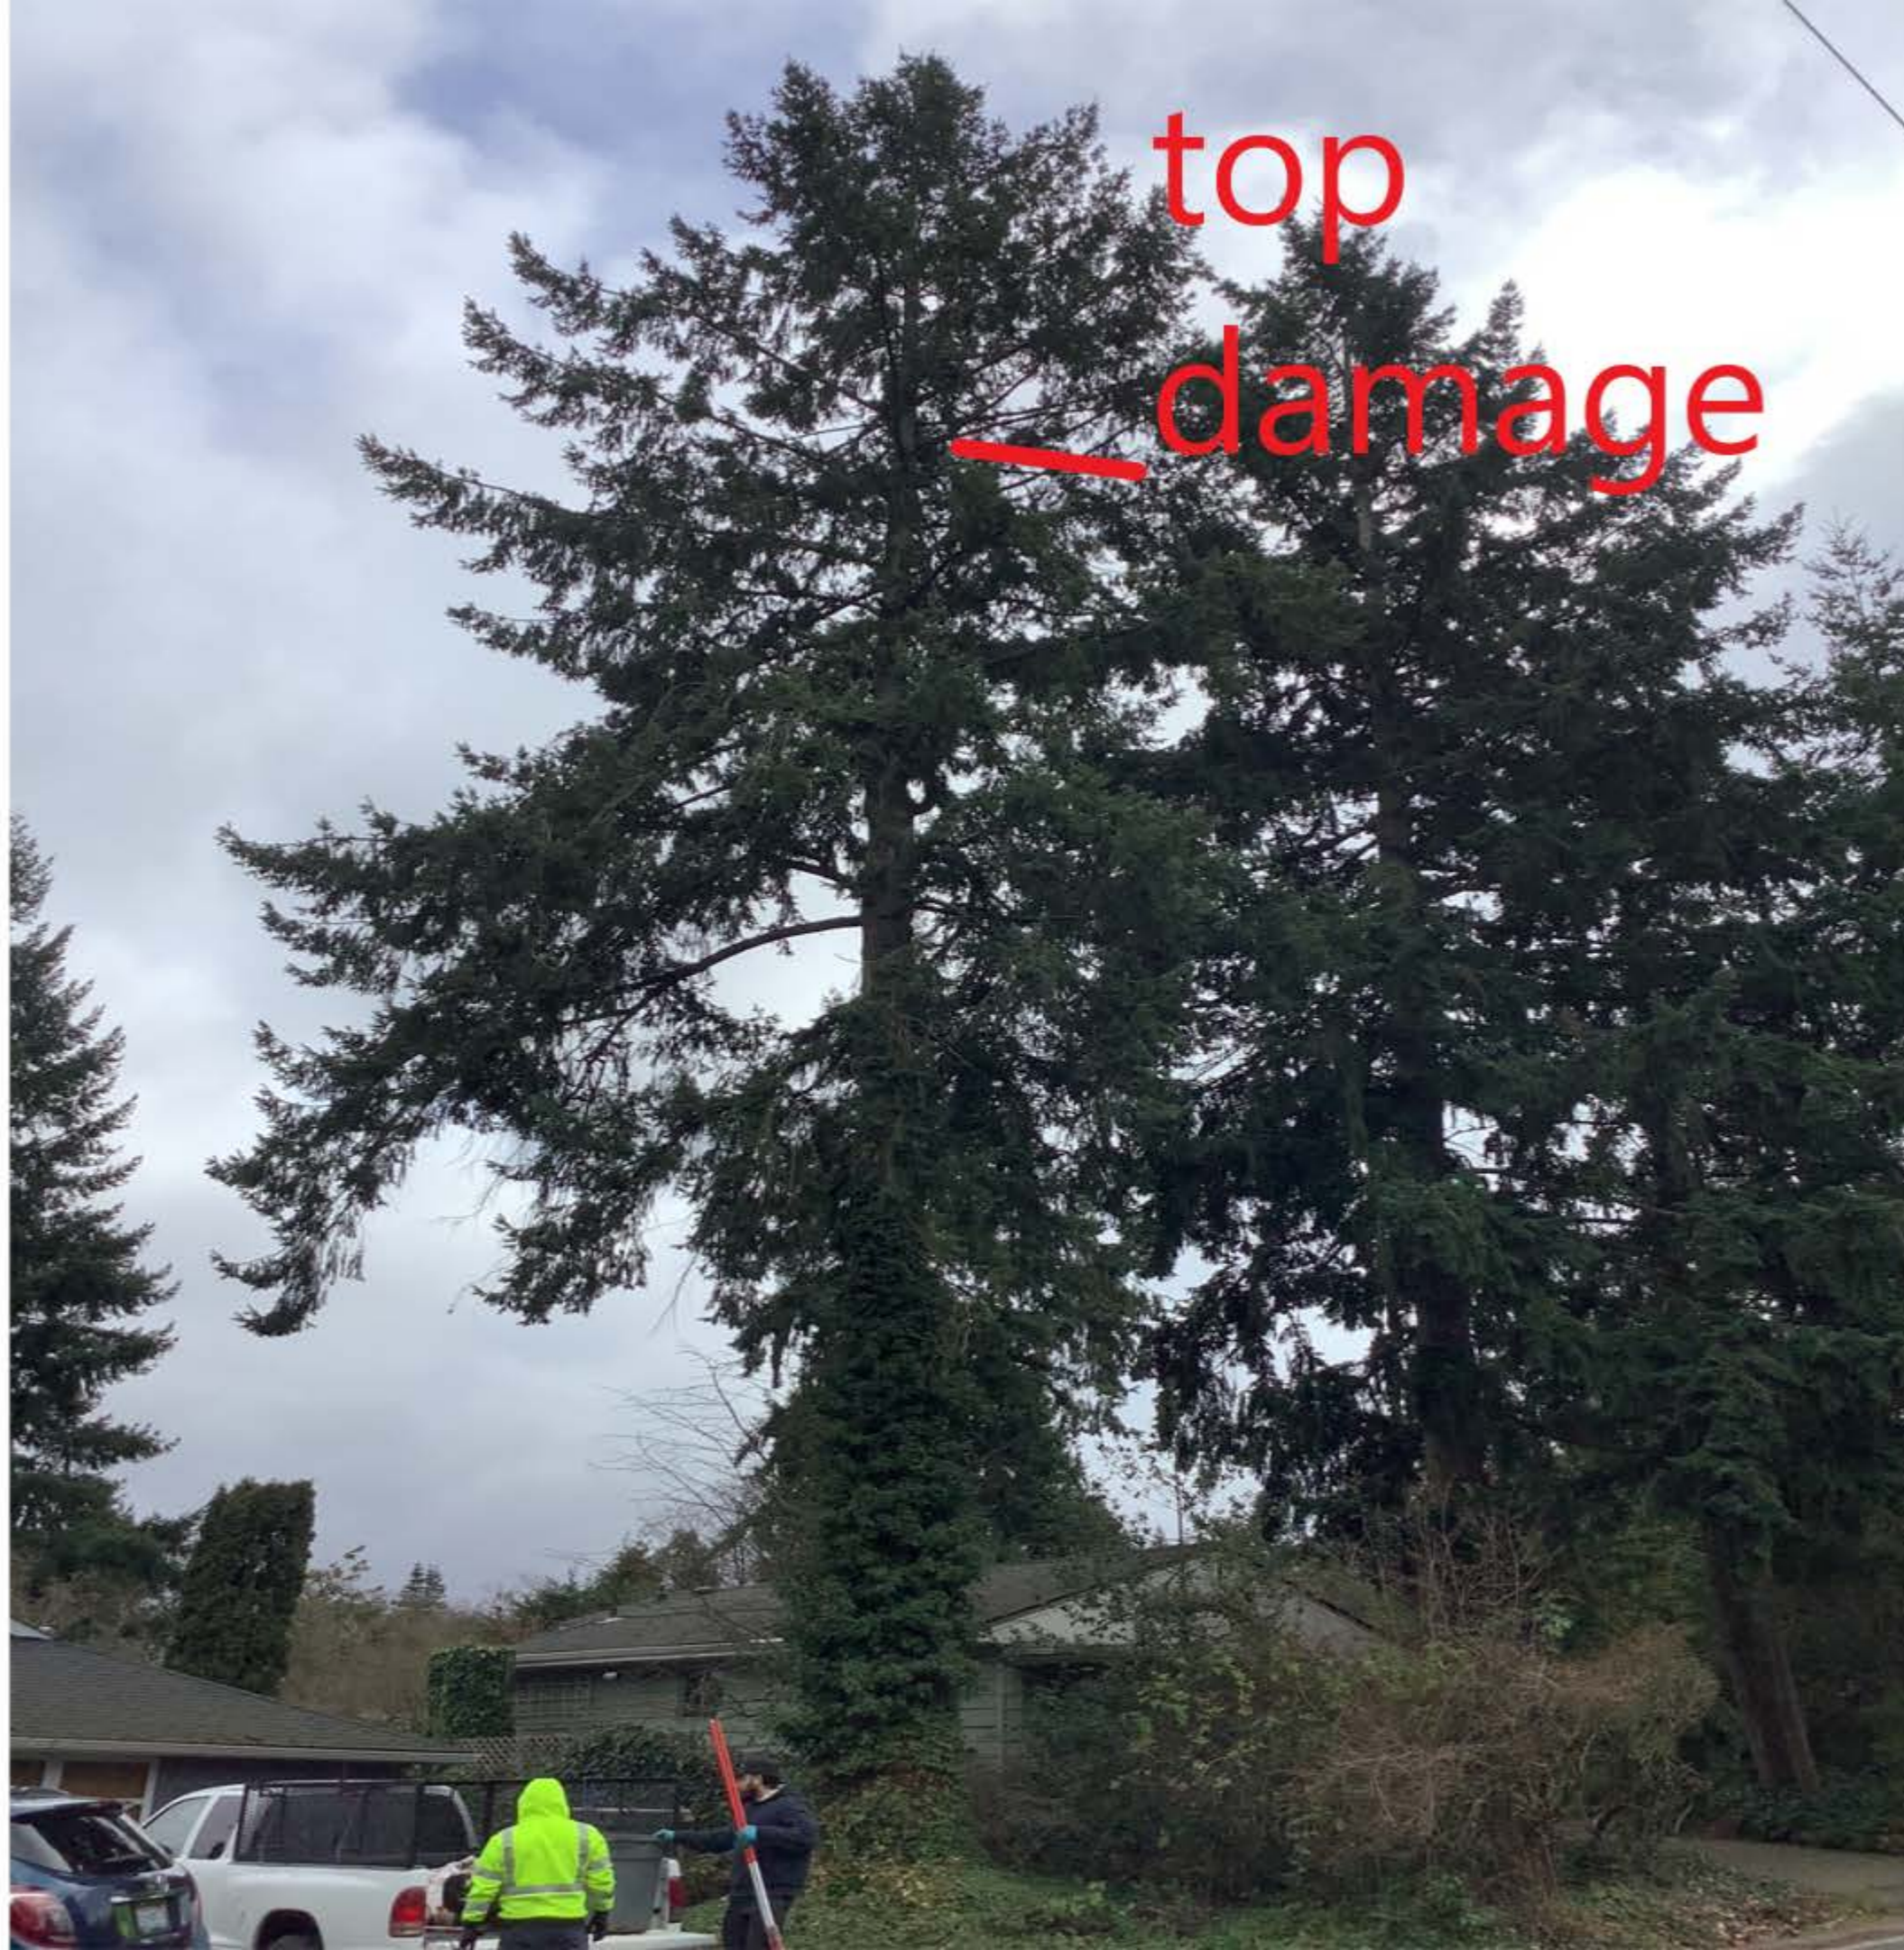
Tree #2 The Douglas Fir has poor taper. The DBH of this tree suggests what normally would be a much taller tree, this tree is 95' tall with a 20' dripline. The foliage on the tree has good color, but the crown is thinner than what would be normal. The top of the tree has been damaged and resprouted. English Ivy covers 25% of the tree. A higher level of inspection may expose inner weakness of the trunk.

top  
— damage
