RE: HU - 02 Arborist, 2448 72nd AVE SE Mercer Island, WA.

I inspected the lot for significant trees and found two. A Japanese Maple with a 8.8" DBH and a Douglas Fir with a 32" DBH.

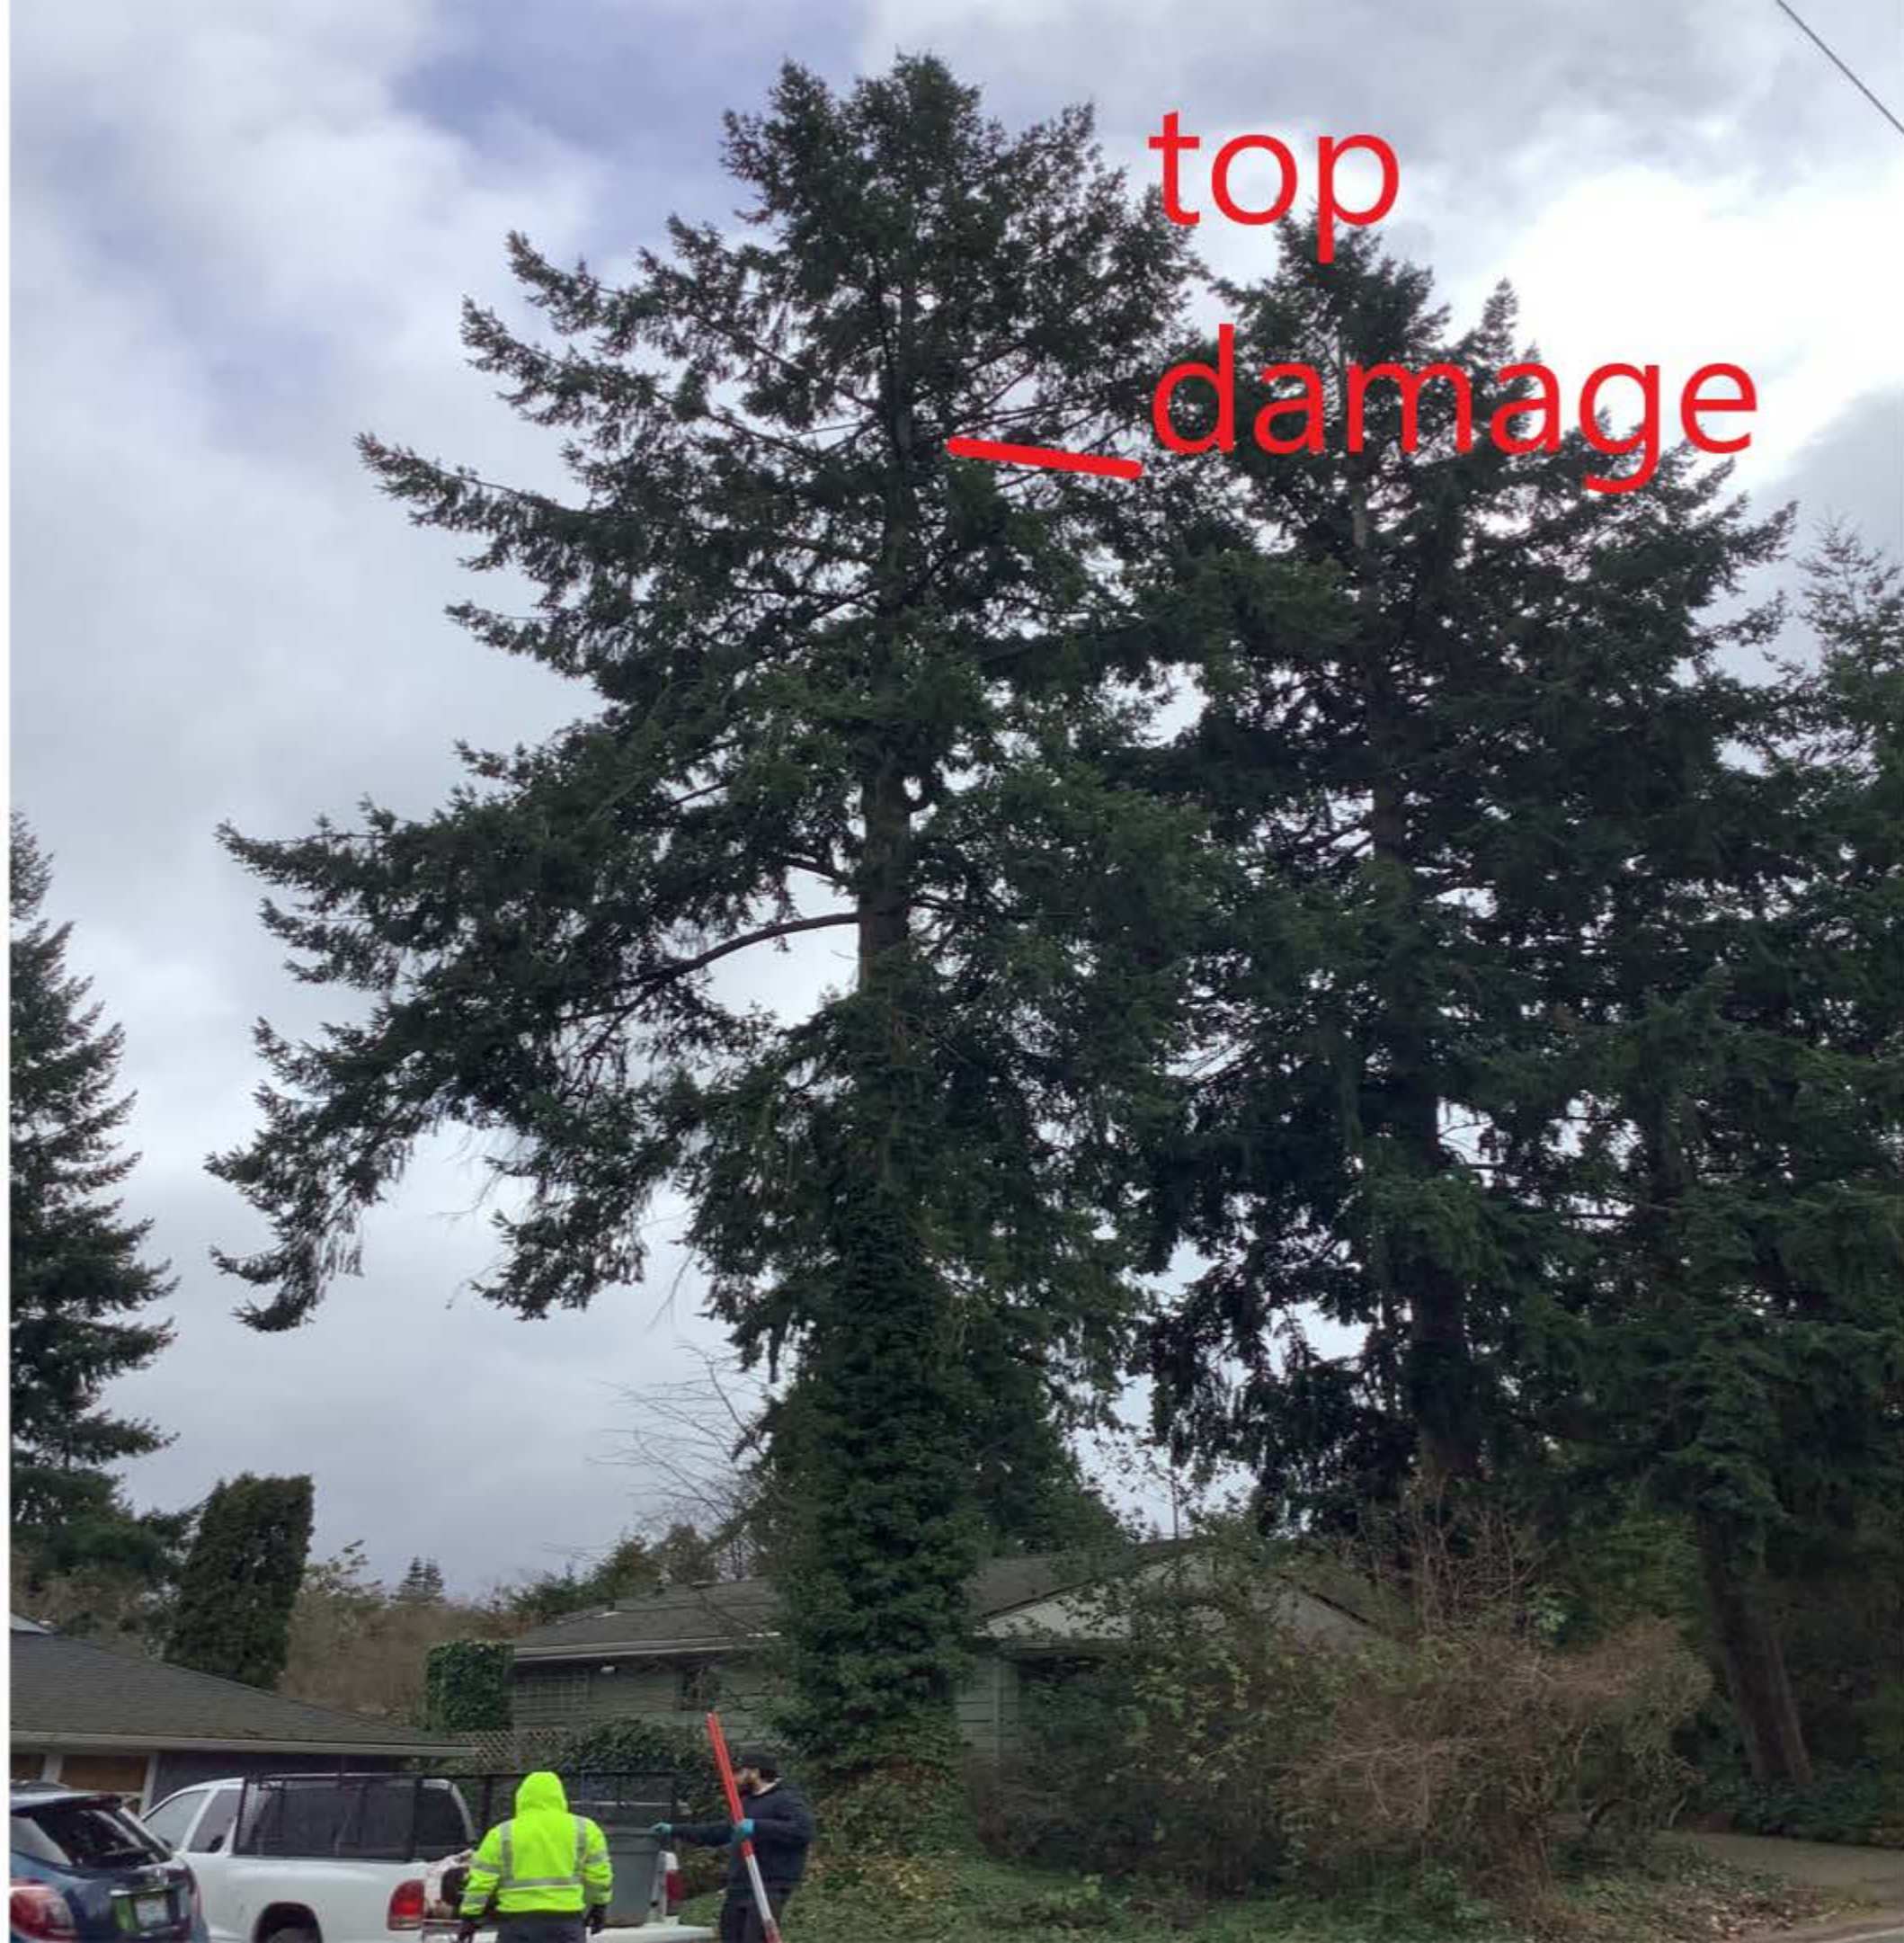
Tree #2 The Douglas Fir has poor taper. The DBH of this tree suggests what normally would be a much taller tree, this tree is 95' tall with a 20' dripline. The foliage on the tree has good color, but the crown is thinner than what would be normal. The top of the tree has been damaged and resprouted. English Ivy covers 25% of the tree. A higher level of inspection may expose inner weakness of the trunk.

top
— damage
