Consulting Arborist Services

Reference: Tree Inventory Report

Date: December 21, 2022

Site Address: 4205 85th Ave SE, Mercer Island 98040

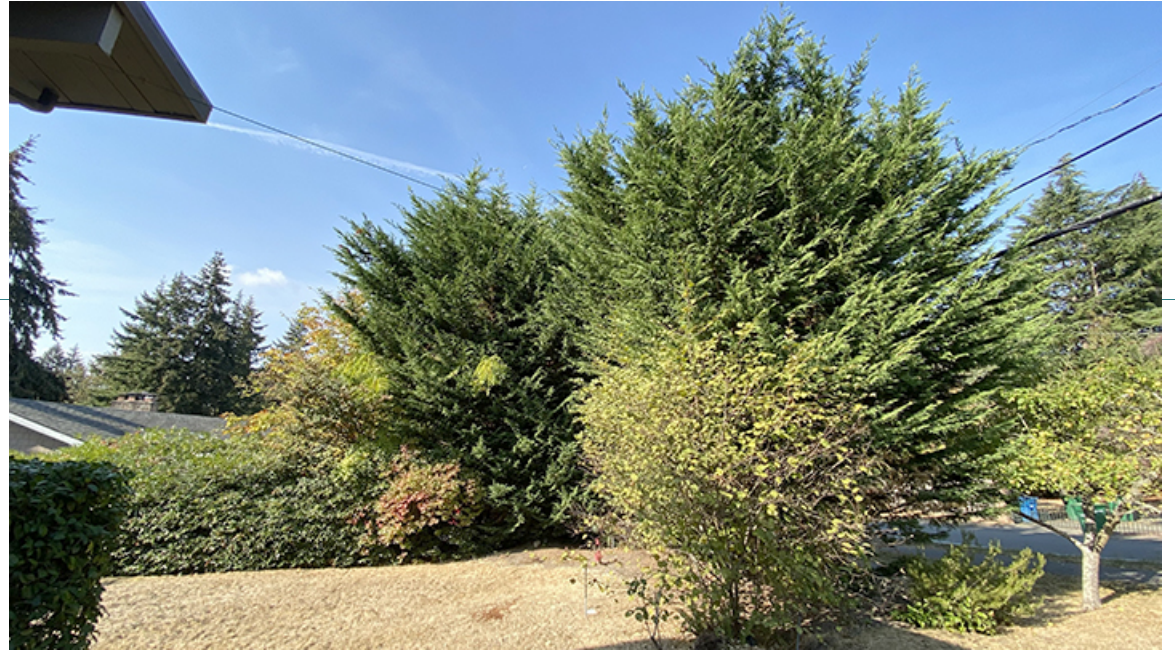
Above: Looking west from the north side of the existing home. Tree #2, 3, 4, and 5, an L-shaped hedge of Leyland cypress.
