# DOWNSTREAM ANALYSIS REPORT

RKK Project  
3419 72<sup>nd</sup> Place SE  
Mercer Island, WA 98040

Tax Map #130030-1381  
November 2, 2022

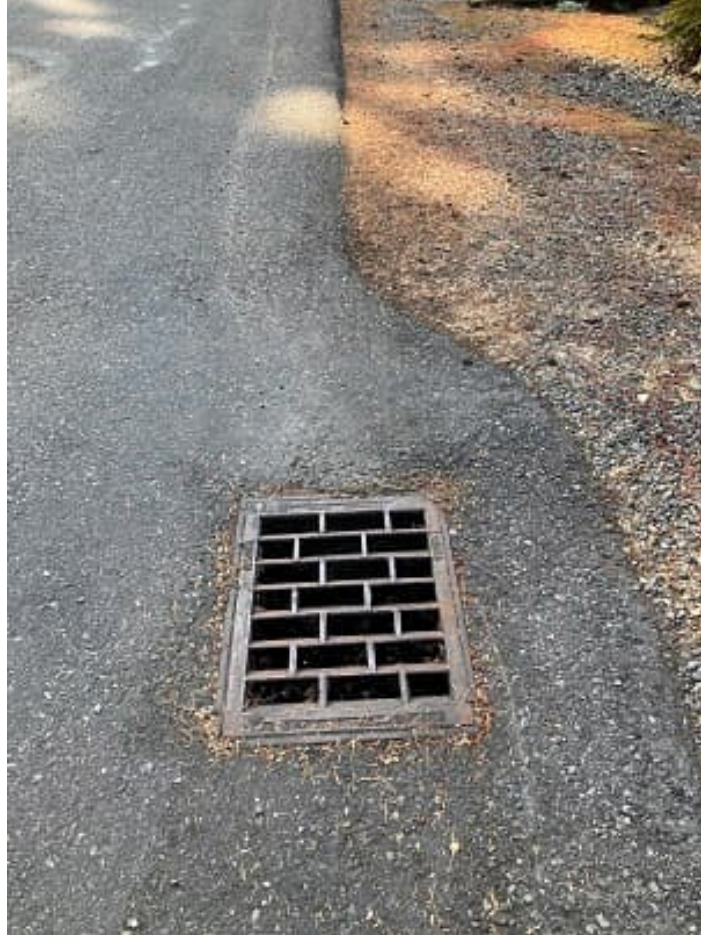
Picture 1:  
ROW in front of 3443 72<sup>nd</sup> Place SE  
Storm will extend south from project site to this catch basin.

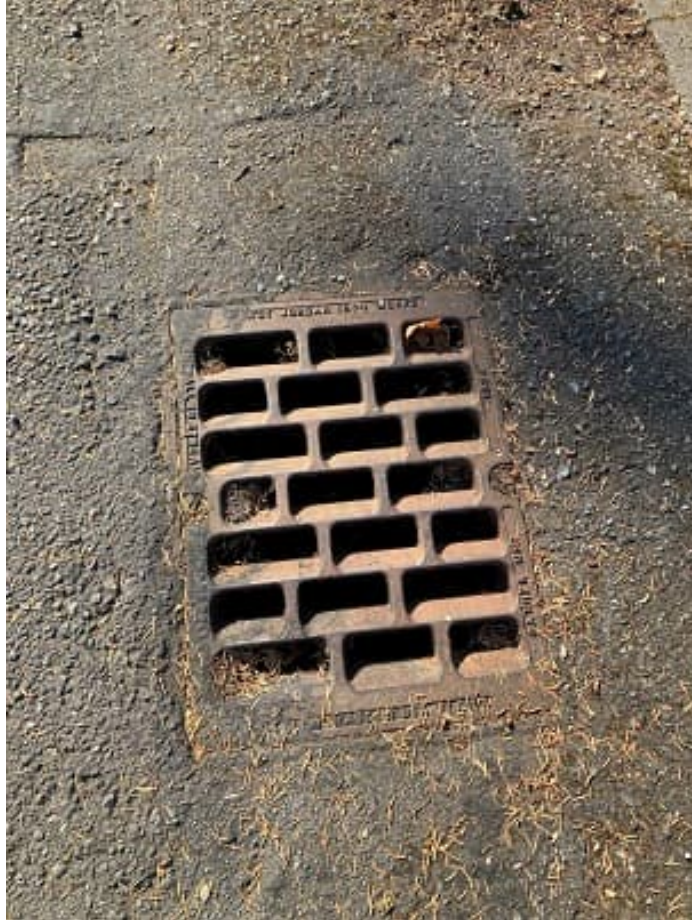
Picture 2  
ROW in front of 3449 72<sup>nd</sup> Place SE  
8" DI pipe discharging toward the south leads to this catch basin.

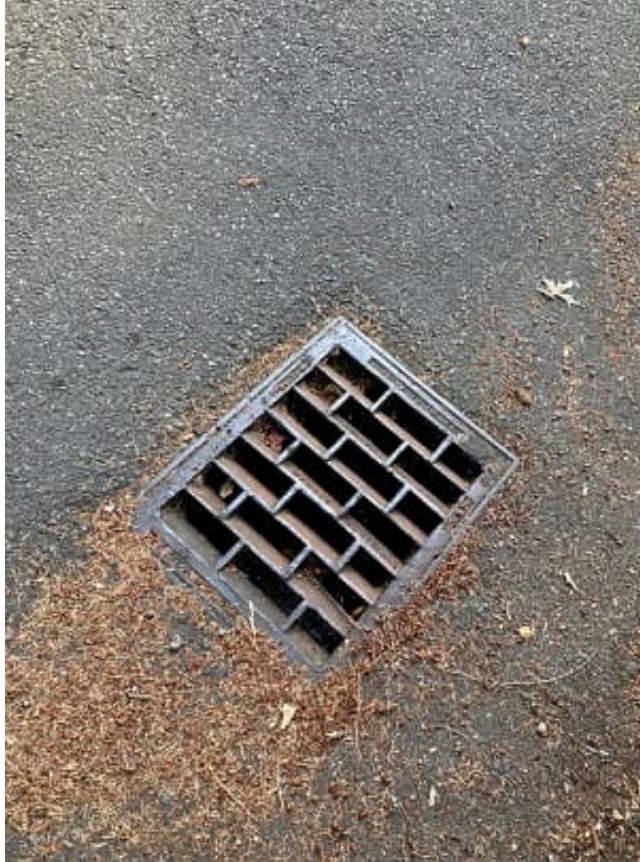
Picture 3  
ROW at intersection of 72<sup>nd</sup> Pl SE and SE 36<sup>th</sup> Street  
From here water turns the corner into SE 36<sup>th</sup> Street.

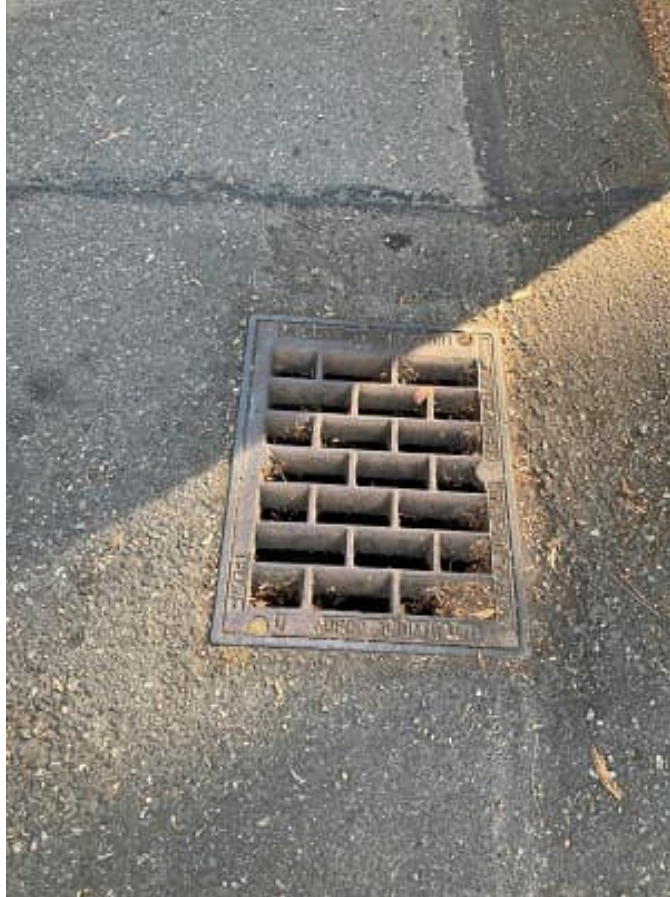
Picture 4  
ROW in front of 7225 SE 36<sup>th</sup> Street  
Another catch basin in line, this one under SE 36<sup>th</sup> Street.

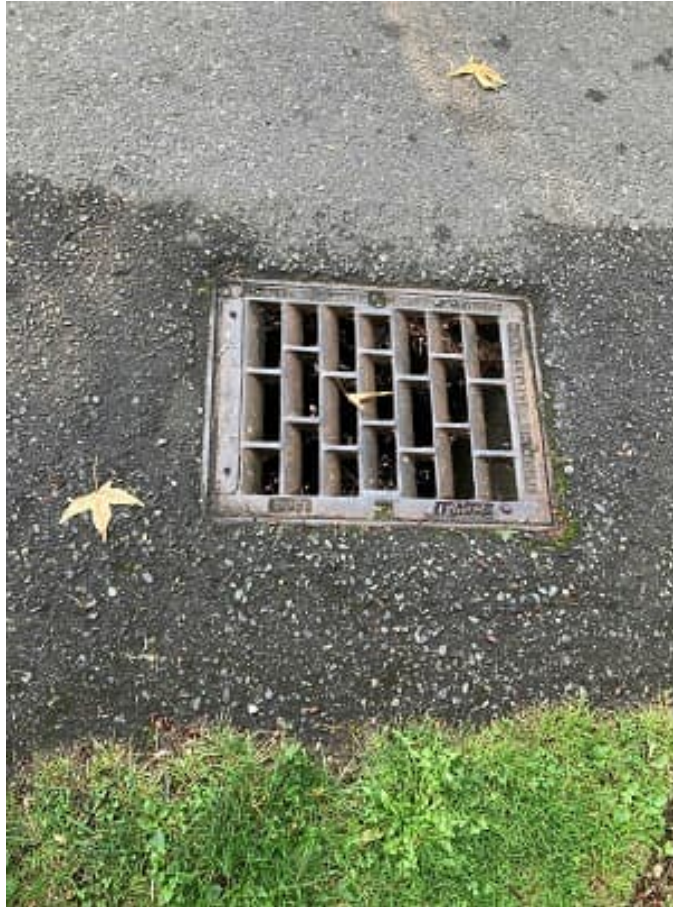
Picture 5  
ROW in front of 3449 SE 36<sup>th</sup> Street  
From this catch basin, water turns toward the south.

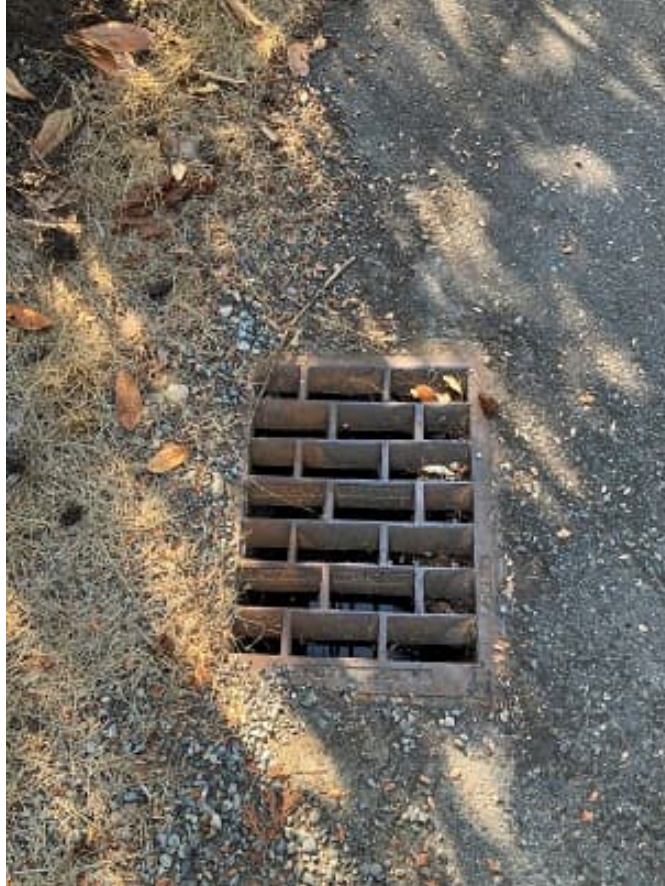
Picture 6  
ROW in front of 7337 SE 36<sup>th</sup> Street  
Water discharges toward the south in this 12" concrete pipe.  
CBs are on the east side of the street on this block.

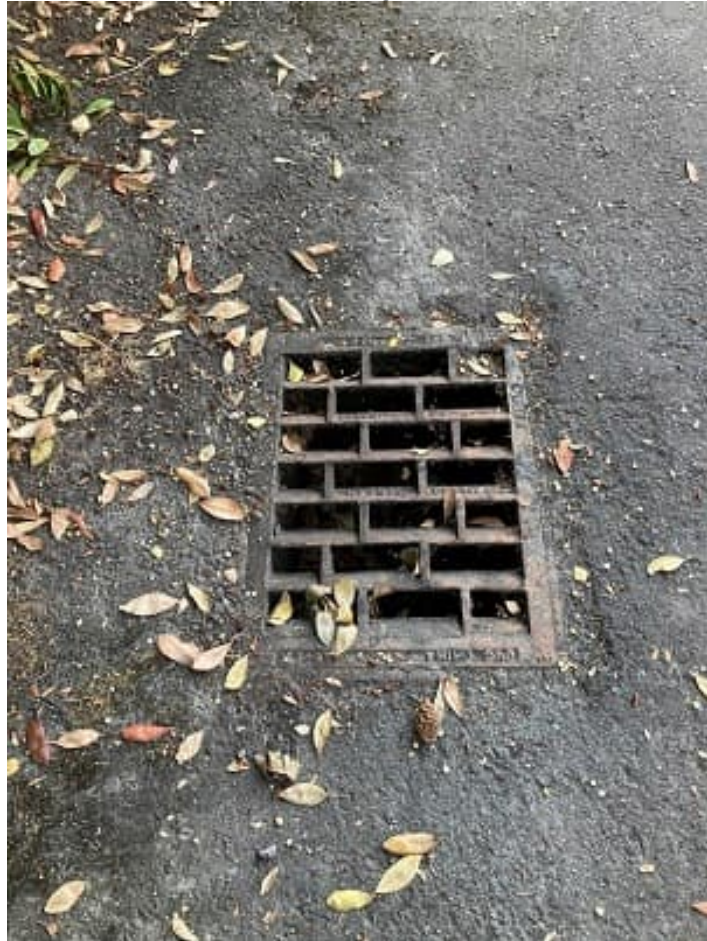
Picture 8  
ROW in front of 3616 73<sup>rd</sup> Avenue SE (south)  
Still flowing south

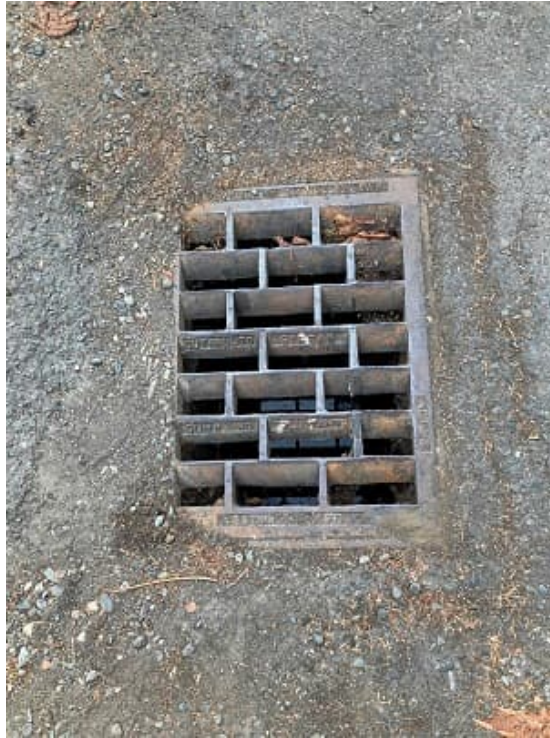
Picture 12  
ROW in front of 3650 73<sup>rd</sup> Avenue SE  
storm direction is due south

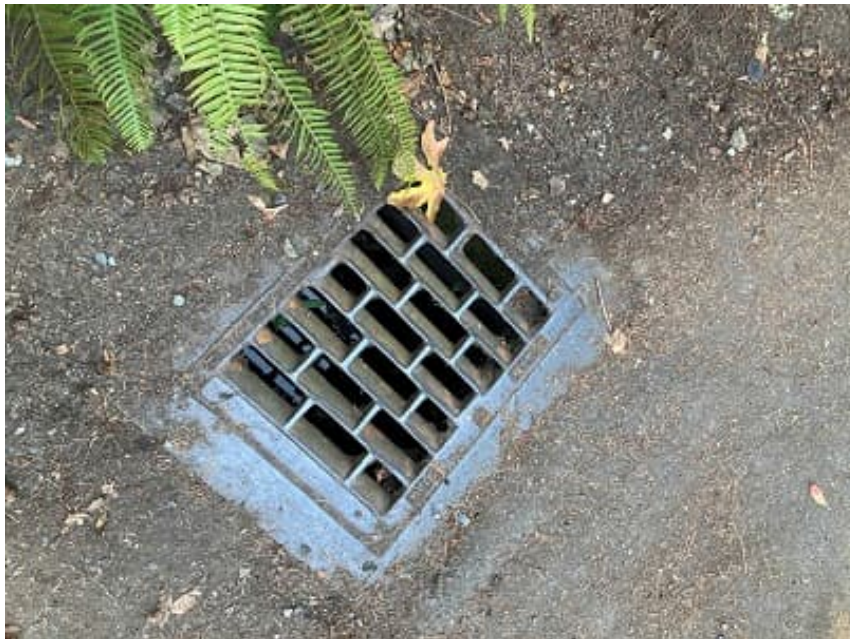
Picture 13  
ROW at the NE corner of 73<sup>rd</sup> Avenue SE and SE 38<sup>th</sup> Street  
At this CB the storm drain makes a turn east under the SE 38<sup>th</sup> Street ROW

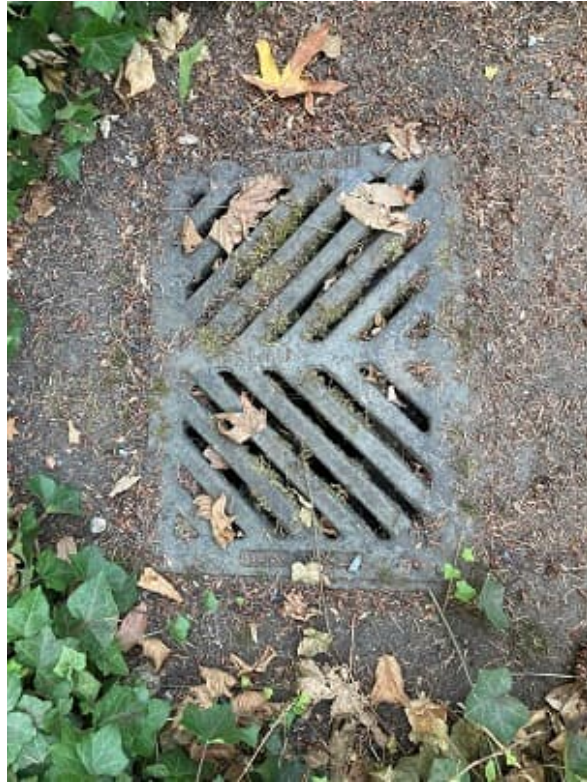
Picture 14  
ROW at the sw corner of 73<sup>rd</sup> Avenue SE and SE 38<sup>th</sup> Street  
runoff heading east

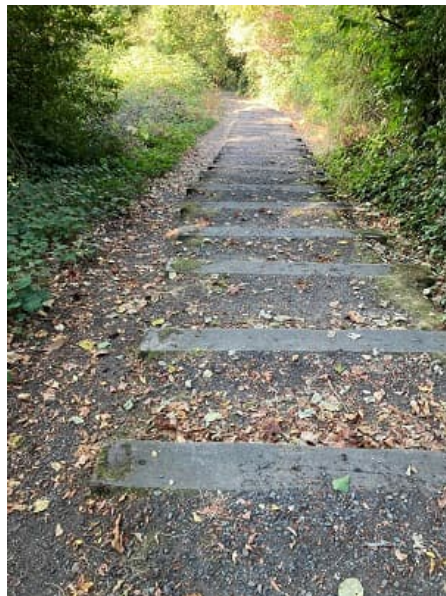
Picture 15:  
SE 38<sup>th</sup> Street ROW  
Engineer could not locate the two catch basins in this area.

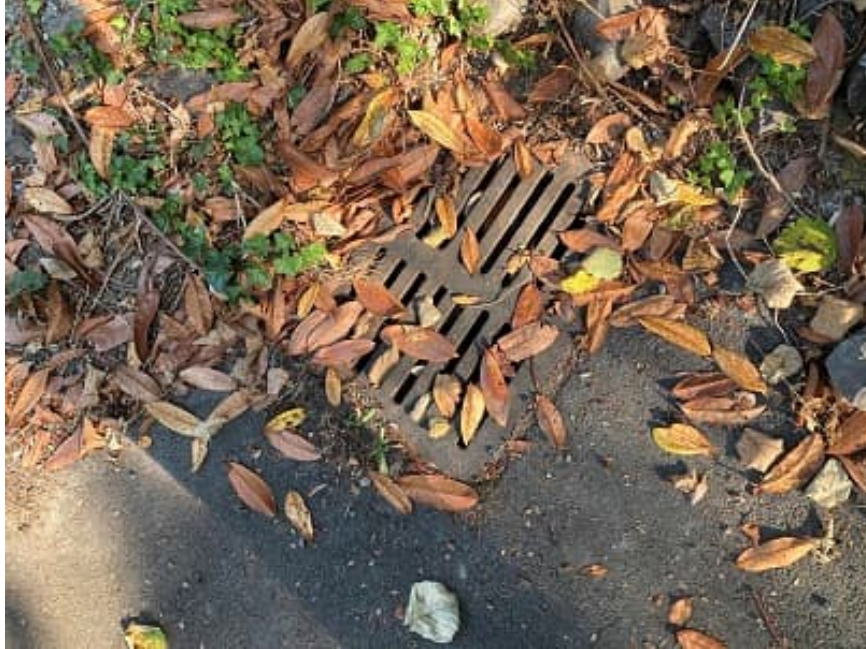
Picture 16

bottom of stairs in SE 38<sup>th</sup> Street ROW @ 72<sup>nd</sup> Place SE  
CB at the bottom of stairs. From here runoff crosses 72<sup>nd</sup> Place SE to its west side.

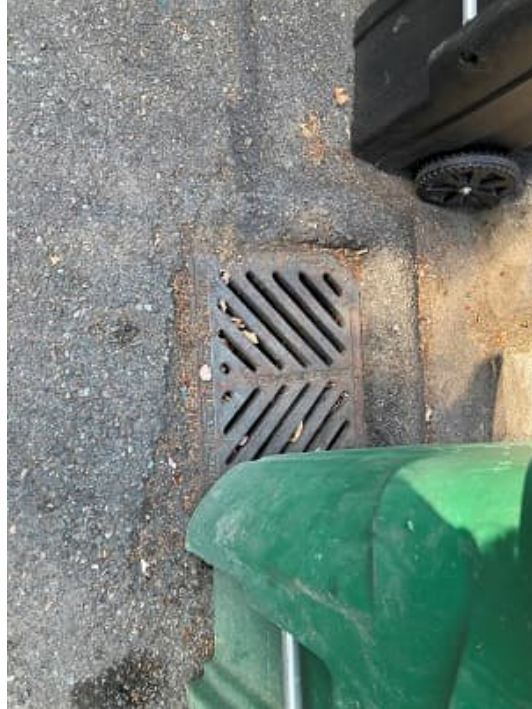
Picture 18  
ROW in front of 3698 72<sup>nd</sup> Place SE  
From this catch basin water heads toward the west.

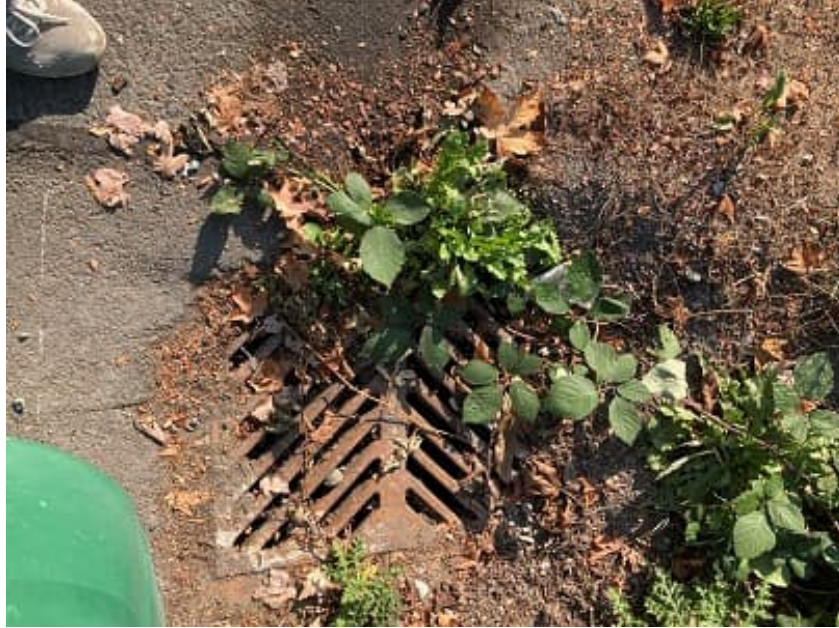
Picture 20

ROW at the NW corner of 72<sup>nd</sup> Place SE and W. Mercer Way  
From this catch basin water heads turns northwest onto W. Mercer Way

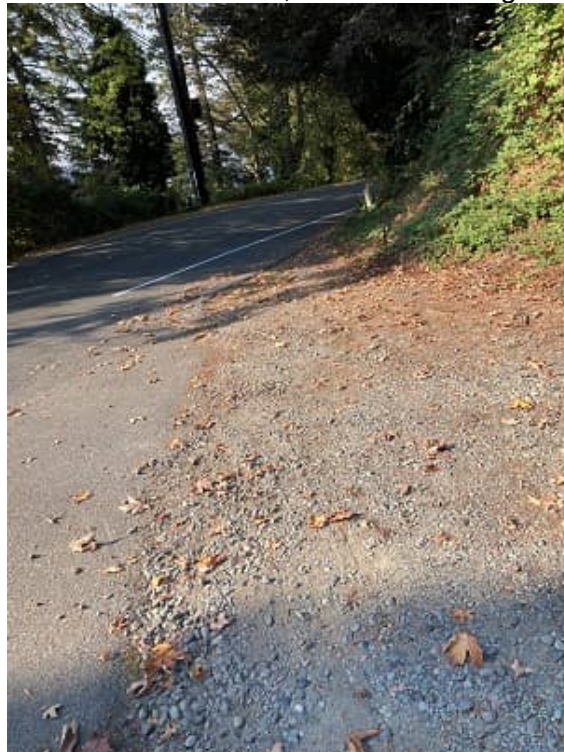
Picture 21

looking nw along West Mercer Way at 72<sup>nd</sup> Place SE  
runoff leaves the CB at Picture 20, and heads along W. Mercer Way.
