Project: Pre-construction assessment for lot re-development at 3419 72nd Place SE, Mercer Island, WA. Parcel number 1300301381.

Objectives: Evaluate health of existing trees and establish criteria for the preservation of those to be retained.

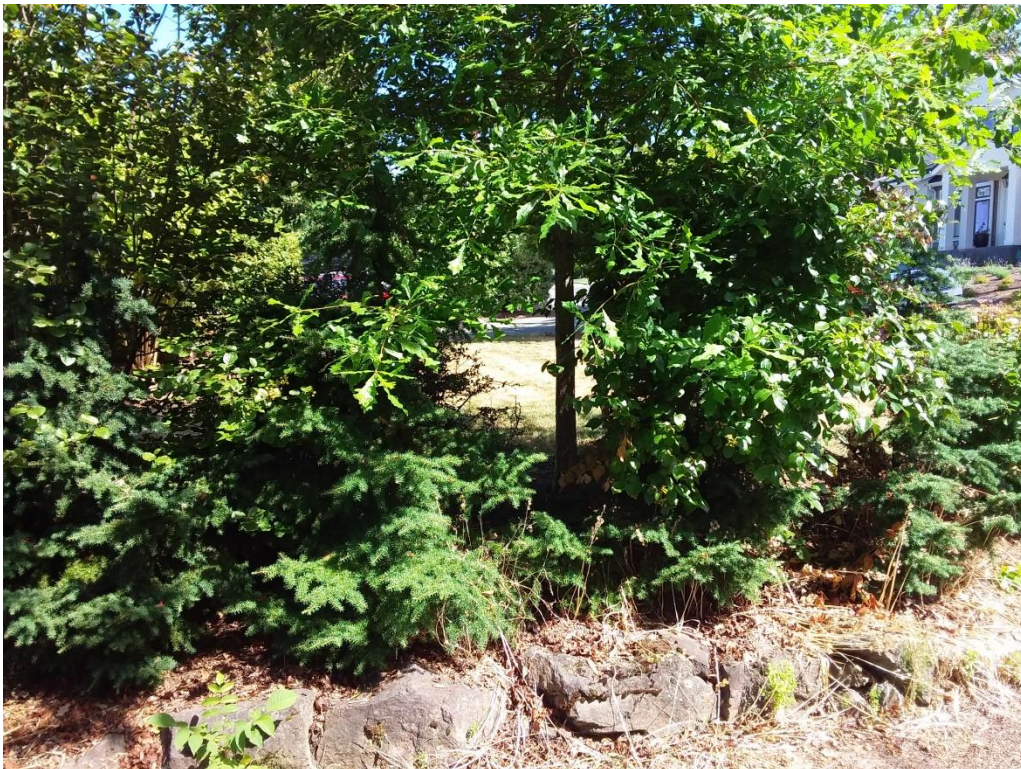
3. A juvenile oak tree (*Quercus sp*) that might be a young Red or even a Burr. It is difficult to tell because of its age. Not sure if this tree was planted or volunteered. It is standing 5' N of the north side of the existing driveway about 12' W of the road. There is also several small Mountain Hemlocks (*Tsuga mertensiana*) standing to either side of the oak (Figure 10). All these trees are less than 4" caliper. A small stone border lines the edge.

The #3 set of trees is technically within the primary impact zone, being just 5' off of the existing driveway which will be removed. As long as the stones at the edge are not disturbed the root systems of the young trees will be fine.

Figure 10. Looking north at the #3 oak and hemlocks and the stone border wall.

Ideally protection fencing will be set up prior to the demolition. In front a short section of fence set on the north side of the existing driveway south of the stone border will ensure the #3 set of trees will be fully protected.

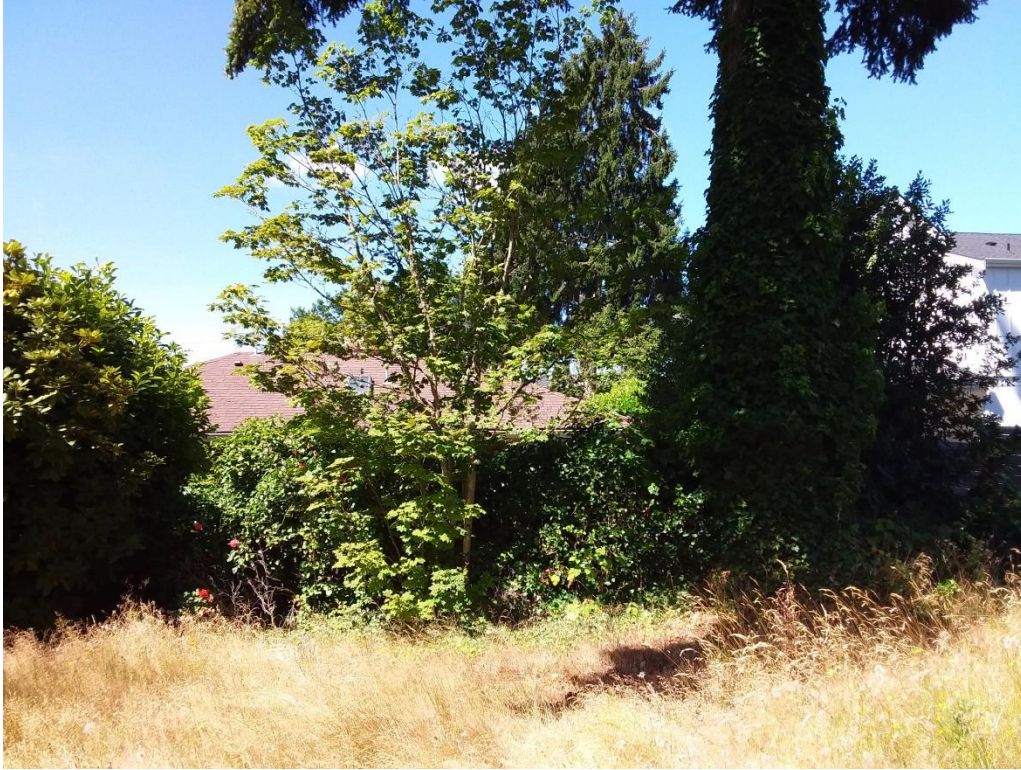
4. Douglas fir (*Pseudotsuga menziesii*) engulfed in ivy from the ground to at least the midpoint of the column (Figure 11). Accounting for the sheath of ivy stems the tree measures out to be 31" DSH. It stands 14' S of the northwest corner marker for the property, 28' W of the existing house foundation, and 22' W of the poured concrete back patio at the northwest corner of the existing house. The fir is 75' tall and its canopy comes down past the halfway point. It exhibits good color and new growth and an above average cone load. The west side (3420) neighbor's yard drops off rapidly 5' W of the base of the tree, as much as 8' over a 10' span. There is likely a retaining wall under the ivy and undergrowth. Exceptional by definition.

5. Vine Maple (*Acer circinatum*) formed from eight stems 2.5-3" DSH and half a dozen in the ½-1" DSH sizing. Tree reaches about 15' tall, has a 6' radial spread, stands 3' E of the back fence, and 11' S of the #4 fir. The older stems are in below average condition. The young ones exhibit good new color and growth. Likely struggling with Verticillium Wilt. Significant even with the small stems because of its typical formation for the species.

The #4 fir will experience disturbance from the demolition. The tree is large enough that it has likely extended its root system around the north end of the house and the full length of patio. It is doubtful that any roots go under the concrete because of its distance from the tree. The proposed new construction is 12-24' further east from the tree than the existing. Taking everything into consideration there could be a potential loss of 35 square feet of Critical Rooting Area.

Assuming that the tree only has 1750 square feet of rooting space because of the drop offs and/or retaining walls to its north and west and that based on its diameter it should have 3018 square feet of CRA it is highly likely that the fir has nearly double the root concentration present in the area. Even taking all that into account the loss in rooting space from the demolition will be significantly below threshold for the tree.

Figure 11. Looking west at the base of the #4 fir and the #5 vine maple to its left. Note the thick ivy on the base of the fir which needs to be severed.

The fence on the west side should run from the north property line south along the edge of the NW patio to meet up with the edge of the SW patio and hence to the south line. This will protect both the #5 vine maple and the #6 dogwood along with the larger fir and pine.

The ivy needs to be severed at the base of the #4 fir creating at least a 3' tall completely clear swath all the way around the trunk of the tree.

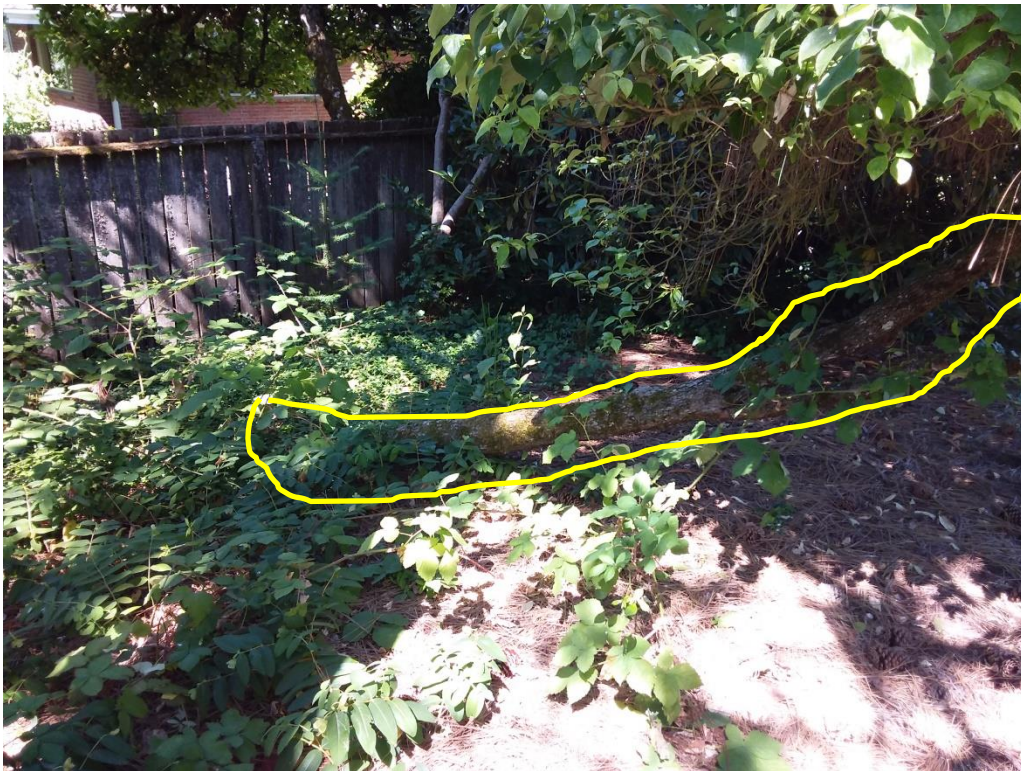
6. Dogwood (*Cornus florida*) whose base is 16' N of the south line and 12' E of the west fence. The tree grows nearly horizontal 12' east from its base before beginning to turn upright (Figure 12). The east end of the tree stops 11' W of the existing house. The majority of the canopy forms a 7' radial spread centered on a point 16' W of the house as shown in Figure 13.

Figure 12. Looking west at the stem of the #6 dogwood.
