# DOWNSTREAM ANALYSIS REPORT

RKK Project  
3419 72<sup>nd</sup> Place SE  
Mercer Island, WA 98040

CES #2036

By Stephenie Seawall, Civil Engineer  
Edited by Duffy Ellis, PE

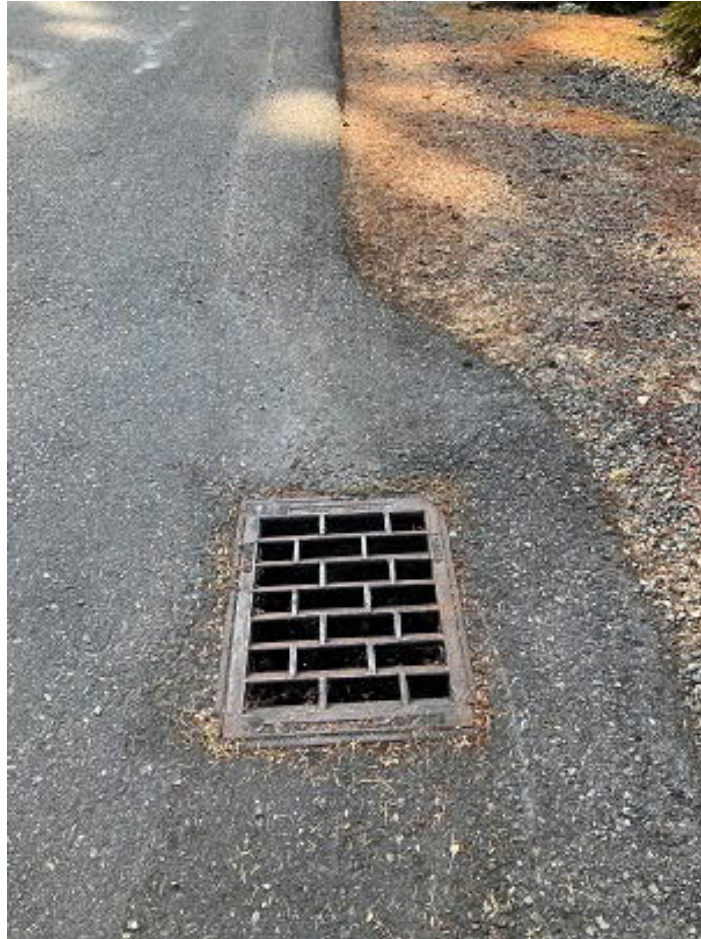
Picture 1:  
ROW in front of 3443 72<sup>nd</sup> Place SE  
Storm will extend south from project site to this catch basin.

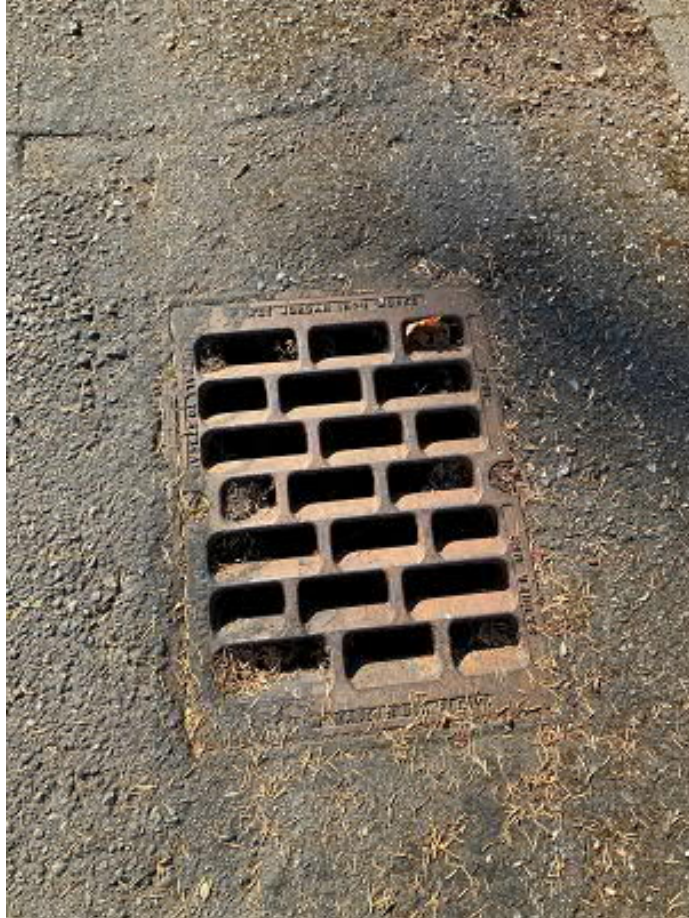
Picture 2  
ROW in front of 3449 72<sup>nd</sup> Place SE  
8" DI pipe discharging toward the south leads to this catch basin.

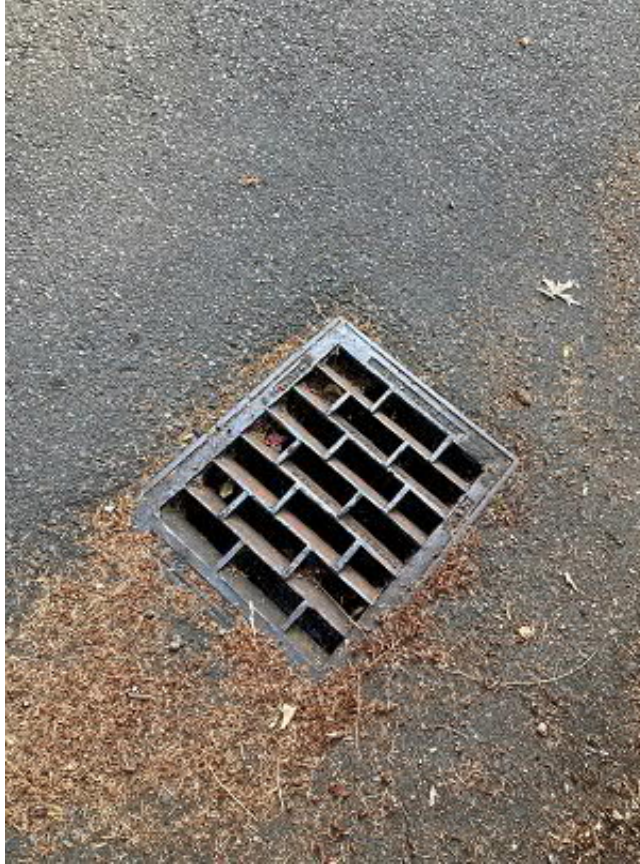
Picture 3  
ROW at intersection of 72<sup>nd</sup> Pl SE and SE 36<sup>th</sup> Street  
From here water turns the corner into SE 36<sup>th</sup> Street.

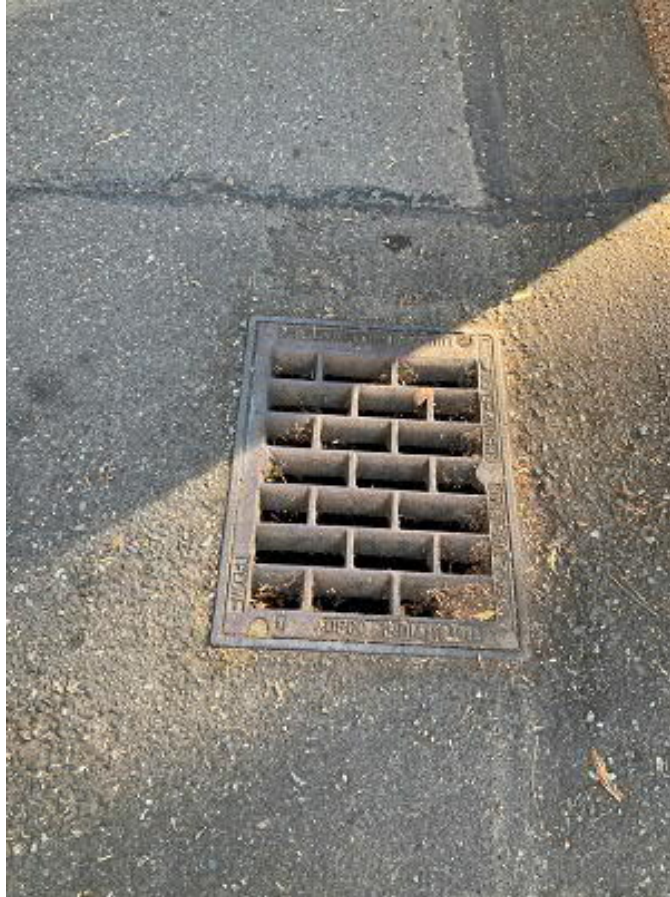
Picture 4  
ROW in front of 7225 SE 36<sup>th</sup> Street  
Another catch basin in line, this one under SE 36<sup>th</sup> Street.

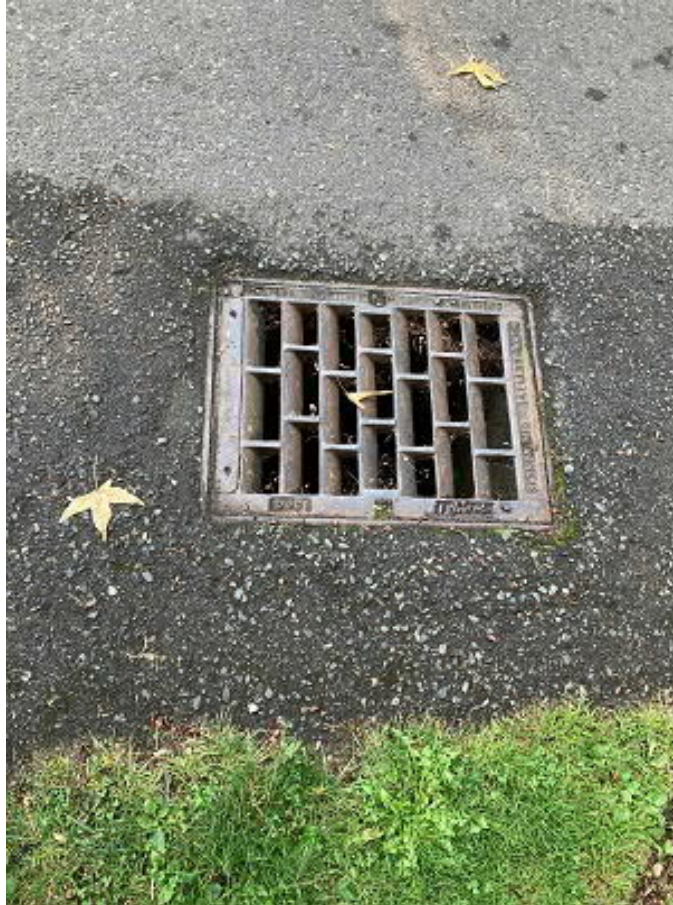
Picture 5  
ROW in front of 3449 SE 36<sup>th</sup> Street  
From this catch basin, water turns toward the south.

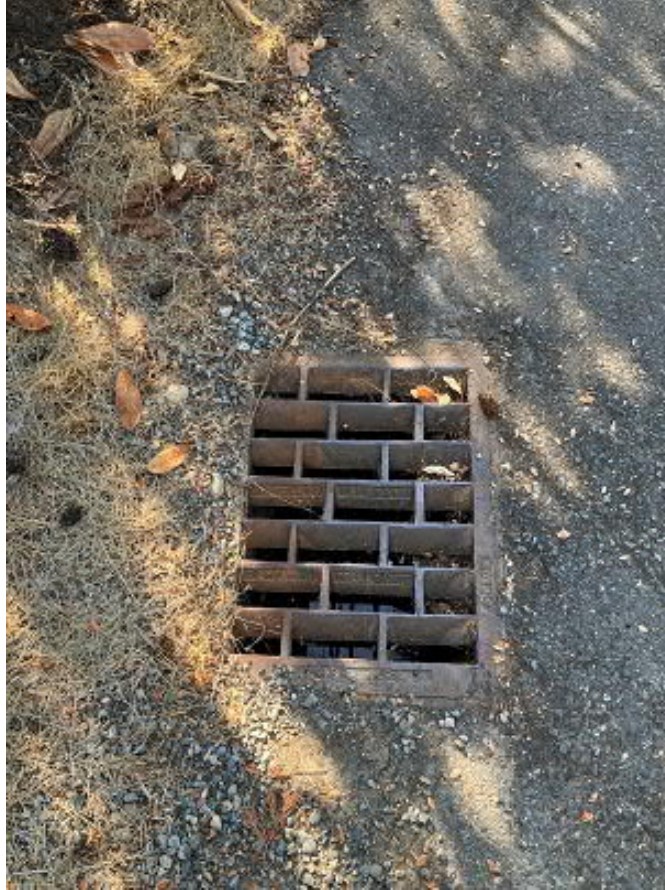
Picture 6  
ROW in front of 7337 SE 36<sup>th</sup> Street  
Water discharges toward the south in this 12" concrete pipe.  
CBs are on the east side of the street on this block.

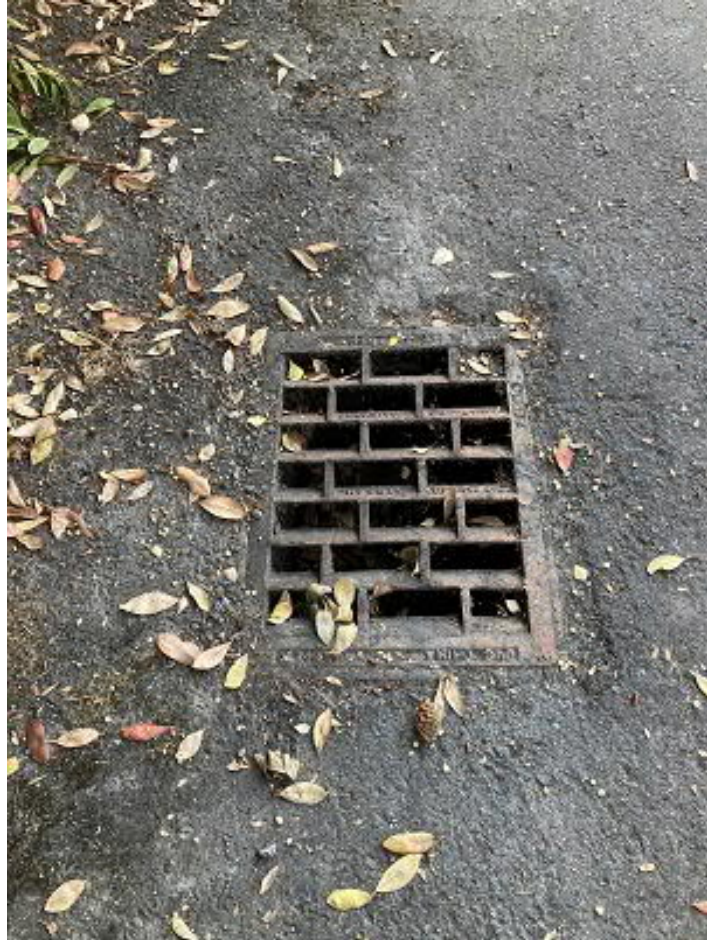
Picture 8  
ROW in front of 3616 73<sup>rd</sup> Avenue SE (south)  
Still flowing south

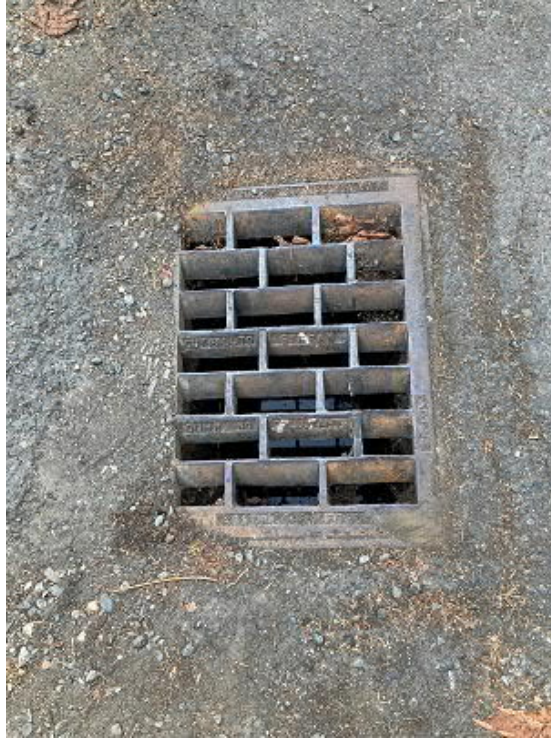
Picture 12  
ROW in front of 3650 73<sup>rd</sup> Avenue SE  
storm direction is due south

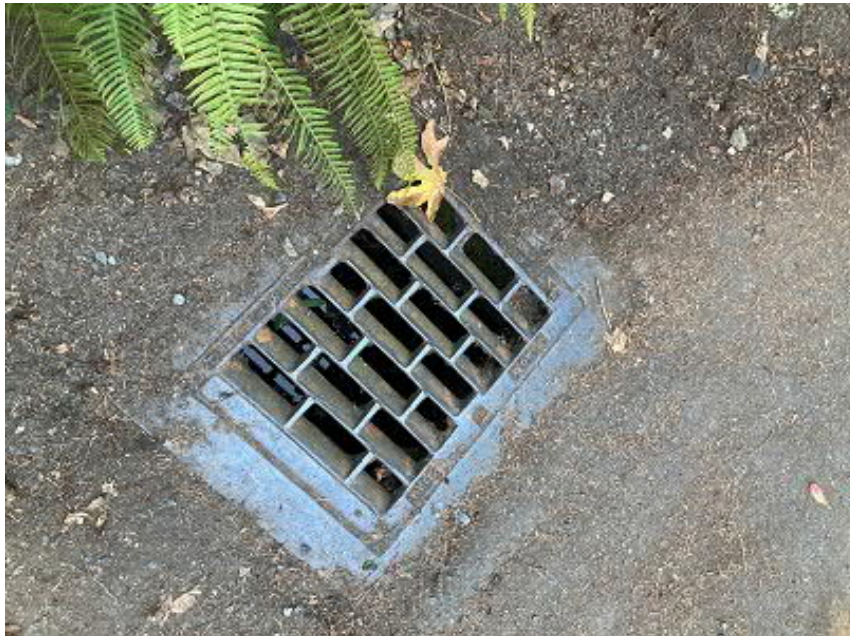
Picture 13  
ROW at the NE corner of 73<sup>rd</sup> Avenue SE and SE 38<sup>th</sup> Street  
At this CB the storm drain makes a turn east under the SE 38<sup>th</sup> Street ROW

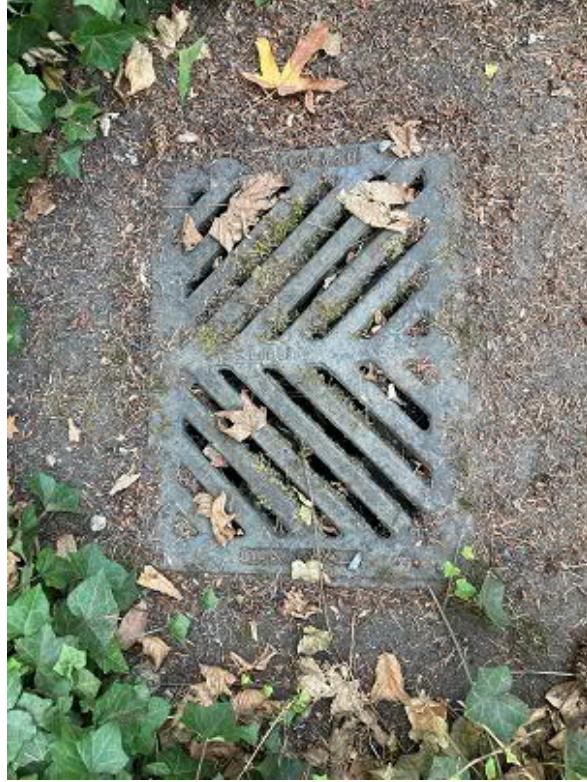
Picture 14  
ROW at the sw corner of 73<sup>rd</sup> Avenue SE and SE 38<sup>th</sup> Street  
runoff heading east

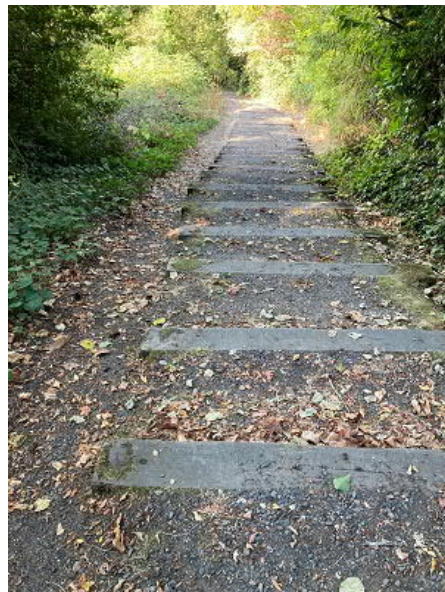
Picture 15:  
SE 38<sup>th</sup> Street ROW  
Engineer could not locate the two catch basins in this area.

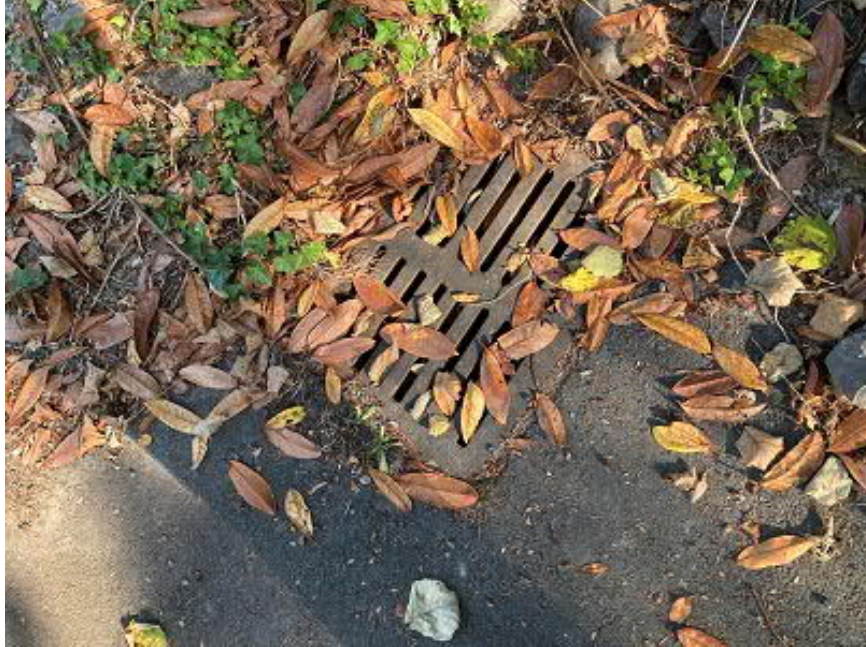
Picture 16  
bottom of stairs in SE 38<sup>th</sup> Street ROW @ 72<sup>nd</sup> Place SE  
CB at the bottom of stairs. From here runoff crosses 72<sup>nd</sup> Place SE to its west side.

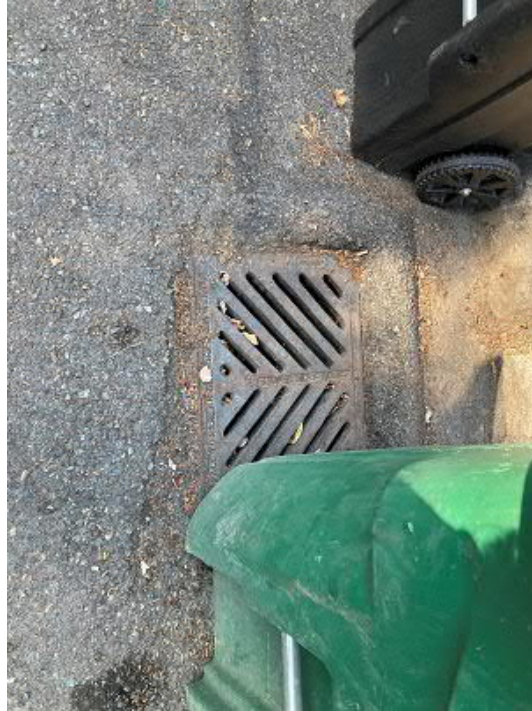
Picture 18  
ROW in front of 3698 72<sup>nd</sup> Place SE  
From this catch basin water heads toward the west.

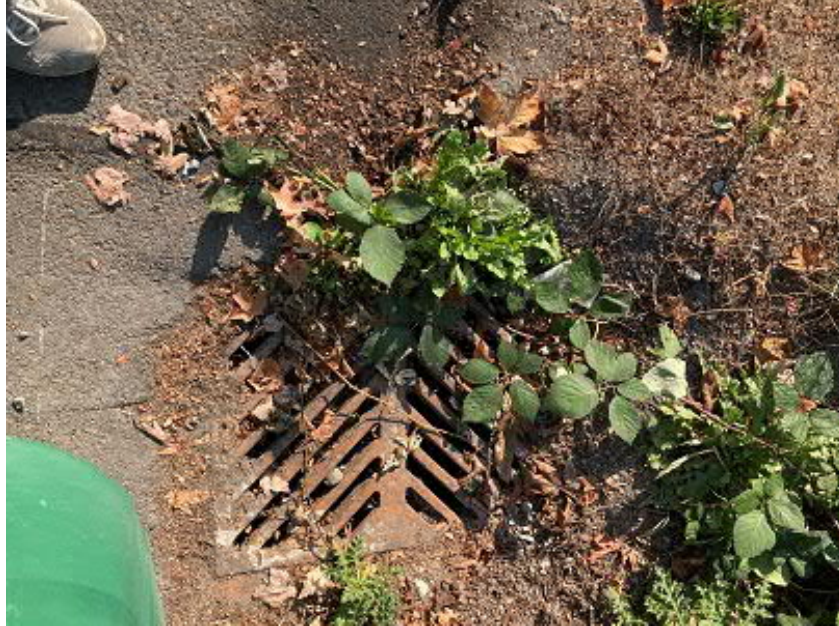
Picture 20

ROW at the NW corner of 72<sup>nd</sup> Place SE and W. Mercer Way  
From this catch basin water heads turns northwest onto W. Mercer Way

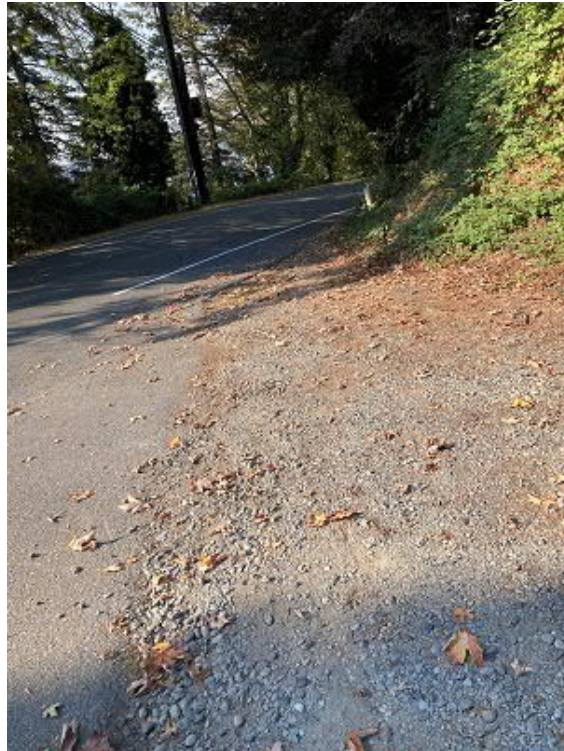
Picture 21

looking nw along West Mercer Way at 72<sup>nd</sup> Place SE  
runoff leaves the CB at Picture 20, and heads along W. Mercer Way.
