January 6, 2023

Project: Pre-construction assessment for lot re-development at 3419 72nd Place SE, Mercer Island, WA. Parcel number 1300301381.

Objectives: Evaluate health of existing trees and establish criteria for the preservation of those to be retained.

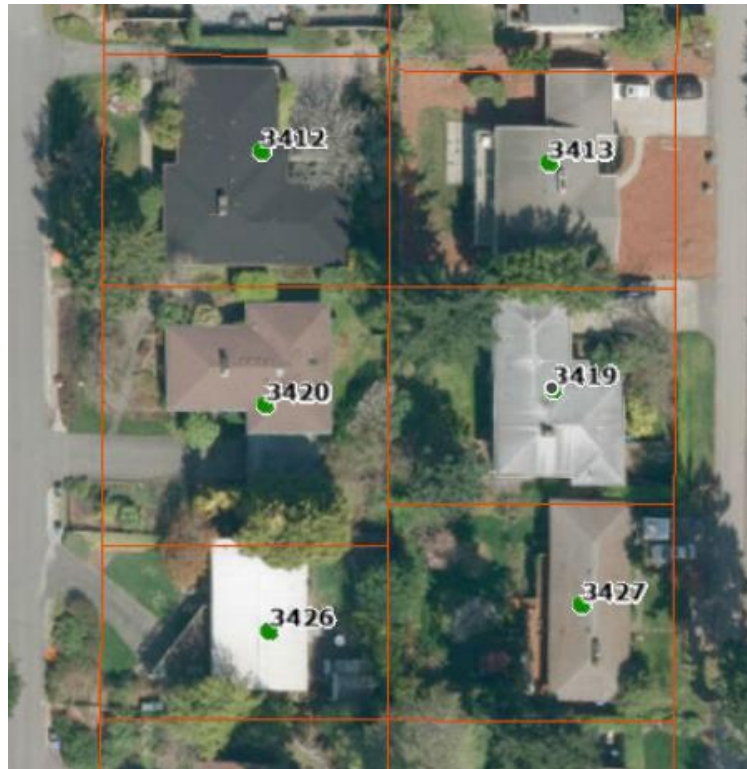
Figure 2. Aerial photo circa 2012 showing the large evergreens missing in the 3413 yard.

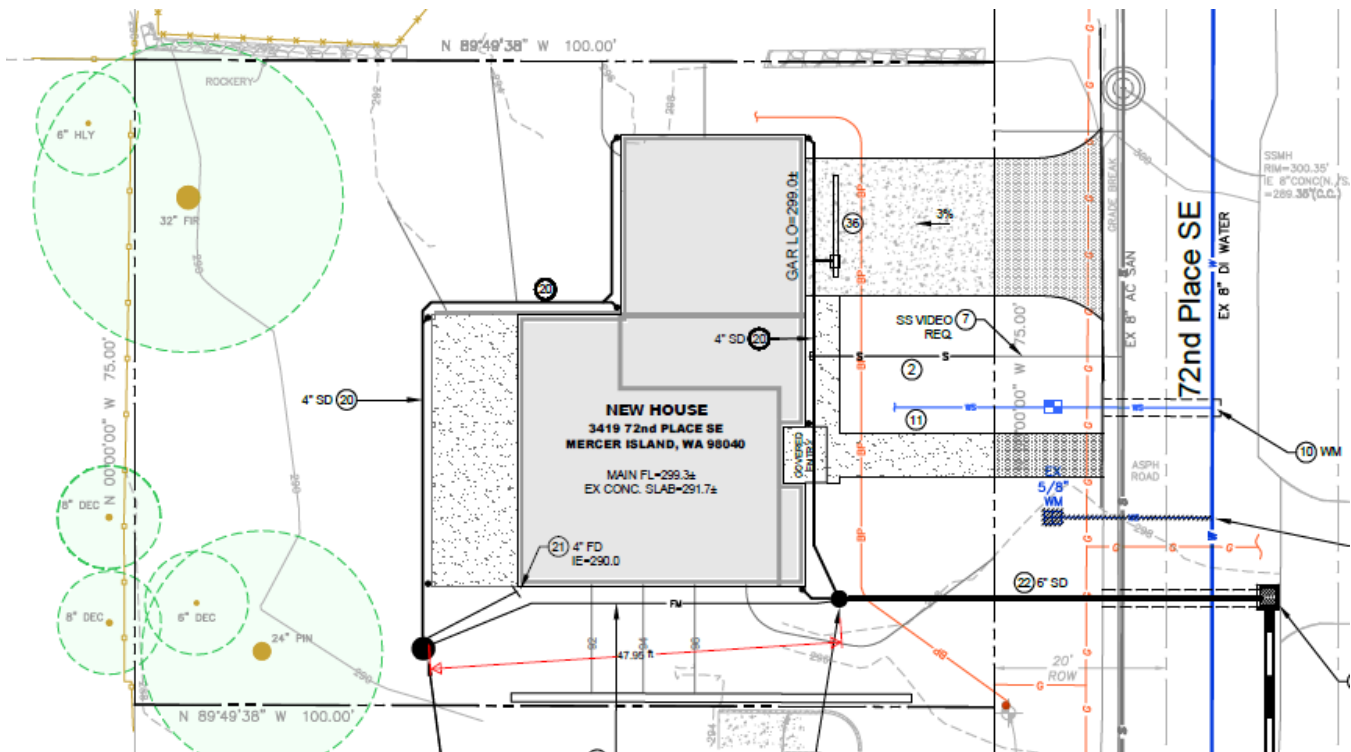
Figure 8. Excerpt from the proposed plan set showing the new layout. Note the greater distance of the west side of the house to the trees on that side. The circles around the trees are not fully representative of the extent of the Critical Root Zones of the subject trees. (See Figure 16 below). Note the new water main cutting through the area where the #2 cherry is standing (blue line).

Removing the #2 cherry will trigger requirements for two replacement trees.

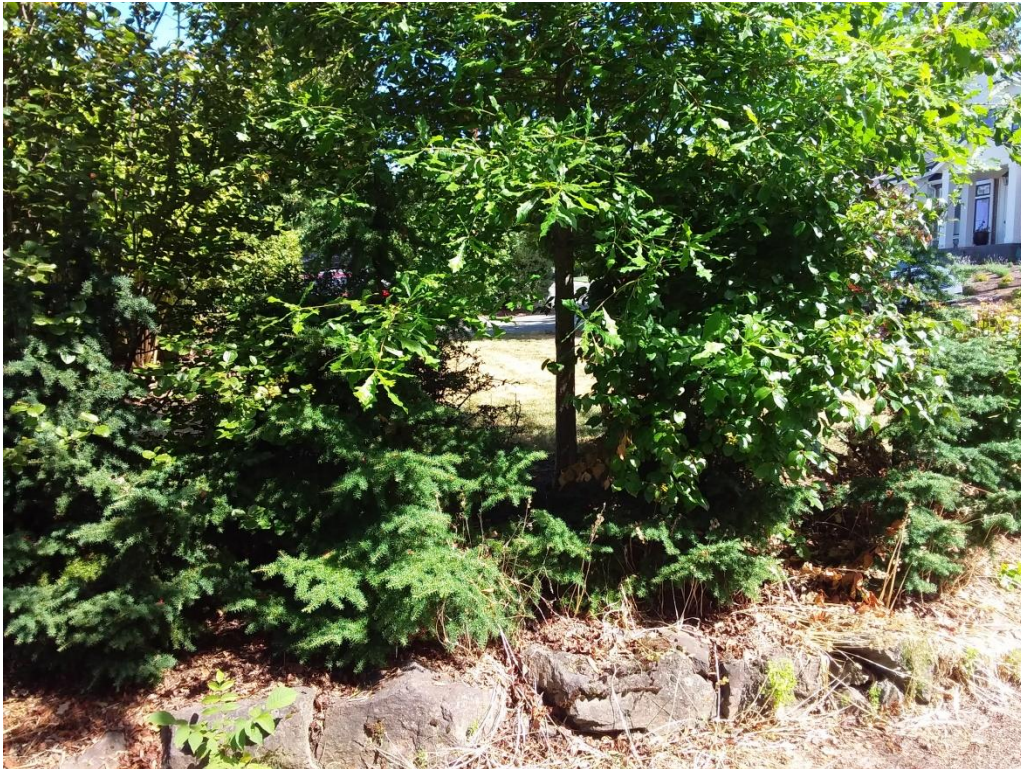
3. A juvenile oak tree (*Quercus sp*) that might be a young Red or even a Burr. It is difficult to tell because of its age. Not sure if this tree was planted or volunteered. It is standing 5' N of the north side of the existing driveway about 12' W of the road. There is also several small Mountain Hemlocks (*Tsuga mertensiana*) standing to either side of the oak (Figure 10). All these trees are less than 4" caliper. A small stone border lines the edge.

Figure 10. Looking north at the #3 oak and hemlocks and the stone border wall.

Ideally protection fencing will be set up prior to the demolition. In front a short section of fence set on the north side of the existing driveway south of the stone border will ensure the #3 set of trees will be fully protected.

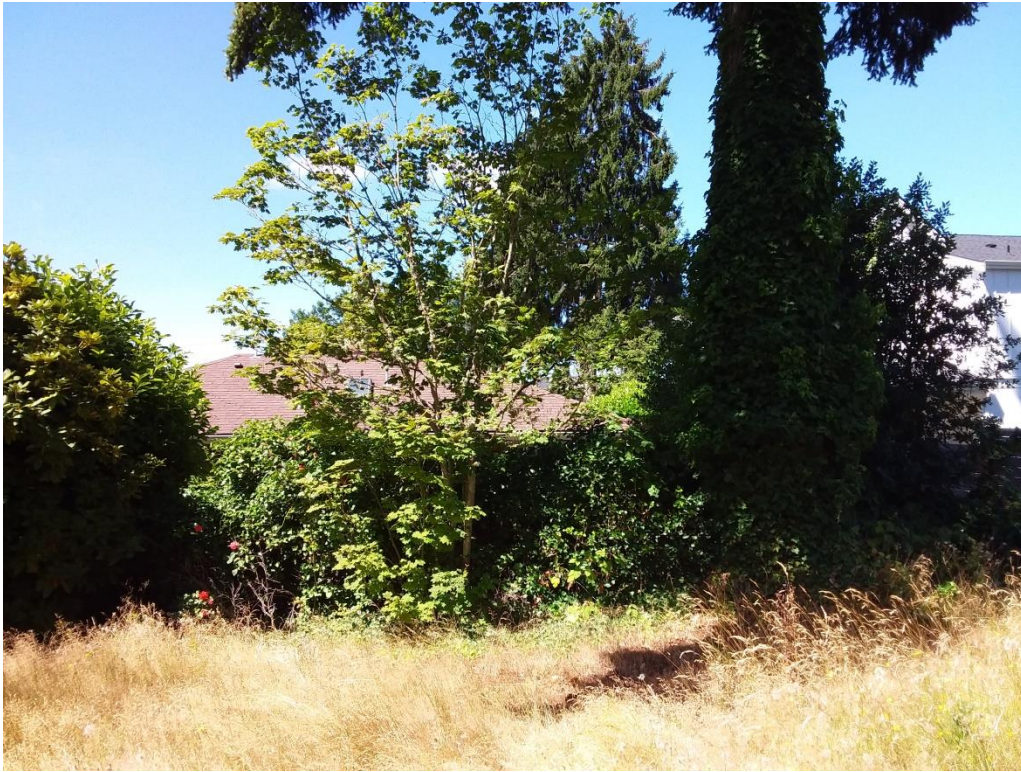
4. Douglas fir (*Pseudotsuga menziesii*) engulfed in ivy from the ground to at least the midpoint of the column (Figure 11). Accounting for the sheath of ivy stems the tree measures out to be 31" DSH. It stands 14' S of the northwest corner marker for the property, 28' W of the existing house foundation, and 22' W of the poured concrete back patio at the northwest corner of the existing house. The fir is 75' tall and its canopy comes down past the halfway point. It exhibits good color and new growth and an above average cone load. The west side (3420) neighbor's yard drops off rapidly 5' W of the base of the tree, as much as 8' over a 10' span. There is likely a retaining wall under the ivy and undergrowth. Exceptional by definition.

The #4 fir will experience disturbance from the demolition. The tree is large enough that it has likely extended its root system around the north end of the house and the full length of patio. It is doubtful that any roots go under the concrete because of its distance from the tree. The proposed new construction is 12-24' further east from the tree than the existing. Taking everything into consideration there could be a potential loss of 35 square feet of Critical Rooting Area.

Assuming that the tree only has 1750 square feet of rooting space because of the drop offs and/or retaining walls to its north and west and that based on its diameter it should have 3018 square feet of CRA it is highly likely that the fir has nearly double the root concentration present in the area. Even taking all that into account the loss in rooting space from the demolition will be significantly below threshold for the tree.

Figure 11. Looking west at the base of the #4 fir and the #5 vine maple to its left. Note the thick ivy on the base of the fir which needs to be severed.

The ivy needs to be severed at the base of the #4 fir creating at least a 3' tall completely clear swath all the way around the trunk of the tree.

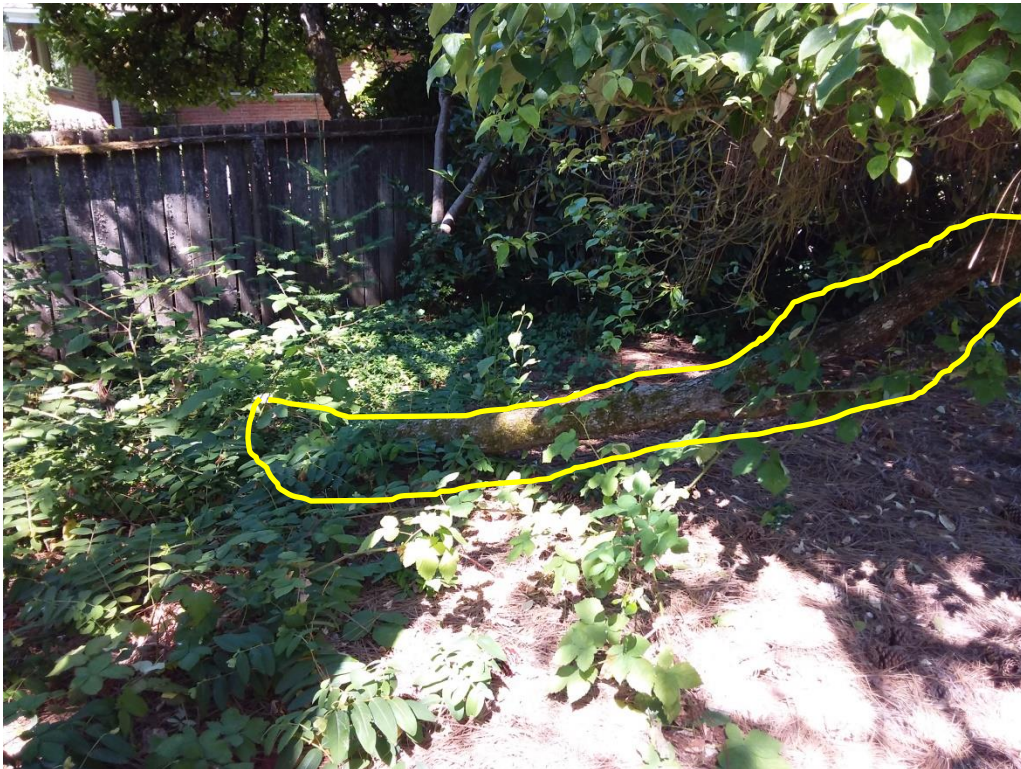
6. Dogwood (*Cornus florida*) whose base is 16' N of the south line and 12' E of the west fence. The tree grows nearly horizontal 12' east from its base before beginning to turn upright (Figure 12). The east end of the tree stops 11' W of the existing house. The majority of the canopy forms a 7' radial spread centered on a point 16' W of the house as shown in Figure 13.

Figure 12. Looking west at the stem of the #6 dogwood.

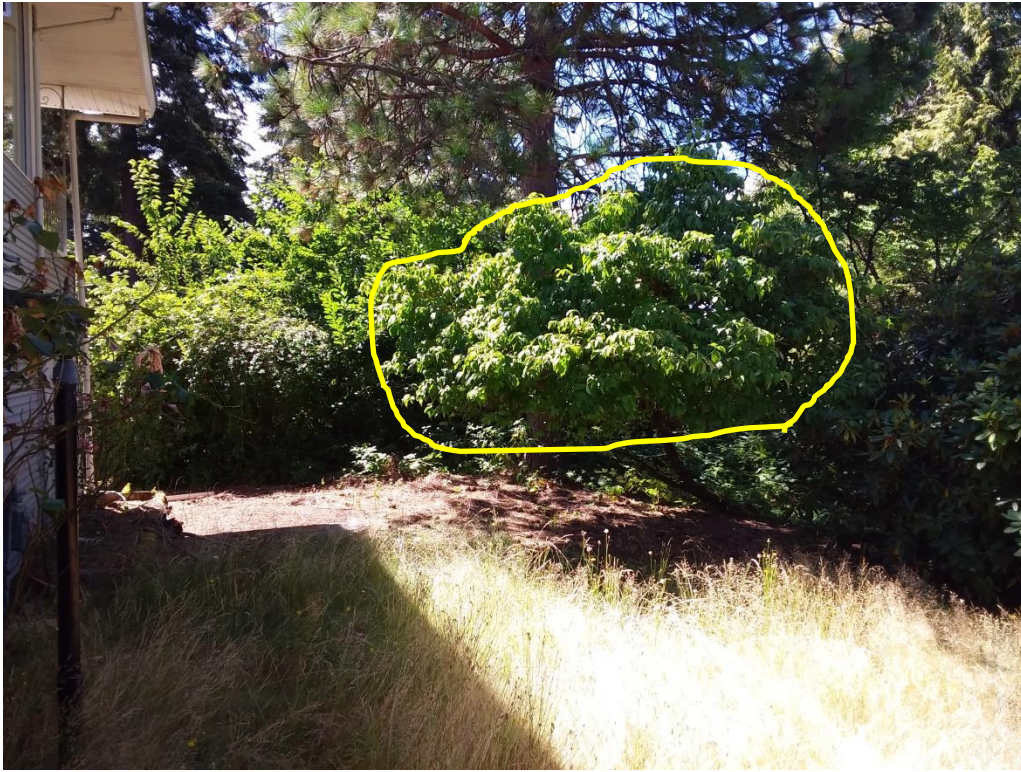
Figure 13. Looking south at the canopy of the #6 dogwood extending toward the existing house. The #7 pine is in the background center.

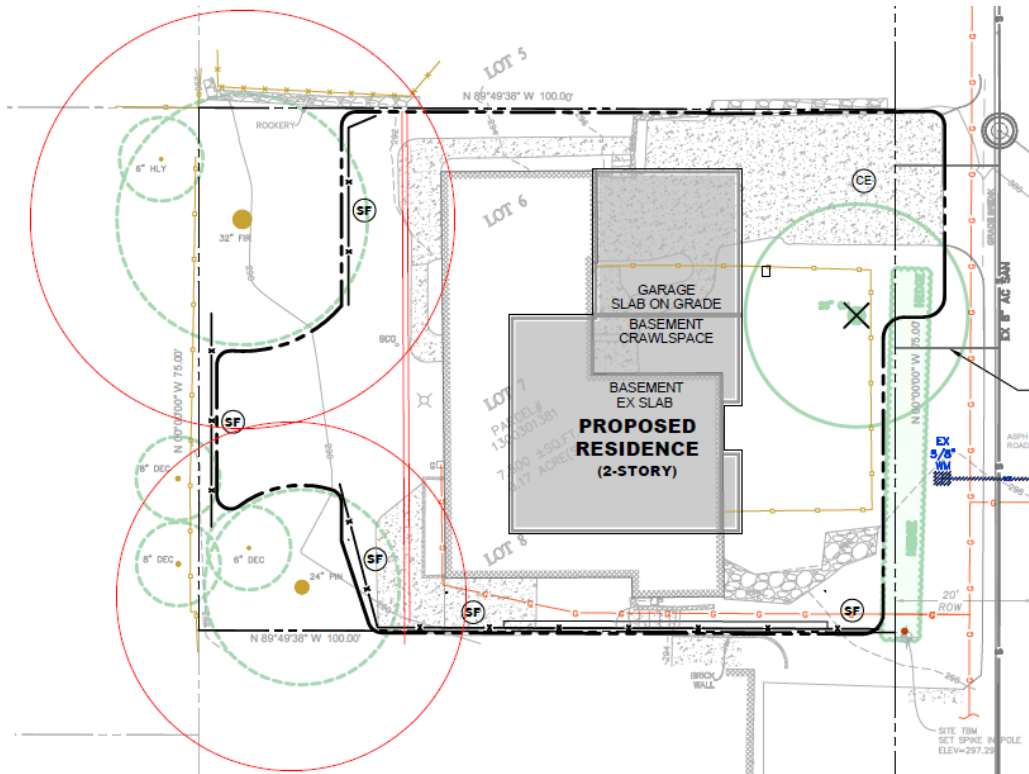
Figure 16. Excerpt from the C1.0 plan sheet with illustrations from the author overlaid. The two large red circles are scaled to match the actual CRZs of the #4 and #7 trees. The double red line running north to south is where the fence for these trees has to be set up to ensure necessary protection. Nothing should happen west of the fence without arborist input and oversight.

The protection fence on the west side should run from the north property line south along the edge of the NW patio (5' W of the existing foundation) to meet up with the edge of the SW patio and hence to the south line (Figure 16). This will protect both the #5 vine maple and the #6 dogwood along with the larger fir and pine.
