AMERICAN FOREST  
MANAGEMENT

**ARBORIST REPORT**  
**for**  
**WW Sustainable LLC**  
**4657 86<sup>th</sup> Ave SE**  
**Mercer Island, WA**

October 10, 2022  
**UPDATED MARCH 17, 2023**

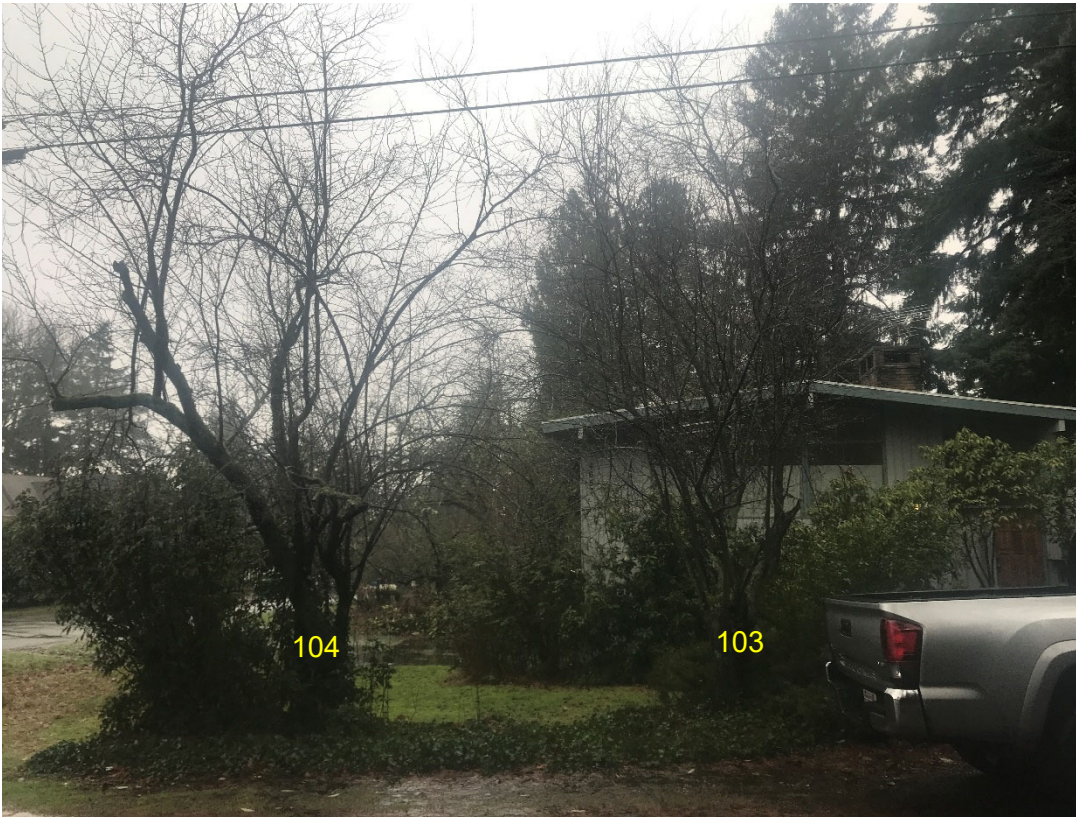
Trees #101- 105 are a row of thundercloud flowering plums (*Prunus cerasifera*) growing east of the property line in the 86<sup>th</sup> Ave SE right-of-way. These are in fair-poor condition with a history of excessive pruning for overhead utility line clearance and internal decay.

Trees #103 and 104 in the 86<sup>th</sup> Ave SE ROW. Note overhead utility lines and excessive pruning for clearance. These trees are in fair- poor condition and unlikely to remain viable in the long-term.

- Obtain all necessary permits from the City of Mercer Island prior to carrying out work that may impact the site trees.
- Consider removing Tree #105 as it is in poor condition and is not considered viable.
- Adhere to tree protection measures outlined in this report for all retained trees.
- Any disturbance within the drip lines of retained trees should be monitored by the project arborist.
- Have retained trees re-assessed for health and structure once development work has been completed.

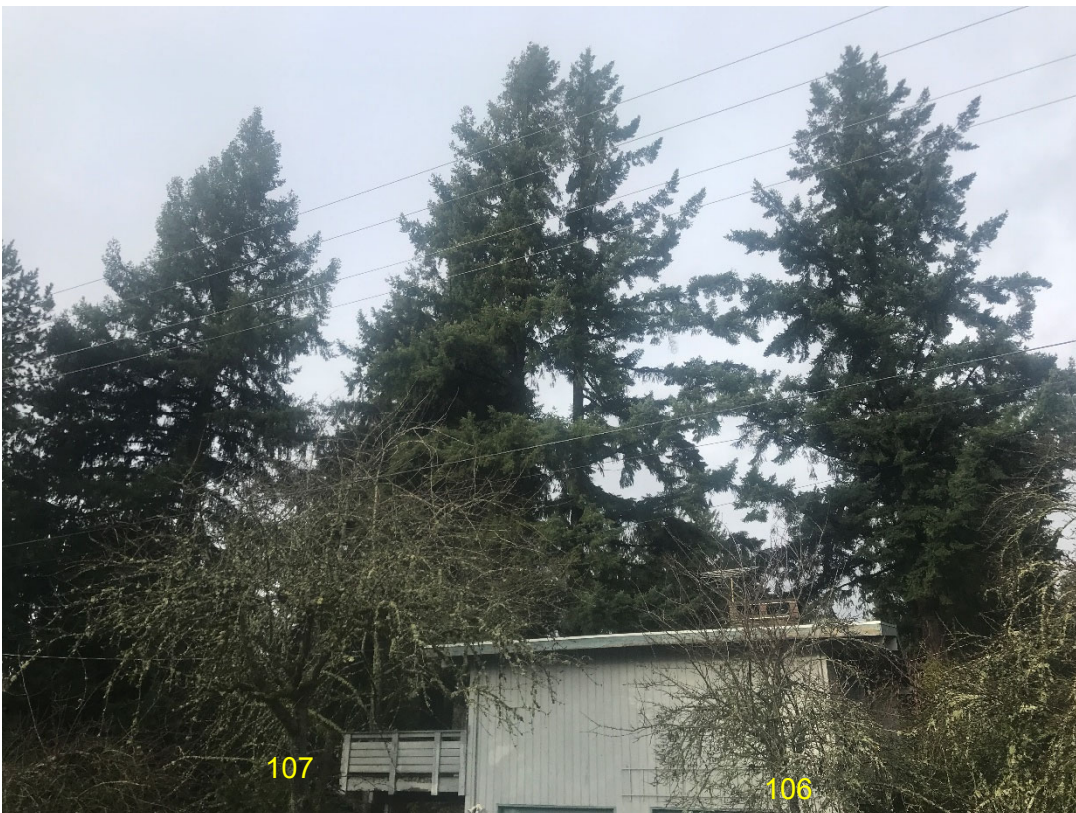
Trees #106 and 108 are apples (*Malus sp.*) growing south of the property line in the SE 47<sup>th</sup> St right-of-way. These are in fair condition with a history of excessive pruning to maintain a height of 10-15 feet.

The existing house viewed from the south. Trees #106 and 107 are on either side of the driveway in the SE 47<sup>th</sup> St. ROW. These trees are in fair- poor condition and unlikely to remain viable in the long-term.

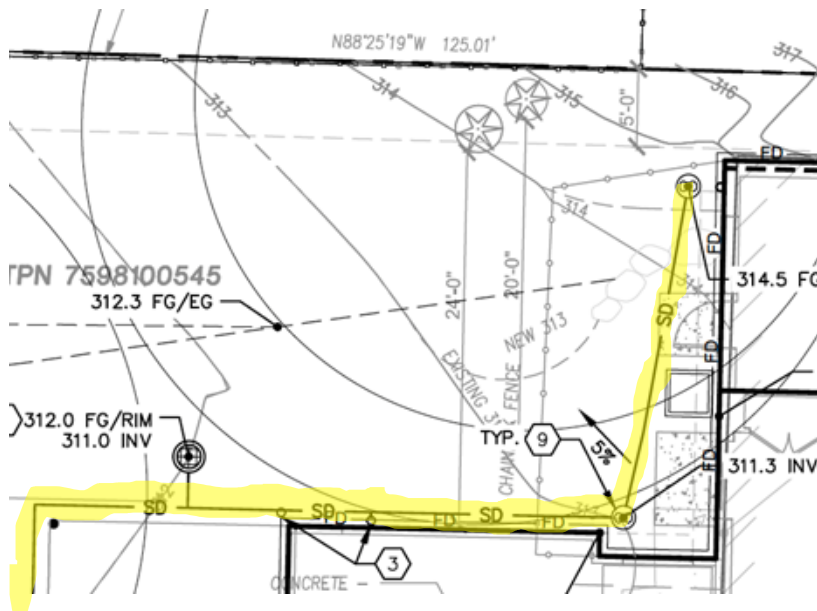
The current site plan shows a storm drain trench is planned to be installed within the shared drip line of Trees #9 and #10 west of the existing home's footprint. The route of this storm drain is within the required five-foot space between the existing building footprint and the tree protection fence.

Air excavation of the drainage path will allow the project arborist to assess the potential impacts to trees #9 or #10 and potentially allow for installation of the storm drain below significant structural roots without cutting them.

- Excavate the drainage path within the drip lines with an air-spade to allow the project arborist to assess the roots in the trench. If possible, install the drainage pipe below the structural roots without cutting them. Following excavation, supply supplemental irrigation to the trees until the fill can be replaced.
