AMERICAN FOREST
MANAGEMENT

ARBORIST REPORT
for
WW Sustainable LLC
4657 86th Ave SE
Mercer Island, WA

October 10, 2022
UPDATED MARCH 17, 2023

To: Cam Weaver
Company: Weaver Construction Co.
From: Benjamin Mark – Salish Restoration Associates
Date: 3/21/23
Re: Planned Excavation Within Driplines of Retained Trees

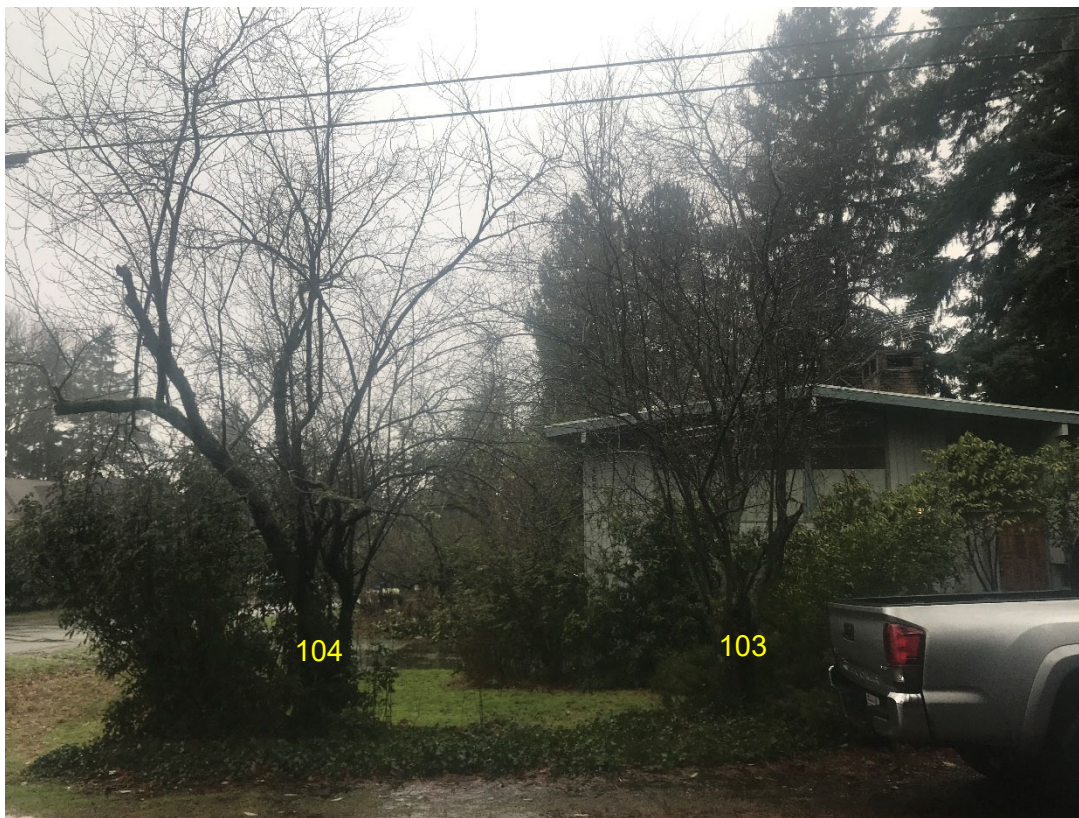
Trees #101- 105 are a row of thundercloud flowering plums (*Prunus cerasifera*) growing east of the property line in the 86th Ave SE right-of-way. These are in fair-poor condition with a history of excessive pruning for overhead utility line clearance and internal decay.

Trees #103 and 104 in the 86th Ave SE ROW. Note overhead utility lines and excessive pruning for clearance. These trees are in fair- poor condition and unlikely to remain viable in the long-term.

- Obtain all necessary permits from the City of Mercer Island prior to carrying out work that may impact the site trees.
- Consider removing Tree #105 as it is in poor condition and is not considered viable.
- Adhere to tree protection measures outlined in this report for all retained trees.
- Any disturbance within the drip lines of retained trees should be monitored by the project arborist.
- Have retained trees re-assessed for health and structure once development work has been completed.

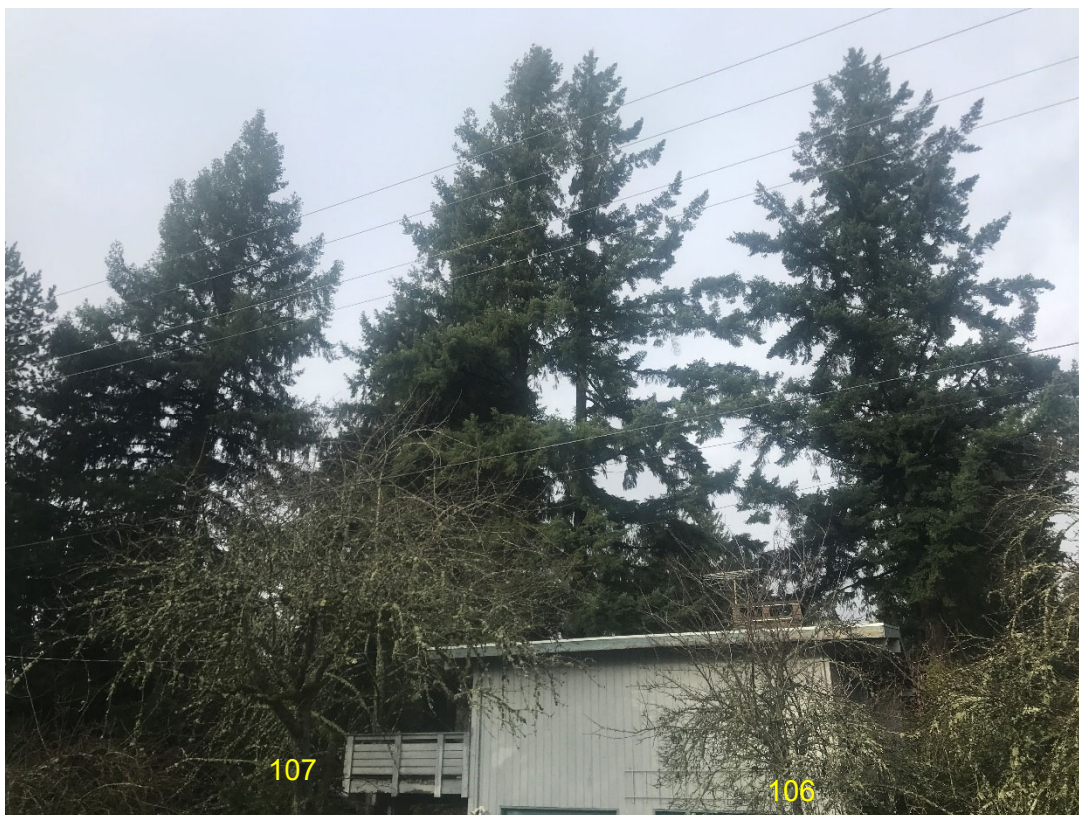
Trees #106 and 108 are apples (*Malus sp.*) growing south of the property line in the SE 47th St right-of-way. These are in fair condition with a history of excessive pruning to maintain a height of 10-15 feet.

The existing house viewed from the south. Trees #106 and 107 are on either side of the driveway in the SE 47th St. ROW. These trees are in fair- poor condition and unlikely to remain viable in the long-term.

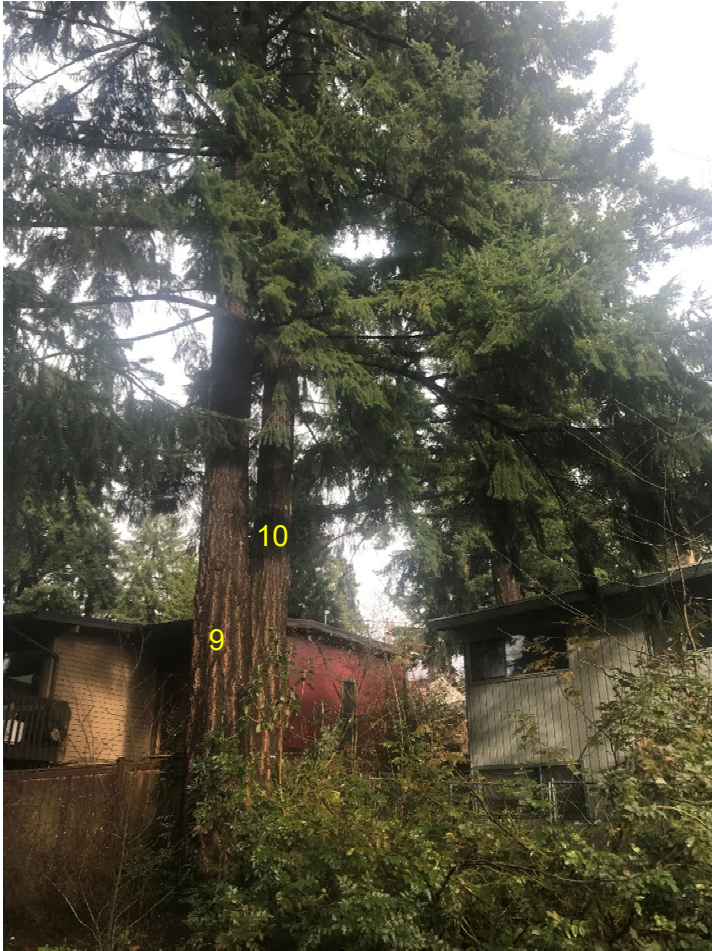
Trees #9 and 10 are Douglas-fir in good condition found near the north property line to the west of the existing house. Both are considered 'exceptional' trees with DBH of 36 and 32 inches. The shared canopy of these trees overhangs the existing house.

The lower trunks of Trees #9 and 10 viewed from the south. Note their shared canopy extends over the existing house.

The upper crowns of Trees #9 and 10 viewed from the south. Note their shared canopy extends over the existing house.
