Arborist Report

June 8, 2022

Aspen Homes/Elizabeth Tubbs
3632 90th Ave SE
Mercer Island, Wa

Arborist report for Aspen Homes and Elizabeth Tubbs. Site address: 3632 90th Ave. SE., Mercer Island Washington. May 31, 2022.

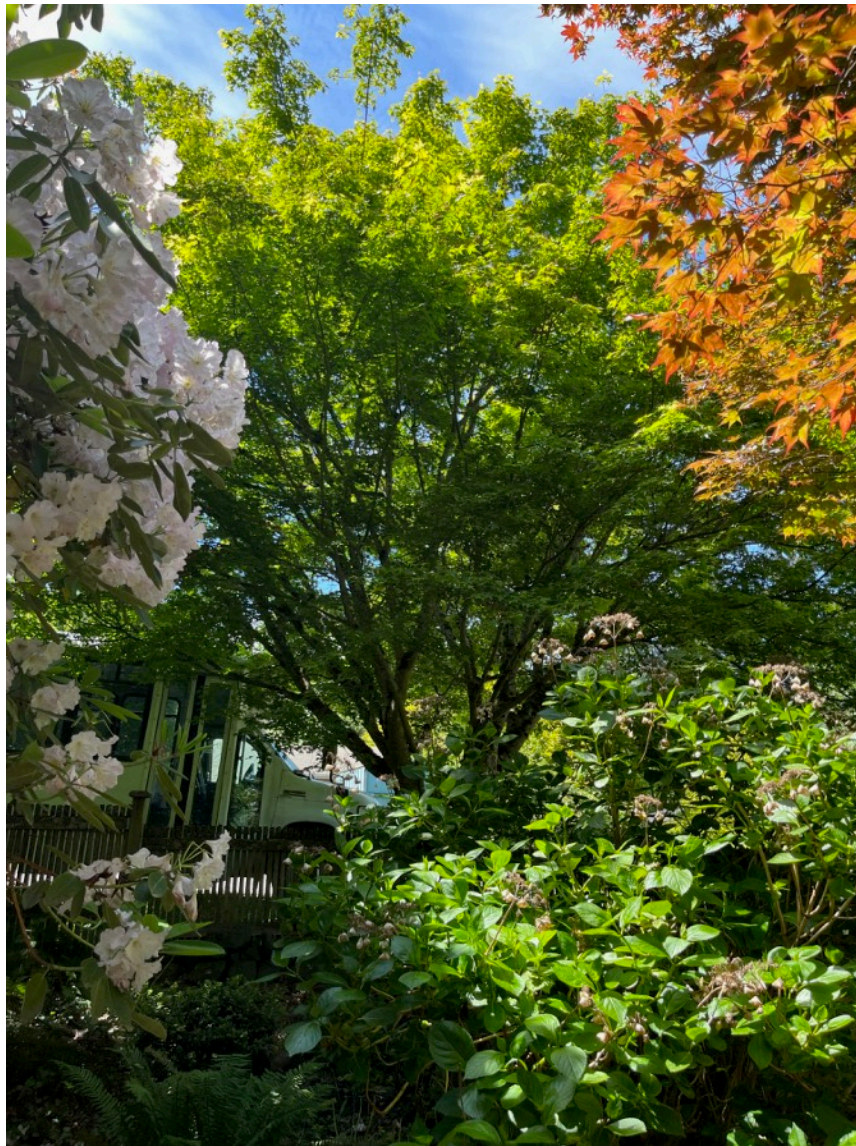
Tree 1653

Tree number 1653 is a Japanese Maple (*Acer palmatum*) with two stems that have diameter at standard height readings of 10.5 inches and 9 inches. This is a fairly low, wide Japanese Maple with a drip line radius of 11 feet. Condition 6. The DSH is 14". The CRZ radius is 14'.

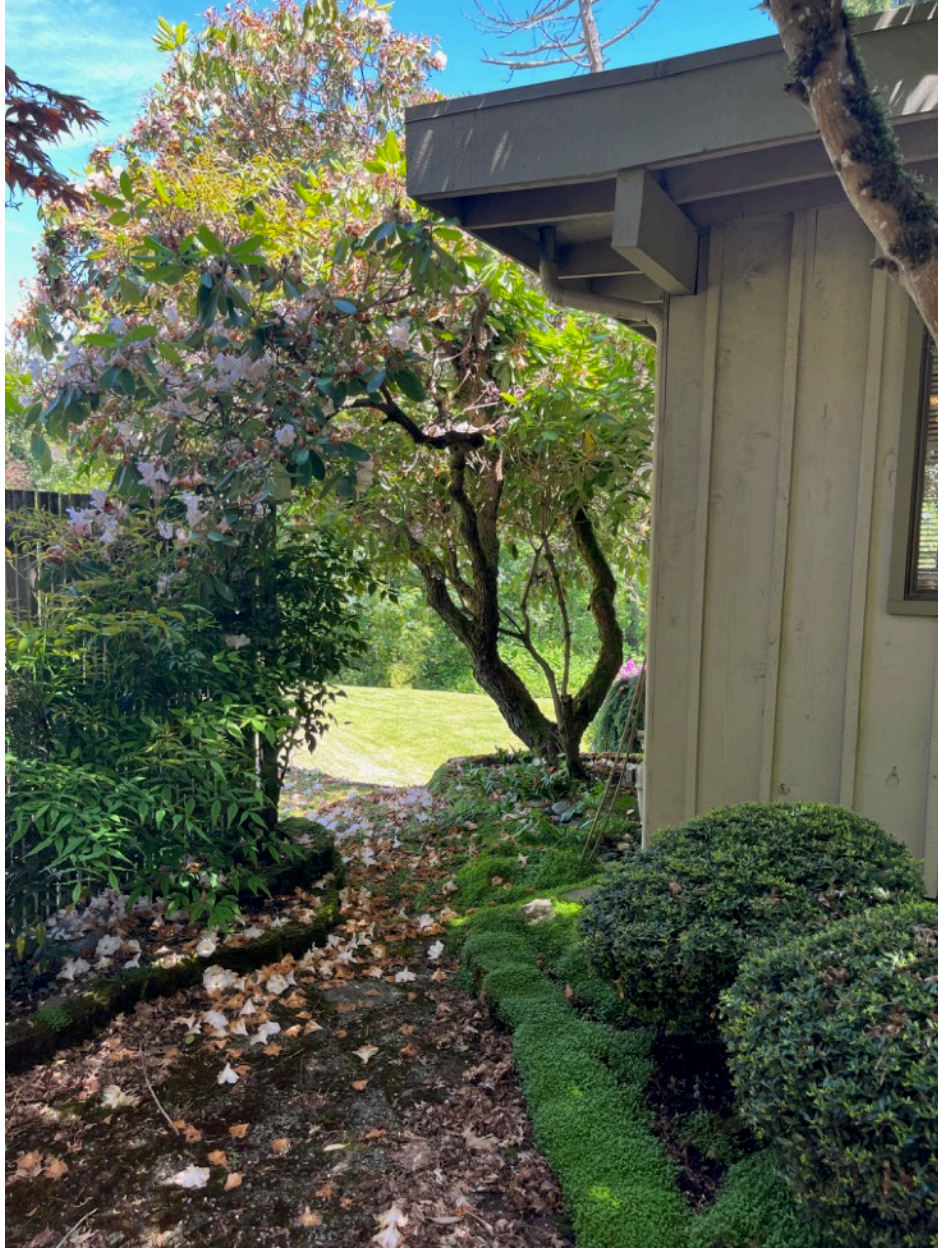
Rhododendron 1658

Tree number 1658 is a multi-stemmed Rhododendron that is northwest corner of the existing house. DSH readings are 6 inches, 6 inches, and 5 inches. Condition 6. Drip line radius is 5 feet.

After reviewing my initial inventory for this site, the client has informed me that they would like to remove Trees #1654, 1656, 1657, and 1658. The removals will need to be mitigated with the installation of 4 deciduous trees of minimum 1.5" caliper, or conifers that are at least 6' tall.

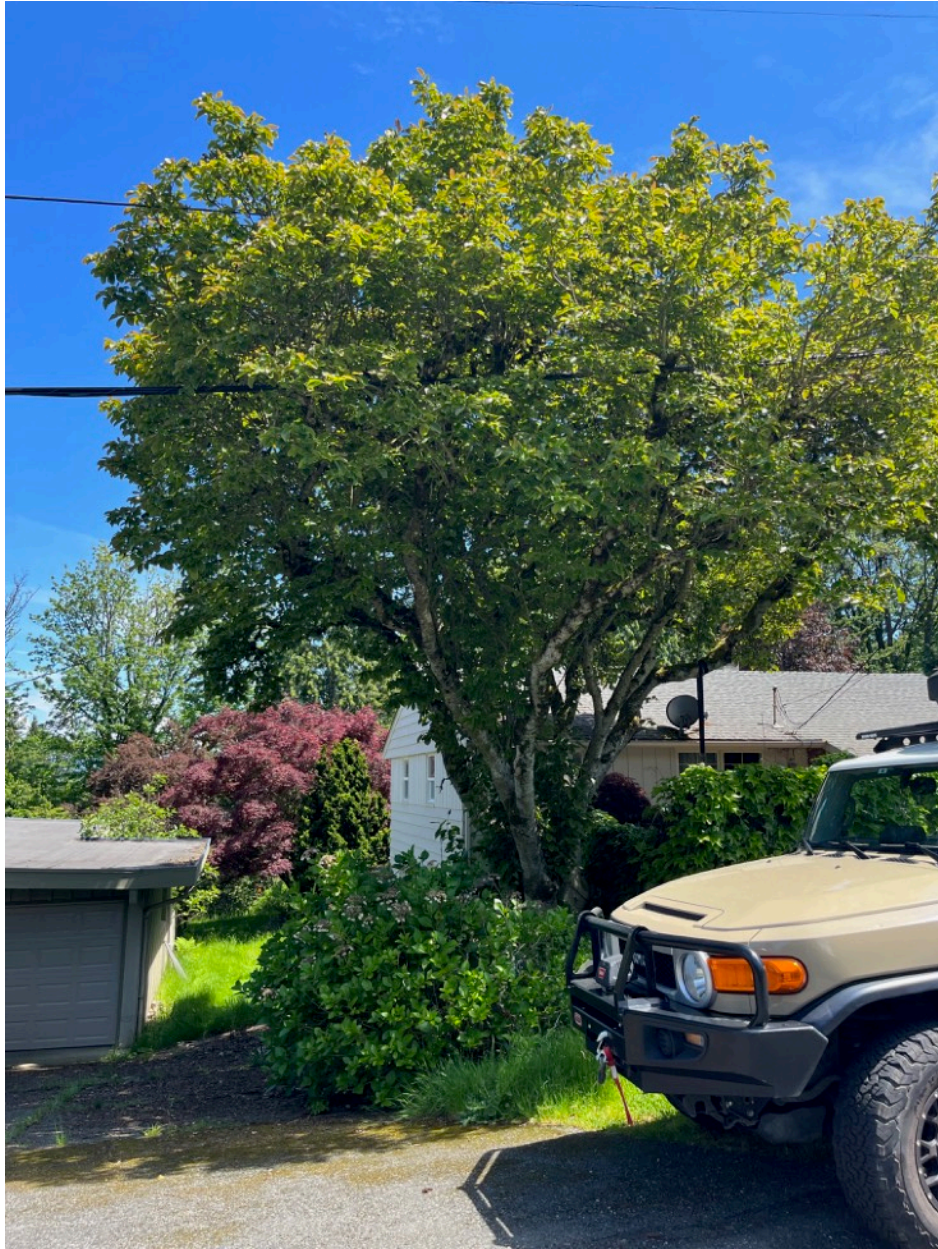
Tree 1659

Tree number 1659 is close to the southwest corner of my client's site. It is a Magnolia (*Magnolia x soulangiana*) with smooth bark that is to the south of the driveway. This tree has five main stems with diameter and standard height readings of 12 inches, 11 inches, 11 inches, 10 inches, and 10 inches. The DSH is 24". This tree's drip line extends 14 foot to the north. Because of all the ivy at the base level, it was not possible to accurately analyze the root flare as the tree is on the south neighbor's property. The multi-stemmed habit of this tree yields a relatively high DSH measurement. I do feel as though it is most appropriate to assign a Critical Root Zone radius for this specimen that is based upon the 22 foot reading that I obtained with a laser rangefinder. The critical root zone radius for this specimen should be based upon the drip line not

the DSH measurement. I am assigning a CRZ radius of 22 foot for this specimen. Much of the area to the north of the tree is below grade or already under impervious surfaces. This specimen will likely tolerate some root zone disturbances north of the root flare, so long as the project is carefully undertaken. The client should expect to have to minimize root zone disturbances around the specimen as it is also on a neighboring property. Condition 6.

under the existing driveway at my client's address, I do believe that this system will tolerate some root zone loss, but I would expect to have to do the necessary demolition work in the root zone of this tree with hand tools, and I would expect to have to protect the majority of the root zone of this system during the construction process.

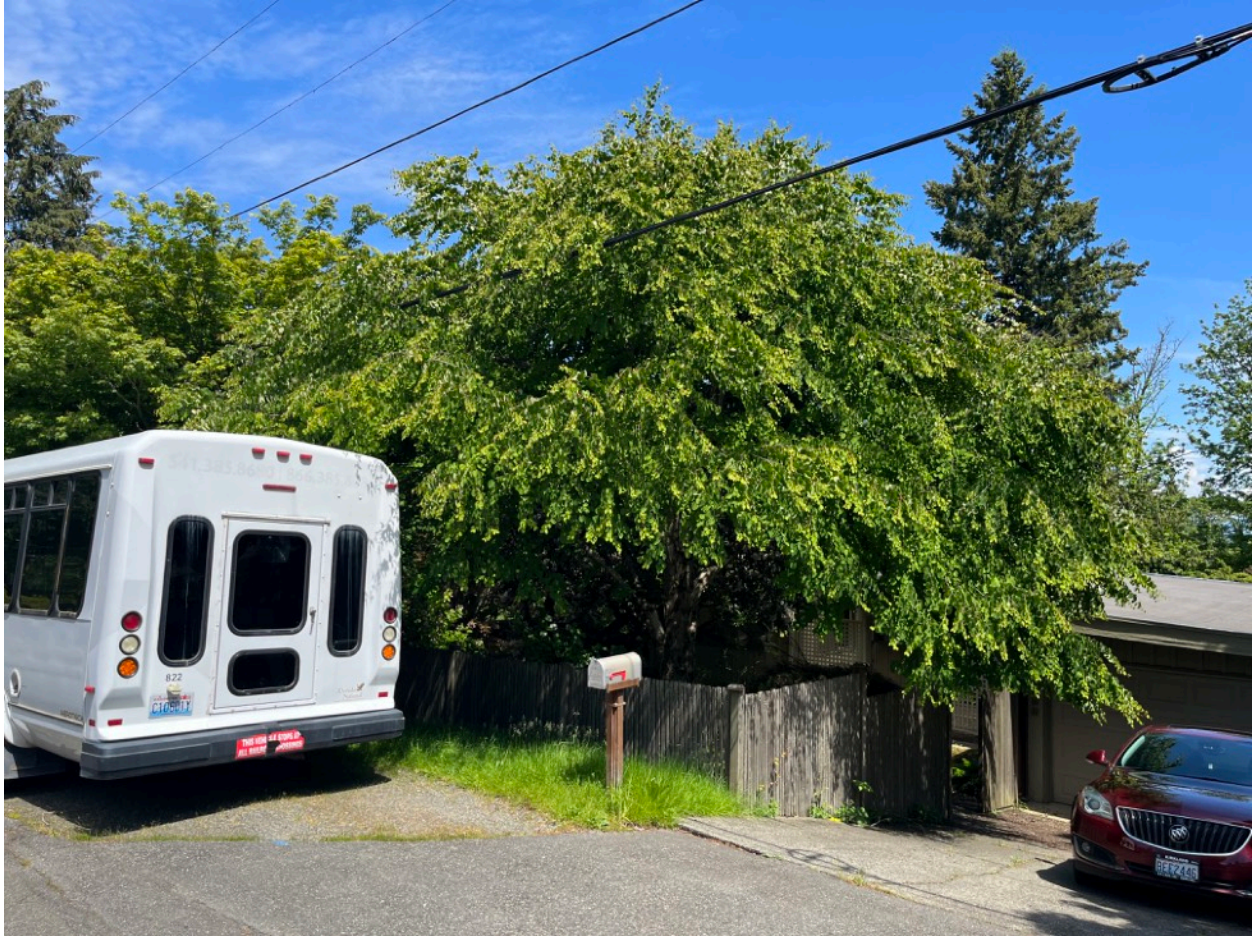
Tree 1654

Tree number 1654 is a Katsura Tree (*Cercidiphyllum japonicum*) with a diameter at standard height reading of 15 inches. That reading was taken just a little bit higher than usual because of a branch collar at standard height. This tree has a larger drip line toward the northwest that has a radius of 19 feet. There is a significant amount of surface rooting coming away from the root flare of this system. This tree will not likely tolerate significant disturbances to the outer critical root zone. Condition 6. The CRZ radius is 15'.

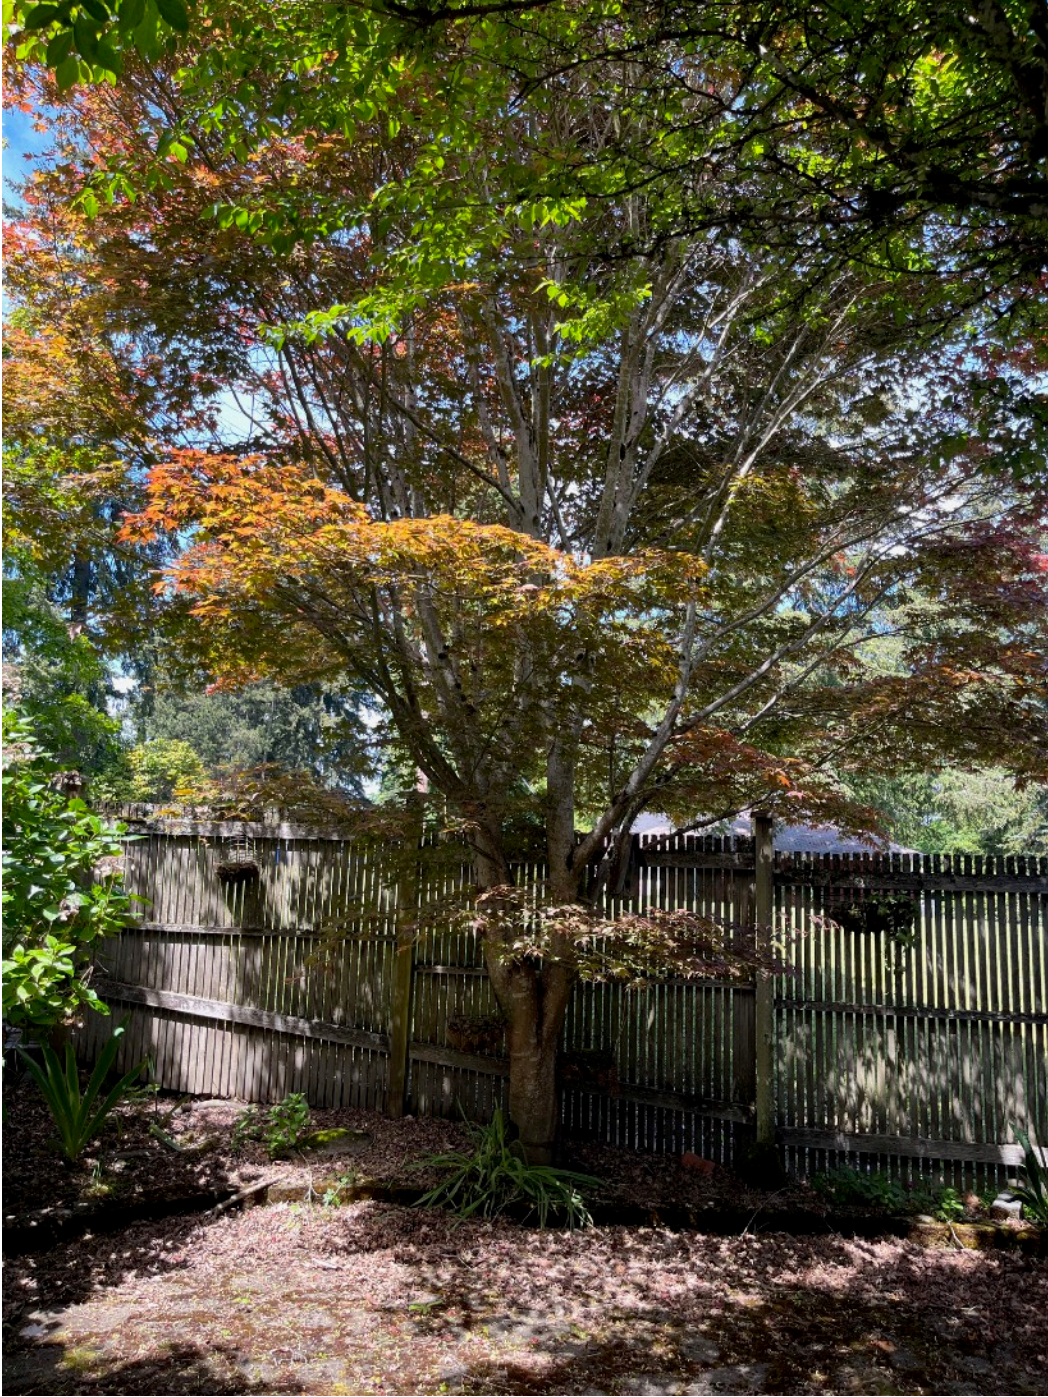
Tree 1656

Tree number 1656 is on the north property line. It is a two stem Japanese Maple (*Acer palmatum*). DSH readings are 8 inches and 7 inches. Condition 6. Drip line radius is 8 feet. The cumulative DSH is 11". The CRZ radius is 11'.

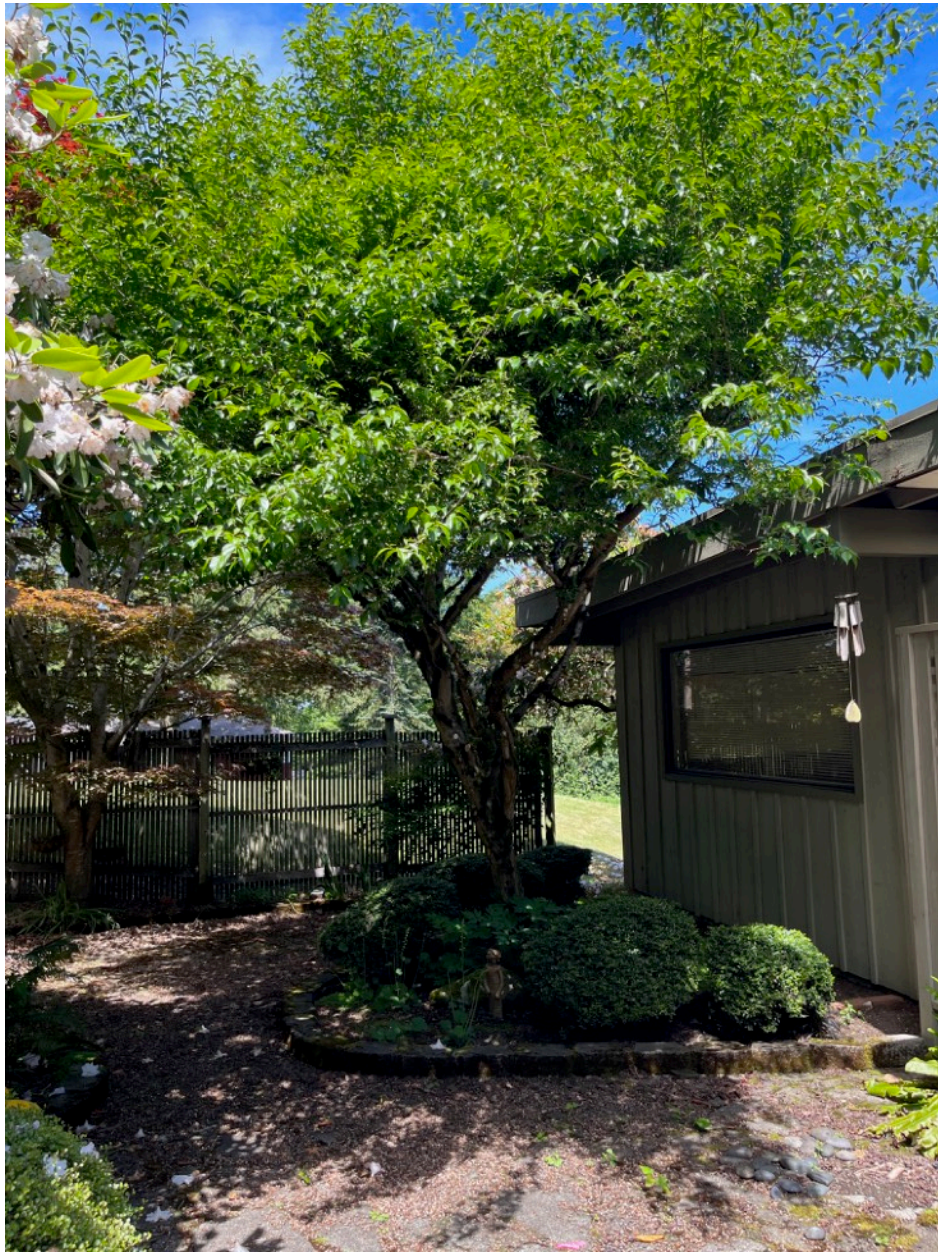
Tree 1657

Tree number 1657 is just west of the existing structure on the site. It is a Japanese Snowdrop Tree (*Styrax japonica*). There are three main stems: 6 inches, 4 inches, and 4 inches. The DSH is 9". The drip line radius for this tree is 9 feet. Condition 6. The CRZ radius is 9'.

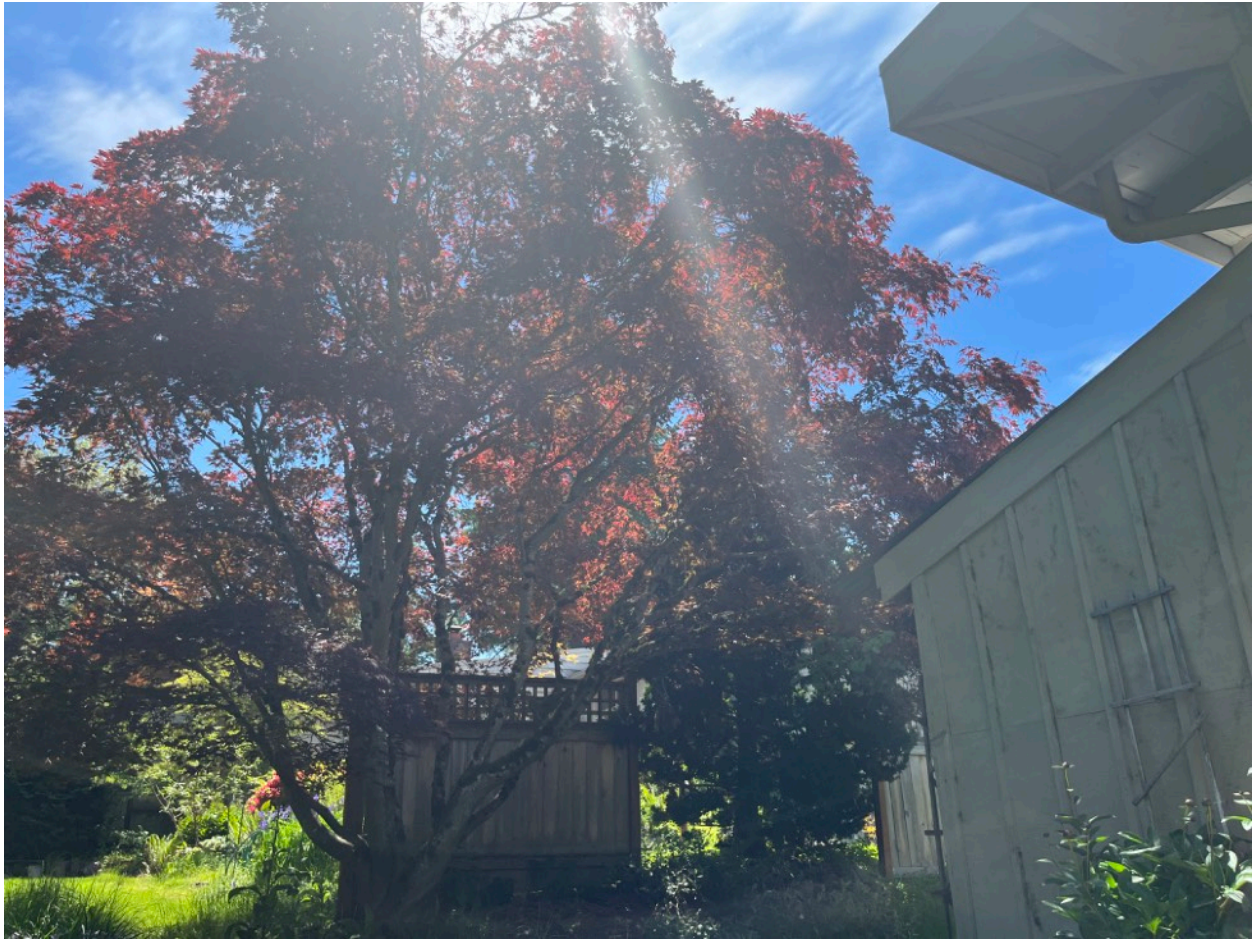
Tree 1660

Tree number 1660 is also on the south neighbor's property or straddling the property line. It is a multi-stemmed Japanese Maple (*Acer palmatum*) and I feel as though it is most appropriate to take the diameter at standard height reading at the base of this particular tree. The DSH is 13 inches in approximately ankle height and I feel as though that appropriately represents the age of this specimen. The drip line radius for this tree, measured from an the north with a laser rangefinder, is 13 feet. 13 feet should be considered the Critical Root Zone radius for this specimen. Condition 6.

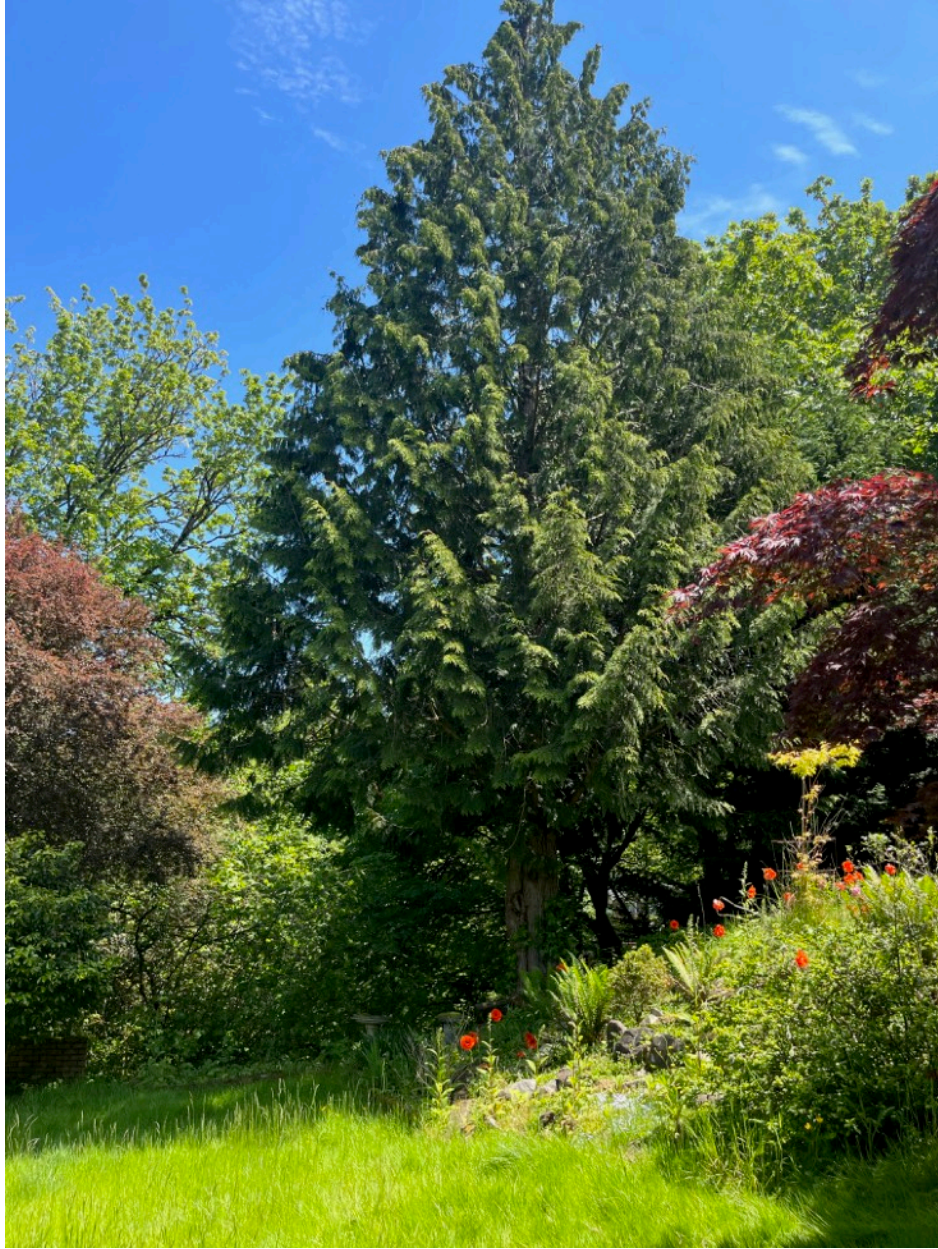
There is one tree that is fairly close to the southeast corner of my client's site that should be considered when the architect is drawing up the site plans. There is a Western Red Cedar (*Thuja plicata*) with a diameter at standard height of 28 inches. It is on the south neighbor's property and the tree has excurrent structure. It is in excellent condition and because it is bigger than 24 inches of diameter at standard height, it is a protected tree in The City of Mercer Island and I expect that there will need to be Tree Protection Fencing put around the Critical Root Zone of the system prior to construction activities commencing.

This is the cedar that should be added to the map

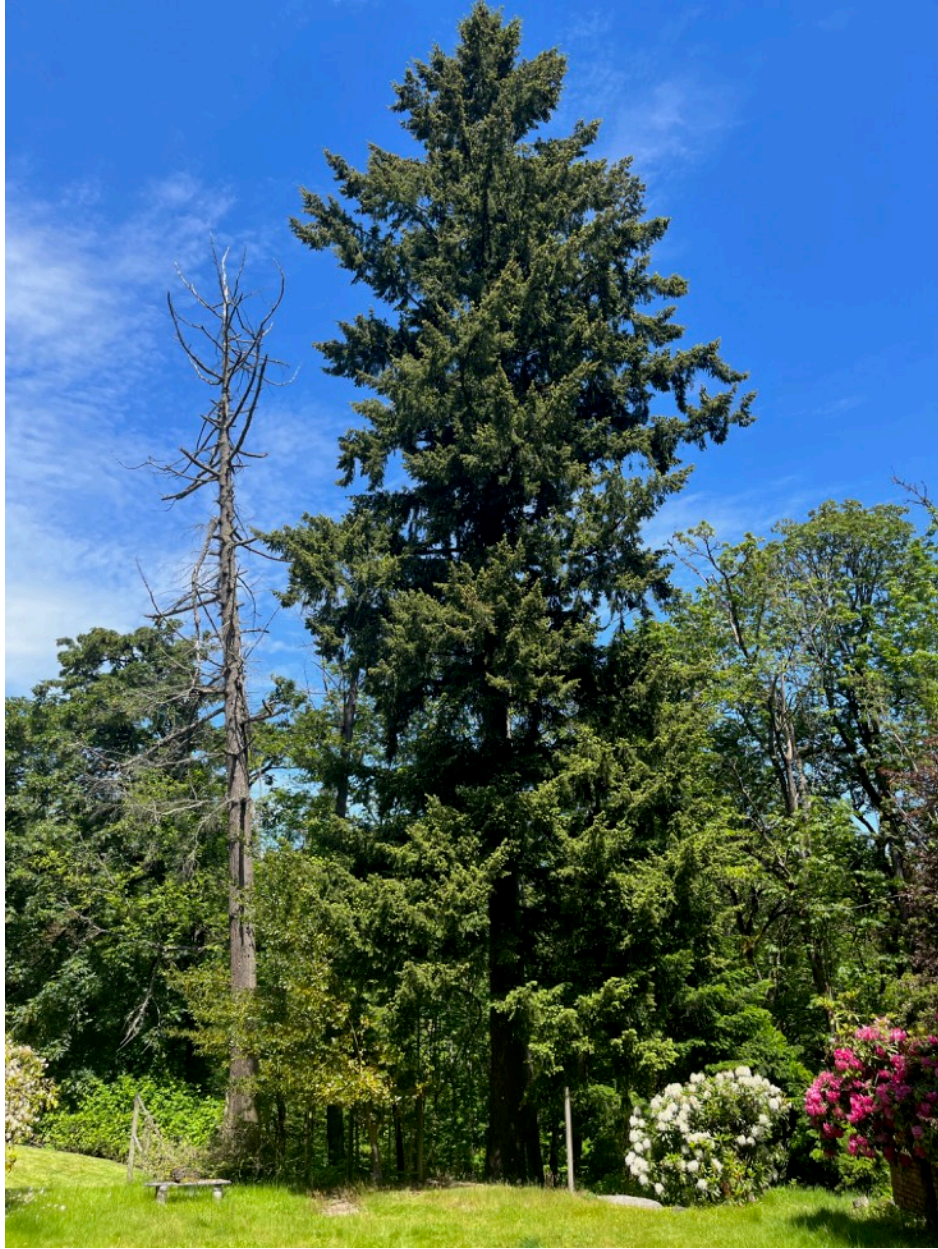
Tree 1662

Tree number 1662 is in the northeast corner of my client's property. It is a Douglas Fir (*Pseudotsuga mensiezii*) with a diameter at standard height reading of 29 inches. This tree has excurrent structure and is in excellent condition. This tree is at the crest of a hill that drops off somewhat steeply toward the east. Condition 6.
