## **Arborist Report**

**June 28th, 2023**

**Site Address:**  
3632 90th Ave SE  
Mercer Island, Wa

**Prepared by:**  
Douglas Smith  
ISA Board Certified Master Arborist PN 6116-B  
Tree Risk Assessment Qualified (TRAQ)  
3907 Aurora Ave N.  
Seattle, Wa. 98103  
(206)457-5706  
[doug@seattletreeconsulting.com](mailto:doug@seattletreeconsulting.com)

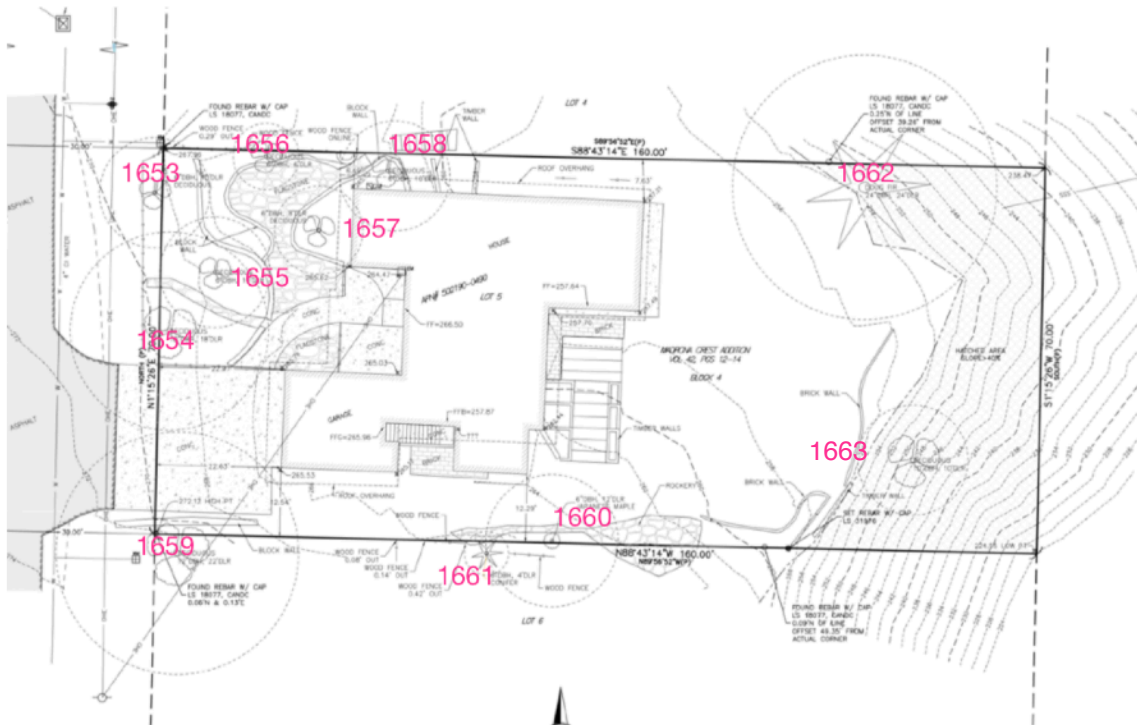
### Ananta Gudipaty Numbered Map

Arborist notes for Ananta Gudipaty/Mercer Island project. This is another return trip to this site for me to verify all of the data that I collected during the initial site visit is accurate. I did verify that all of the trees are tagged with consecutive numbers and I also added those numbers to the map again.

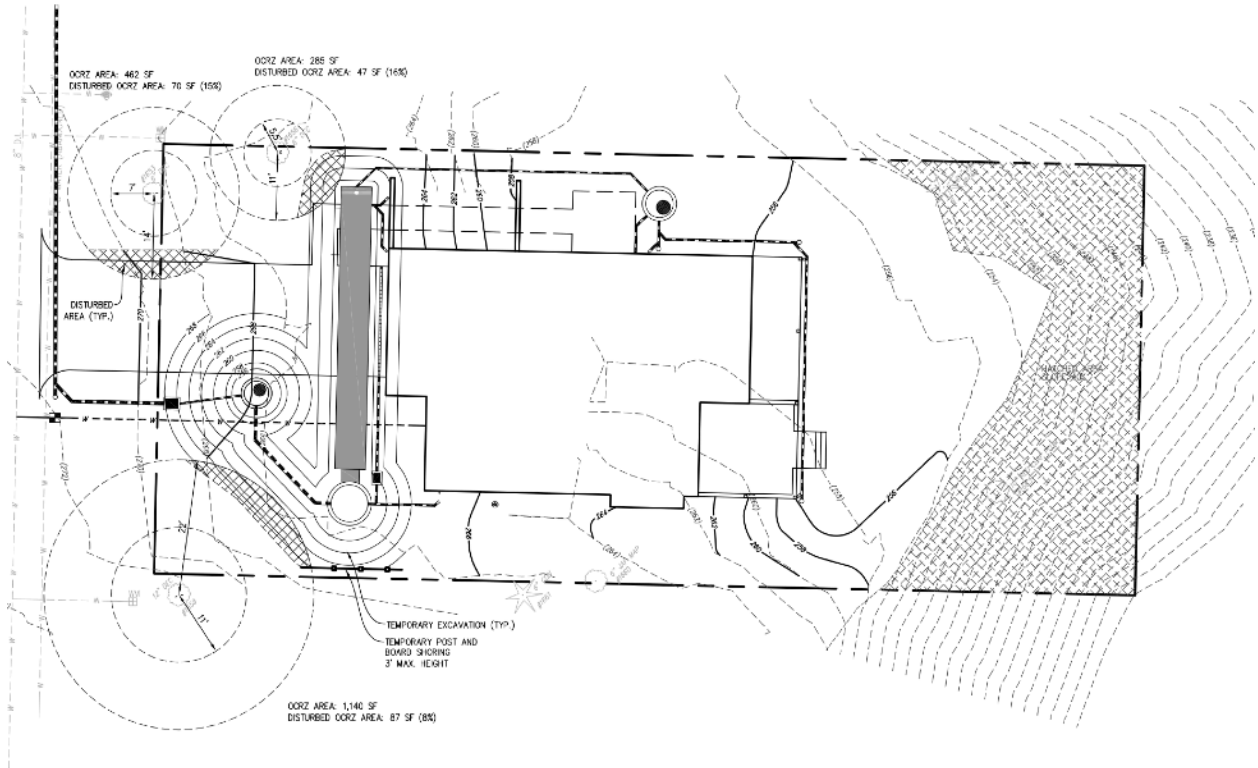
## Details of the Tree Disturbances

On Tuesday, June 27th, the project designers shared the above map with me. It shows the placement of the detention pipe and the extent of the permanent and temporary disturbances that the trees being preserved will endure. The disturbances are within the accepted tolerances in the profession (less than 1/3 of the OCRZ disturbed and no ICRZ disturbances). Tree Protection Fencing will need to be installed at the Limit of Disturbance prior to any construction activities commencing.

The water line avoids the Critical Root Zones of the trees entirely.

The Limit of Disturbance for the driveway cut is 10'1" south of Tree 1653. This avoids the ICRZ entirely and disturbs 15% of the OCRZ.

*All of the trees that are being preserved and that are also experiencing root zone disturbances should be irrigated during the summer months as well as have their root zones mulched to encourage the development of new feeder roots.*
